# **INDOOR AIR QUALITY ASSESSMENT**

**C.D. Hunking Middle School  
98 Winchester Street  
Haverhill, MA**

Prepared by:  
Massachusetts Department of Public Health  
Bureau of Environmental Health  
Indoor Air Quality Program  
April 2012

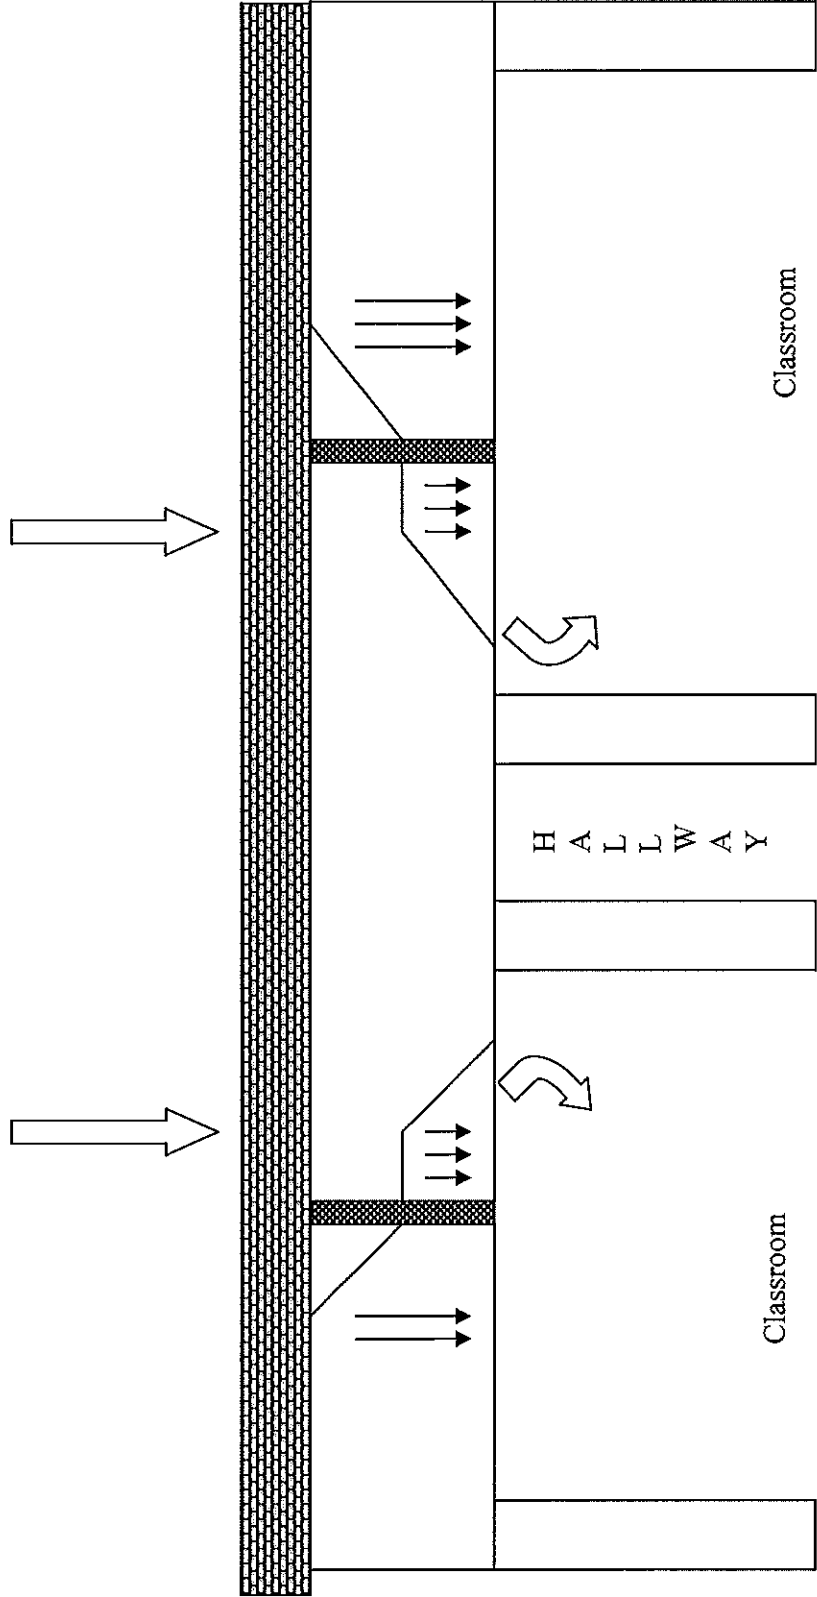
**Figure 5: Roof Beam Exterior Wall Beams Are Not Supported by Beam Traversing the Hallway Walls, Load is Shifted to Roof via Bolts Allow for Exterior Wall Beam Rotation**

wing. As mentioned, the crawlspace under the unoccupied wing is subject to chronic moisture exposure. Water impingement has weakened the foundation walls, reducing the ability of these walls to take on the transferred roof load. Over time, the roof of this wing will cave inwards due to lack of support from interior walls (from beam orientation) and reduced support from exterior walls (from the weakened foundation walls).

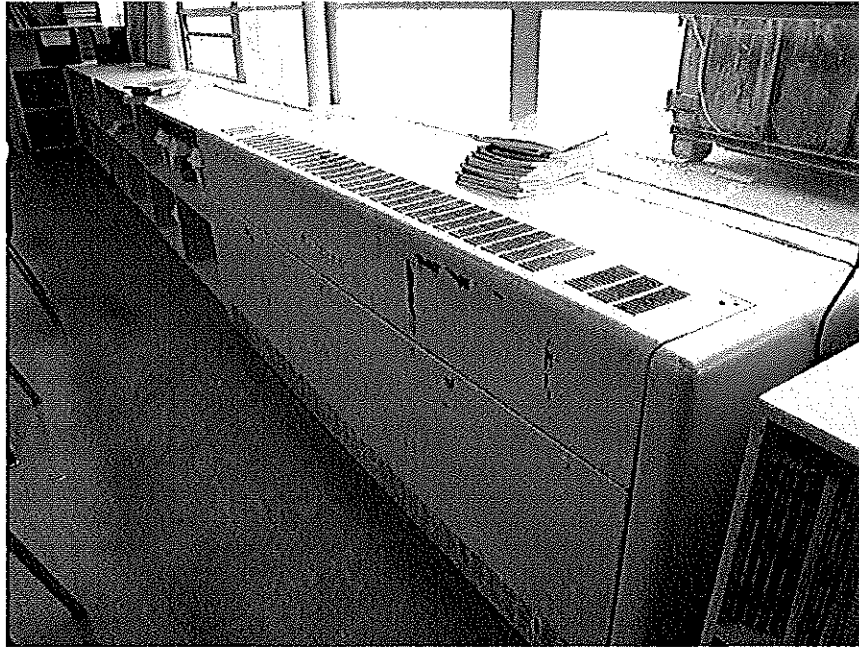
**Picture 1**

Fresh air in classrooms is supplied by unit ventilator (univent) systems (Picture 1). A univent draws air from outdoors through a fresh air intake located on the exterior wall (Picture 2) of the building and returns air through an intake located at the base of the unit (Figure 2). Fresh and return air are mixed, filtered, heated and provided to classrooms through an air diffuser located in the top of the unit. Univents were found obstructed by papers, books, furniture and other stored materials (Picture 3; Table 1). A heavy buildup of dust and debris was also observed on the air diffusers of several univents. In order for univents to provide fresh air as

**Classroom univent**

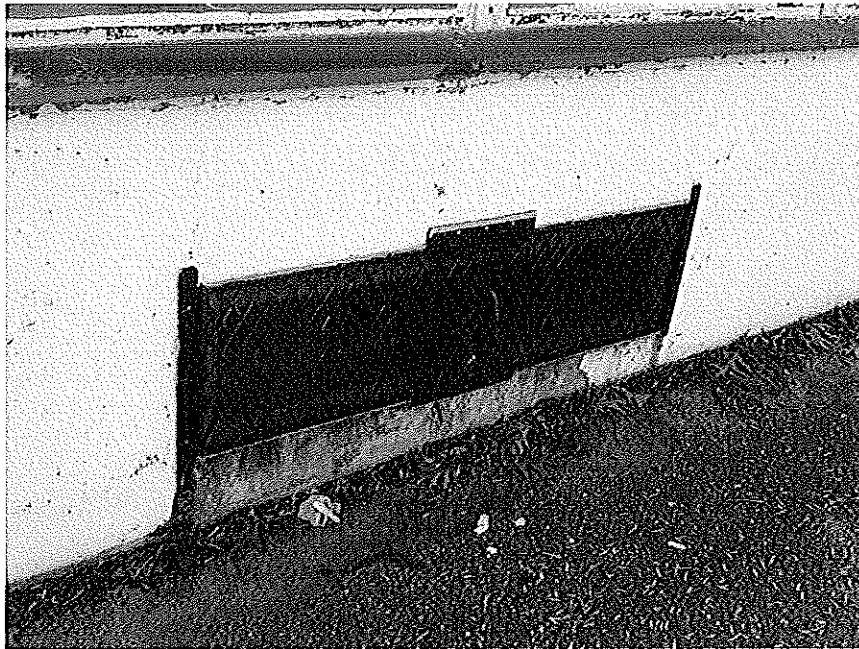
**Picture 2**

**Univent fresh air intake on exterior wall of building**

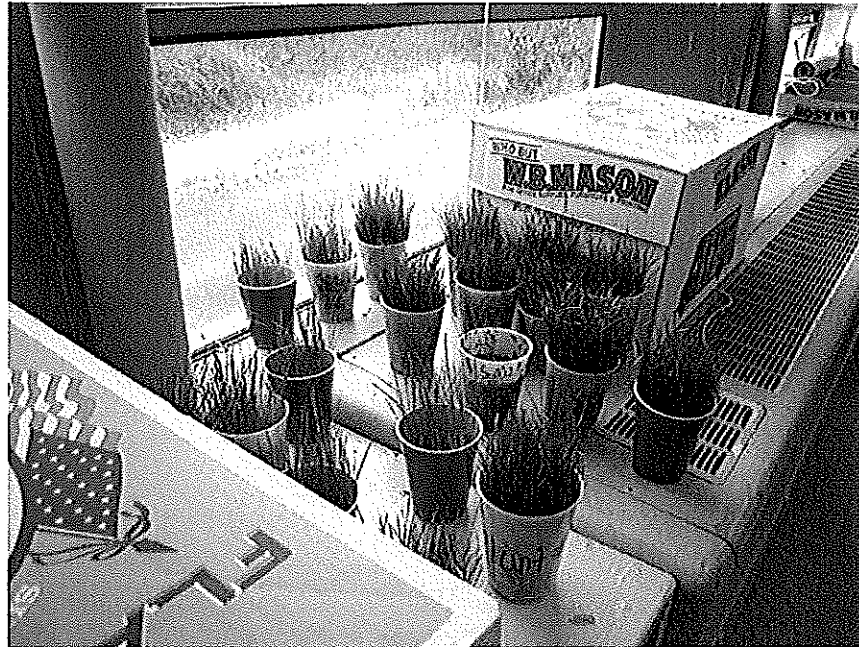
Picture 3

Plants were observed in a number of classrooms (Picture 3). Plants, soil and drip pans can serve as sources of mold growth and should be properly maintained. Over-watering of plants should be avoided and drip pans should be inspected periodically for mold growth. In addition, flowering plants can be a source of pollen. Therefore, plants should be located away from the air stream of univents to prevent aerosolization of mold, pollen and particulate matter.

Plants and other items placed on univent

15. Make adjustments/repairs to crawlspace accesses to render airtight (as possible) to prevent odor/moisture infiltration into occupied areas.
16. Ensure plants have drip pans and avoid over-watering. Examine drip pans periodically for mold growth. Disinfect with an appropriate antimicrobial where necessary. Remove plants from univent air diffusers.

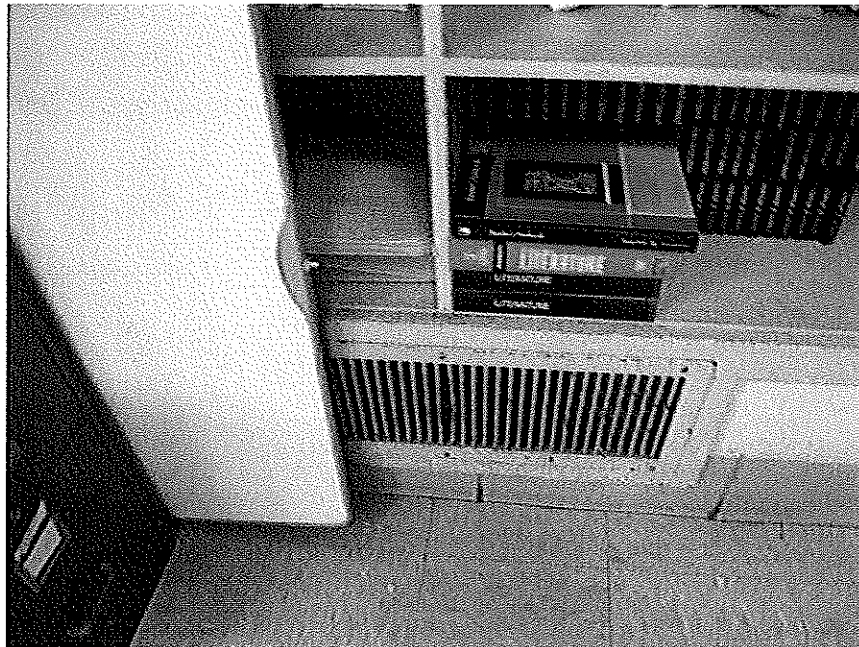
Picture 4

Exhaust ventilation in classrooms is provided by wall-mounted vents (Picture 4) that are connected to ductwork and exhaust fans located inside the crawlspace. At the time of assessment, BEH staff could not detect any draw of air by the mechanical exhaust systems. As reported by AECOM (2011), “structural deficiencies [in the crawlspace] have caused collapse of many of the heating, ventilation and drainage systems.” Corrosion and physical deterioration have rendered the exhaust system inoperable. Without adequate supply and exhaust ventilation, excess heat and normally occurring environmental pollutants can build up, leading to indoor air/comfort complaints.

Classroom exhaust vent

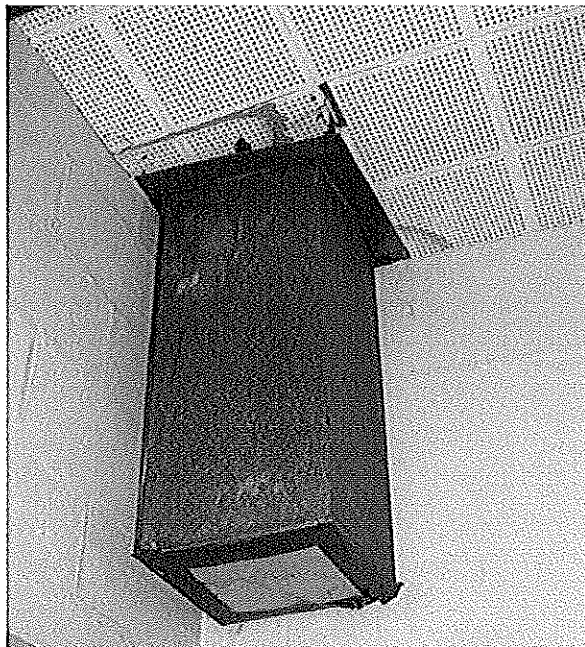
**Picture 5**

Please note, a ducted vent observed in an office (room 158) was sealed with duct tape and cardstock (Picture 5). The purpose of this vent was unknown. Measures should be taken to determine whether this vent can be made operable to create air movement in this office. This office currently lacks any sources for ventilation, relying on air movement from doors opening

**Cardstock-sealed vent, note water-damaged interlocking ceiling tiles**

into adjacent offices. If a means of ventilation can be restored through this vent, a source of fresh air could be established. If the vent is no longer functional, it should be sealed in a manner that does not allow odors, dust/debris and moisture that may be within the vent to penetrate the occupant area.

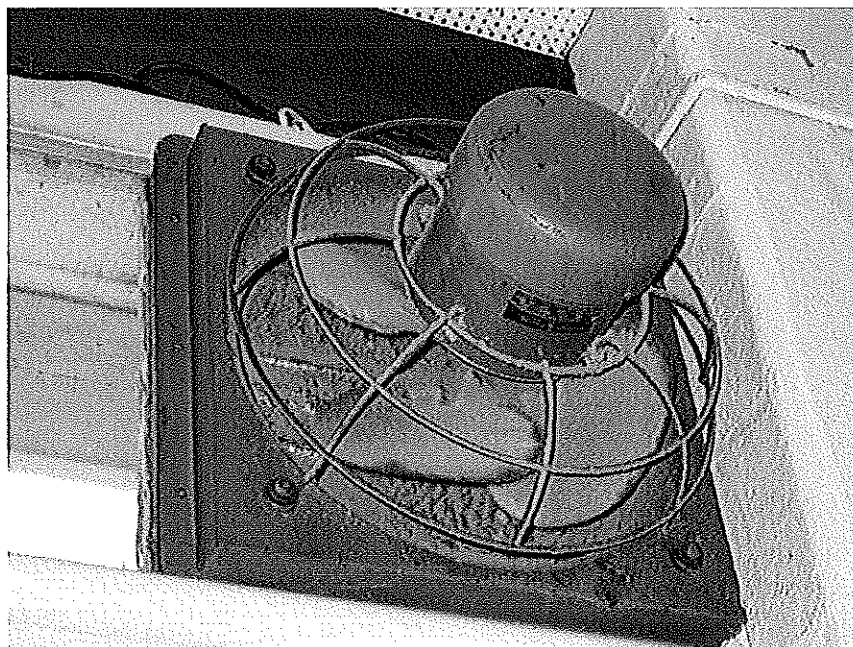
**Picture 6**

**Switch-activated exhaust fan, note occlusion with dust**

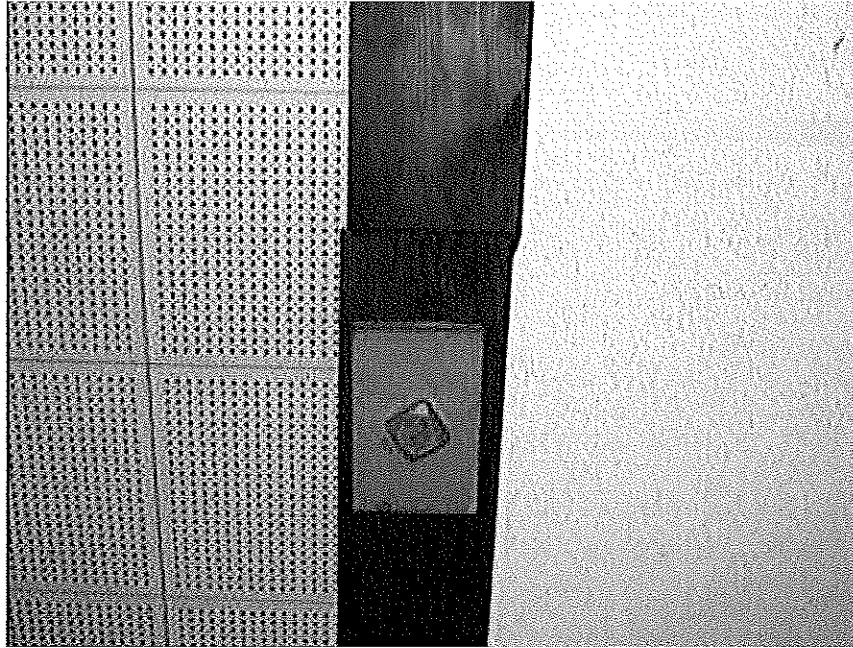
**Picture 7**

**Horizontal movement of load-supporting beam**

7. Monitor all beams and walls for any changes in size of gaps on a monthly basis and after any appreciable snowstorm.
8. For buildings in New England, periods of low relative humidity during the winter are often unavoidable. Therefore, scrupulous cleaning practices should be adopted to minimize common indoor air contaminants whose irritant effects can be enhanced when the relative humidity is low. To control for dusts, a high efficiency particulate arrestance

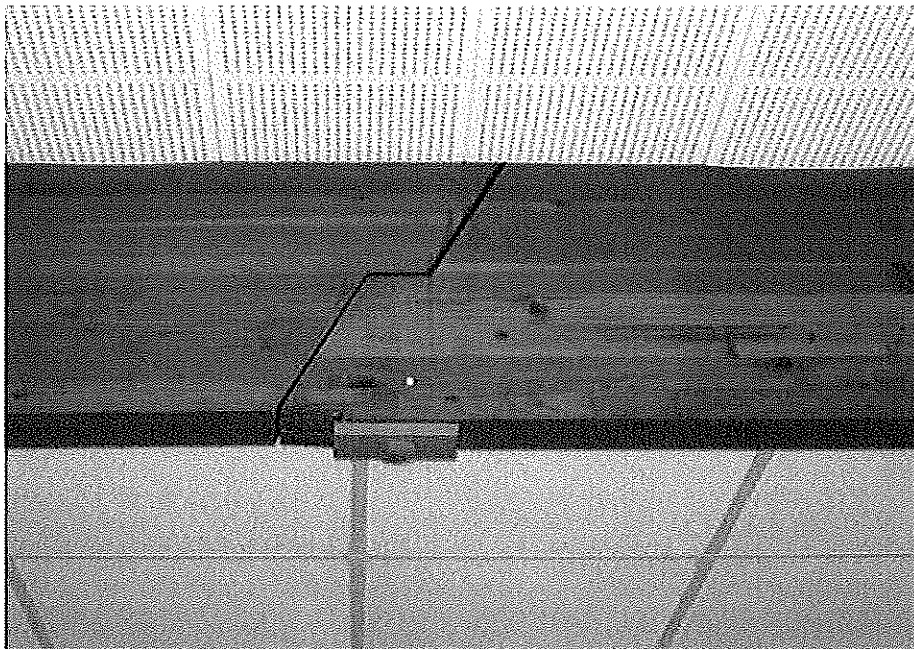
**Picture 8**

**Vertical movement of load-supporting beam**

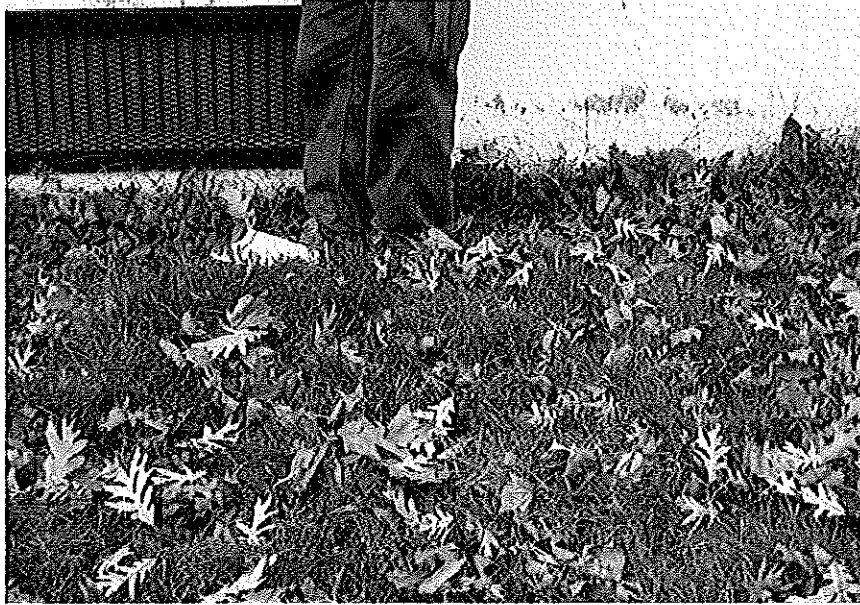
**Picture 9**

roof drain pipes. BEH staff examined the building and noted an additional source of water penetration. Based on observations of the exterior of the building, it is likely that water is also penetrating through the foundation. Compressed soil, forming up to 4-inch depressions, was observed on both sides of the unoccupied wing. These depressions can allow pooling water to come into extended contact with the foundation (Picture 9). Based on these observations as well as documented reports, the crawlspace beneath the unoccupied wing has been chronically exposed to moisture, which in turn has caused significant structural and mechanical damage.

**Depression in soil near footing to building  
(note level of grass in foreground and lack of visibility of feet in background)**

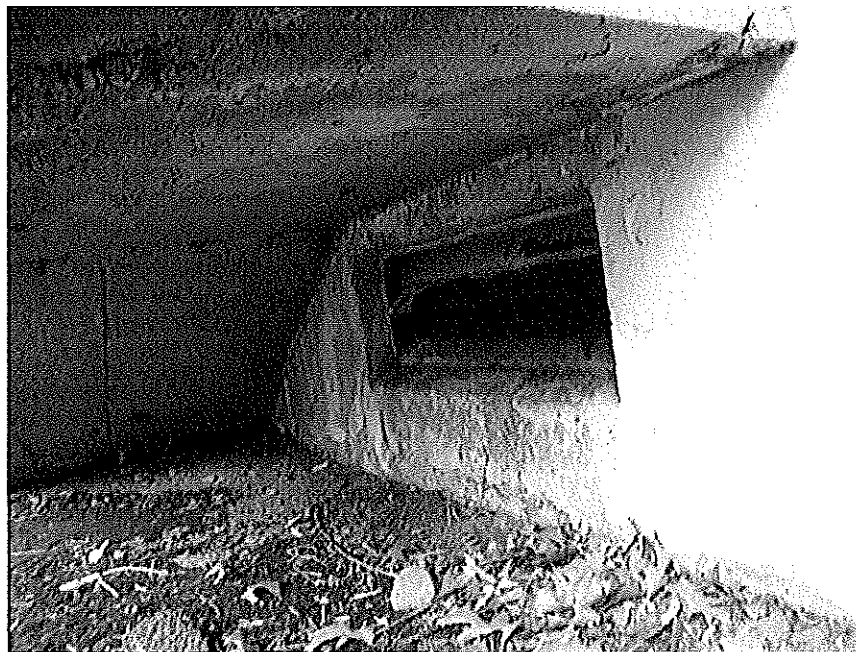
**Picture 10**

Passive vents are typically installed to allow water vapor and other materials in a crawlspace to be removed or diluted. Such vents were observed beneath classroom exterior doors on the western side of the occupied wing (Picture 10). These vents were installed in a manner to create cross-ventilation in the crawlspace. Of note is the orientation of the exterior doors and their stairs/landings, which likely takes advantage of New England's prevailing westerly wind direction. The stairs at position 1 face northwest, while the stairs at positions 2 and 3 face southwest (Figure 3; Picture 11). Depending on the orientation of the wind, the cement stairs/landings either form an air scoop to direct air into the passive vents (windward side) or provide a sheltered location for air to escape from the crawlspace (leeward side). For example, a southwest wind can force air to enter the space formed by the stairs and landing in Positions 2 and 3, creating pressurization that forces air in the crawlspace to escape via the passive vent in Position 1. This airflow created through passive ventilation allows water vapor to escape the crawlspace.

**Crawlspace exhaust vent below staircase**

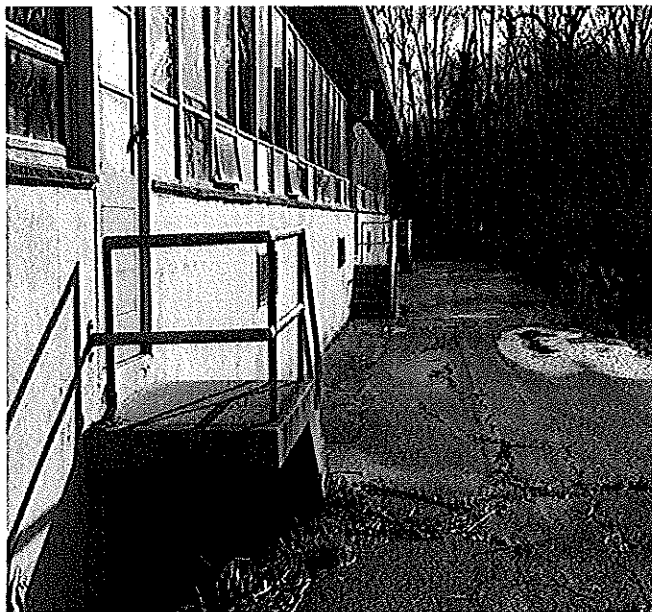
**Picture 11**

**Crawlspace exhaust vents below staircases, note orientation of staircase 1 (foreground) and staircases 2 and 3 (background)**

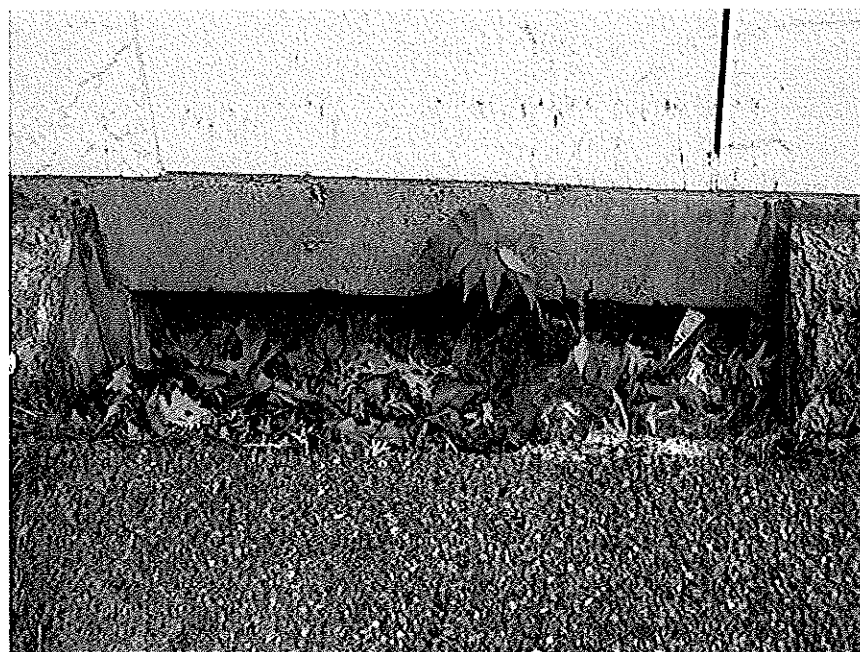
**Picture 12**

**Sealed crawlspace vent near gymnasium**

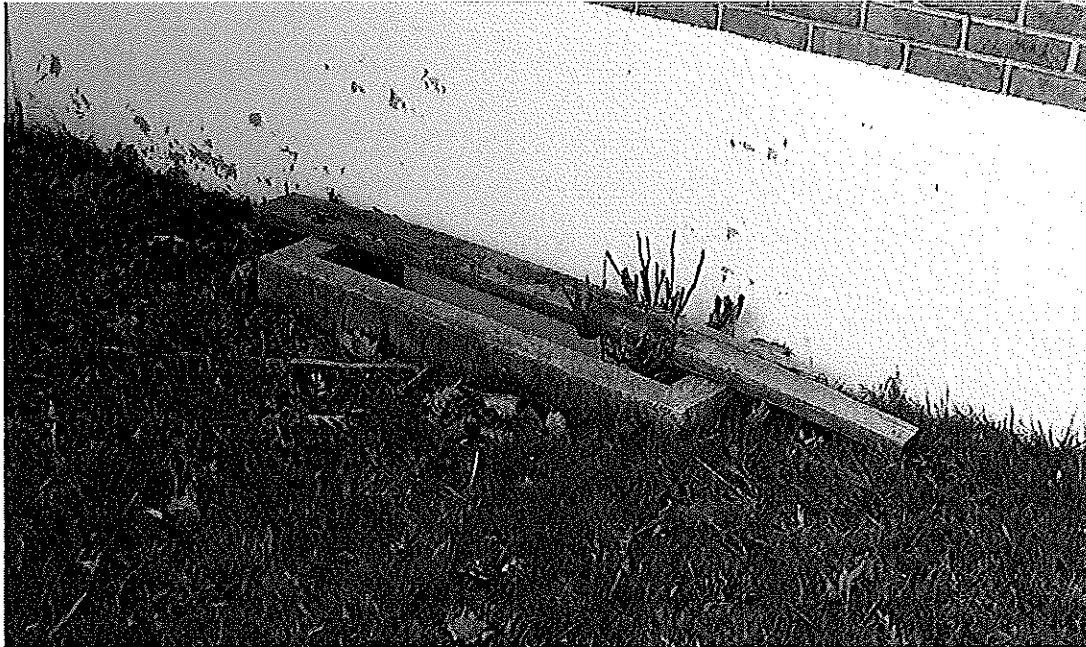
**Picture 13**

**Sealed crawlspace vent near building entrance**

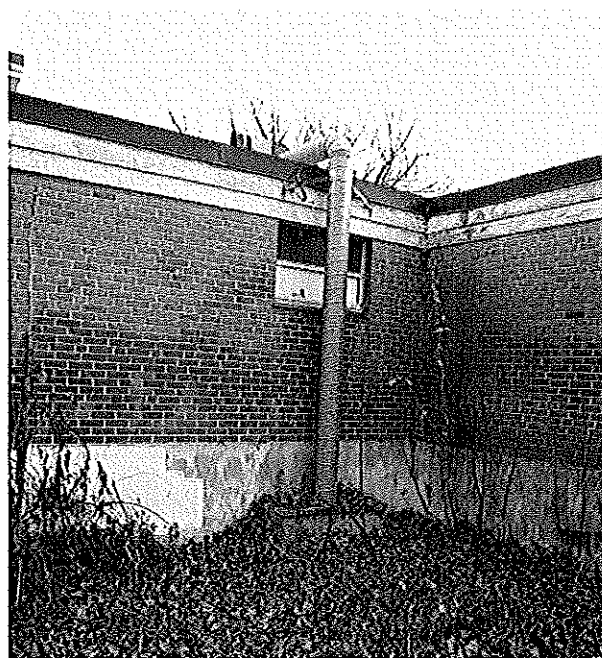
**Picture 14**

**Ductwork connecting exhaust fan to passive vent**

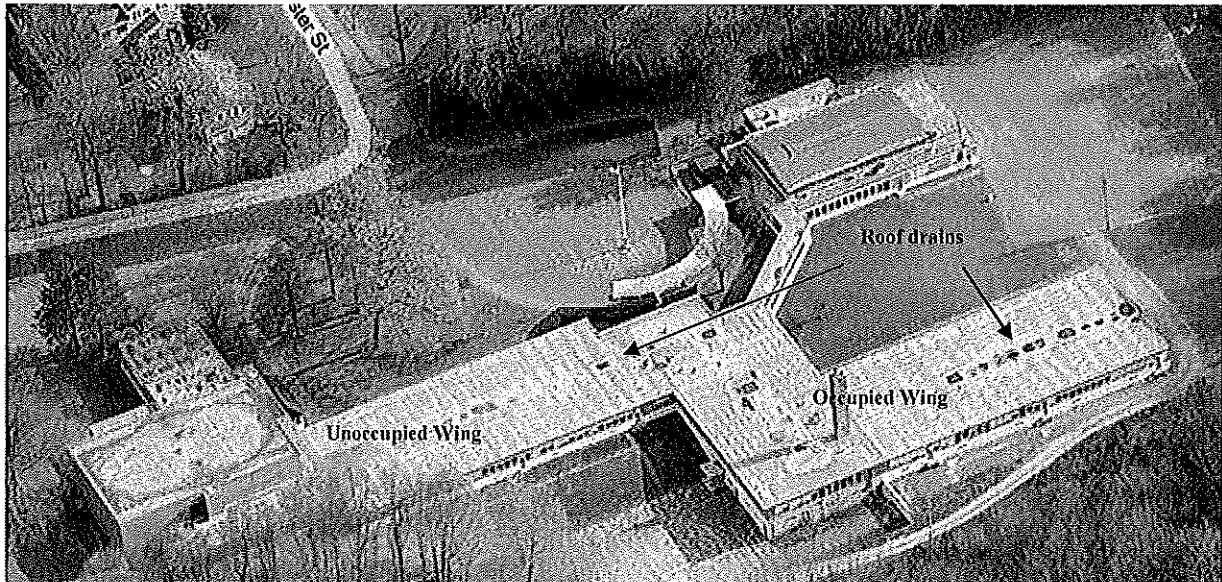
Picture 15

Roof drains located at the center of roof (i.e., along hallway) of each wing. A roof is typically pitched to move water towards the drain, indicating that the roof is convex. (Image source: Bing.com/Maps)

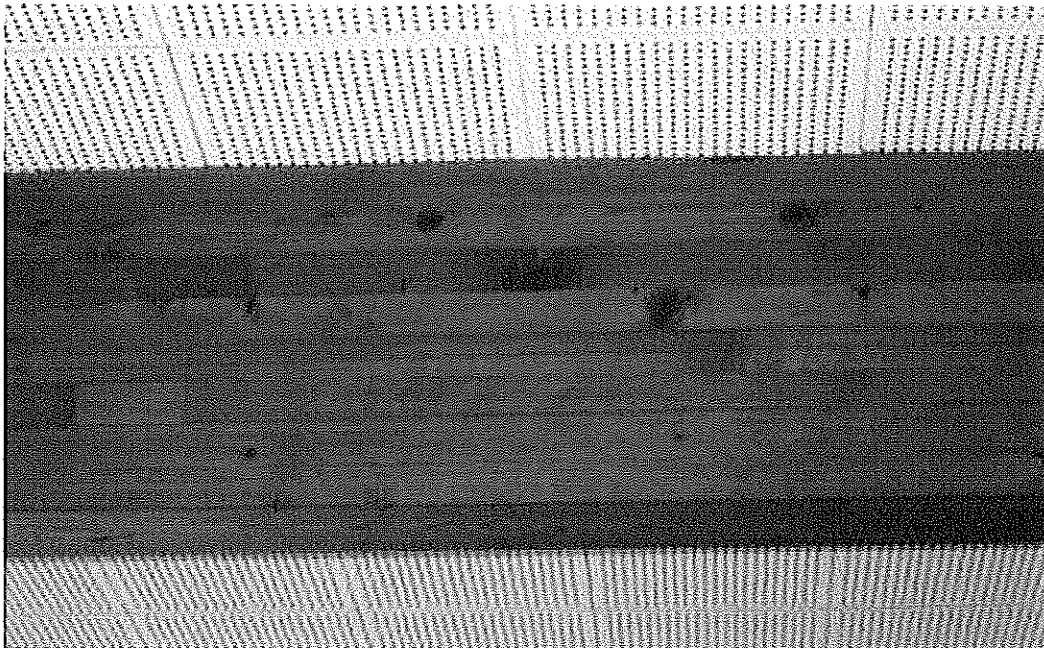
Picture 16

Eight layers of engineered wood glued together to form a laminated beam

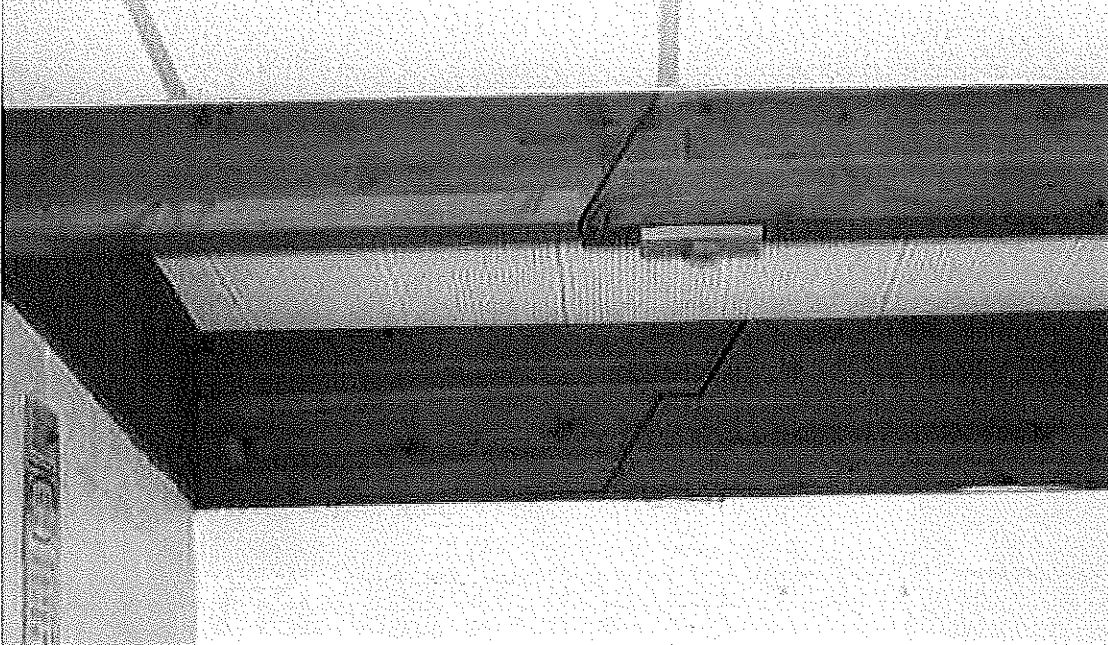
**Picture 17**

**Wooden bolt joining hallway beam (left) to classroom beam (right)**

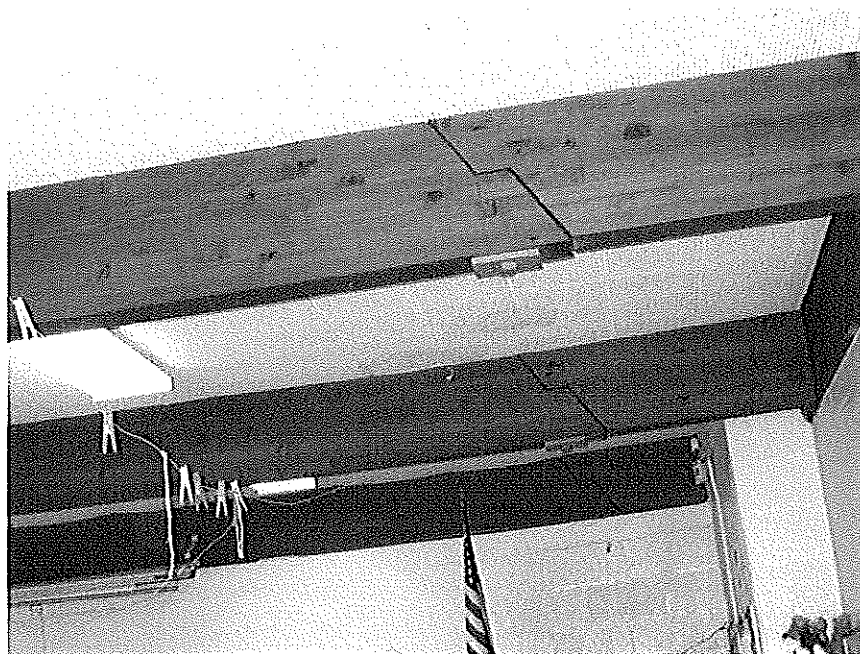
**Picture 18**

**Vertical shift (downwards movement) creating space between two roof beams**

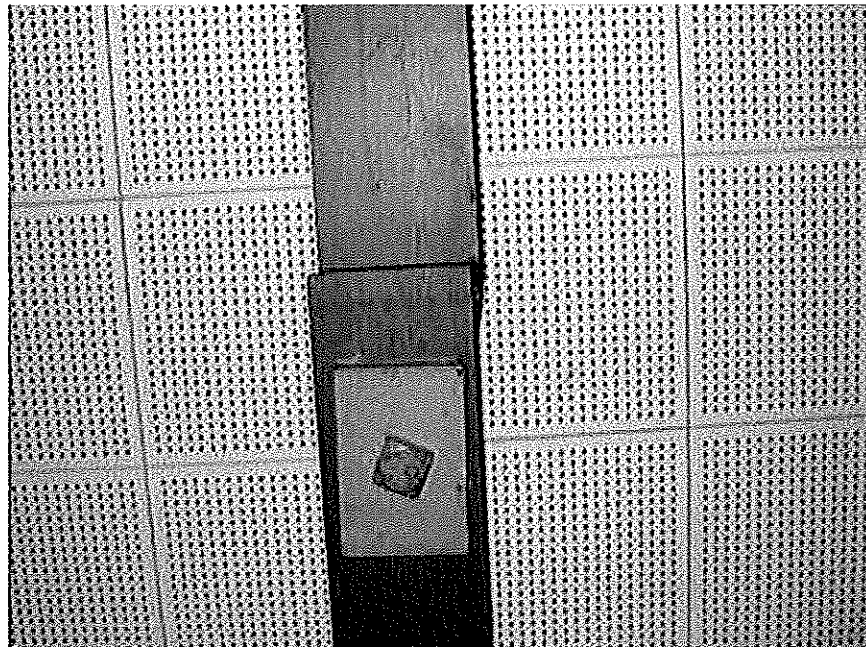
Picture 19

Horizontal shift (left and right movement) of roof beams

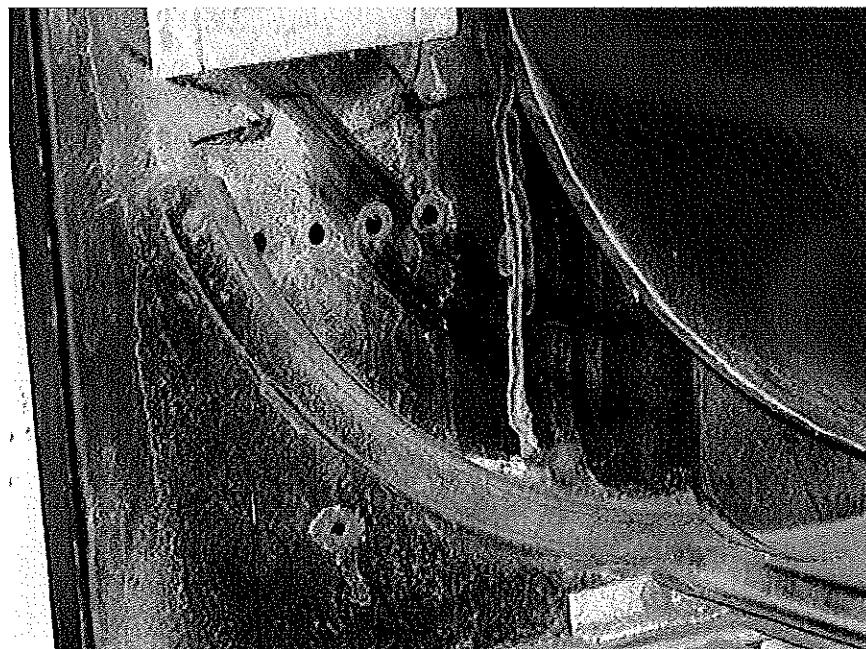
Picture 20

The interiors of some univents were examined. Spaces and holes in the wall, floor, around pipes, and within the air-handling cabinet were observed (Pictures 20 and 21). These breaches can serve as pathways for air, odors and particulates to be drawn from the crawlspace into classrooms. Breaches in cabinet walls allow draw of air, post-filtration.

Holes in univent cabinet wall

12. Repair cracks in the exterior cement walls and brick work
13. Seal open utility holes around plumbing fixtures beneath sinks.
14. Seal holes in univent cabinets.

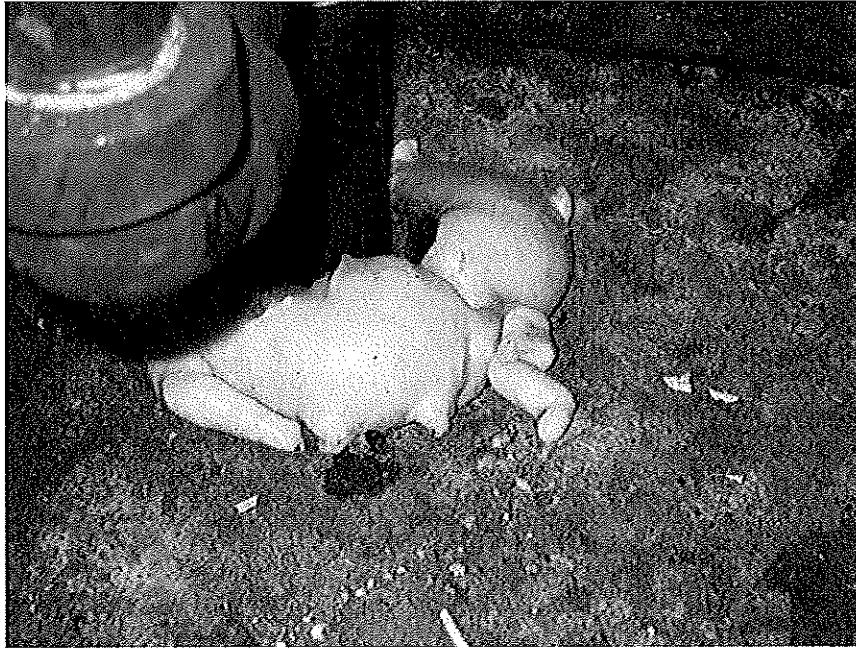
**Picture 21**

**Space around pipe (with deteriorating old spray foam)**

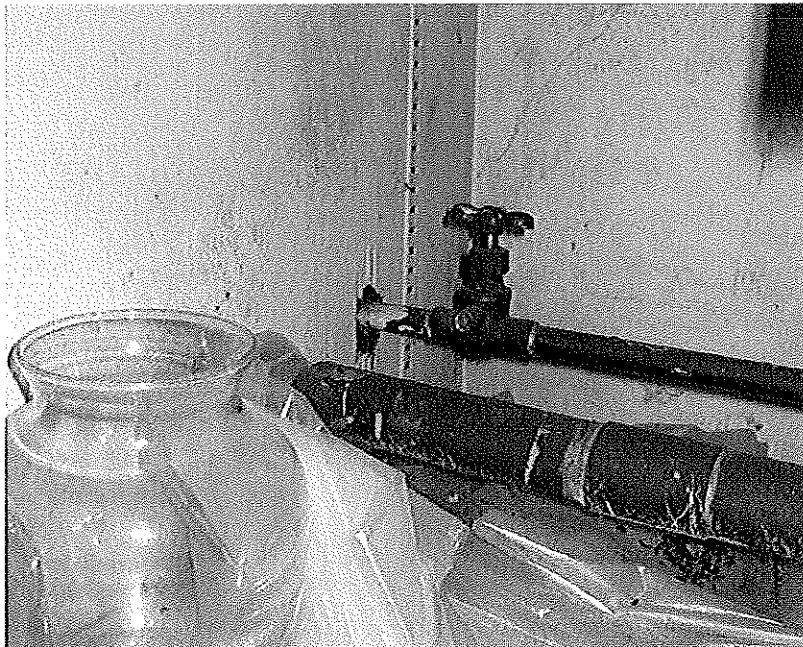
**Picture 22**

Similar breaches were observed around water utility pipes for sinks (Picture 22). Breaches around these water pipes can allow for air from the crawlspace to enter classrooms. Air penetration is magnified when the exhaust ventilation is operating, since exhaust vents are adjacent to the sinks in some classrooms.

**Space around sink pipe**

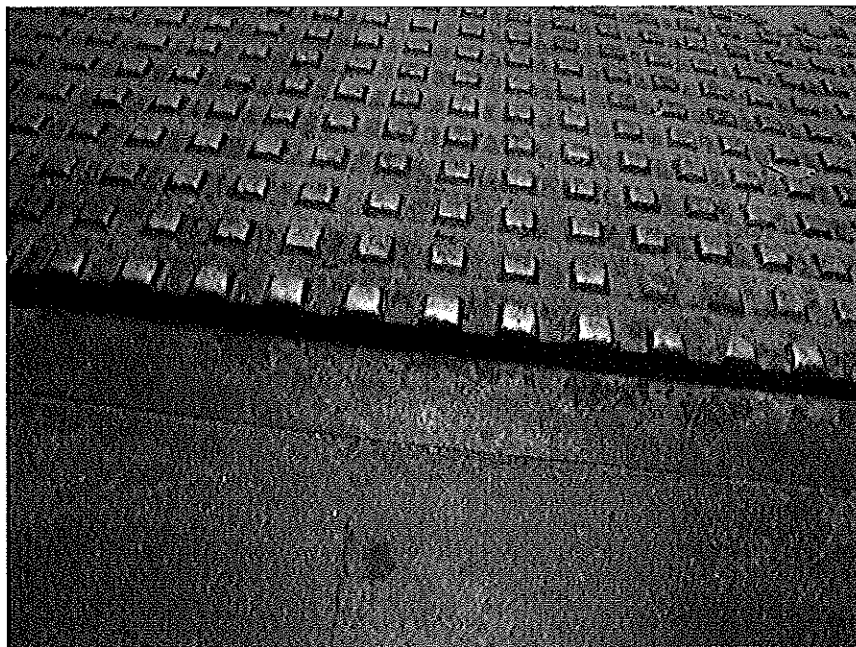
**Picture 23**

Musty odors were detected in the AV storage room, where a crawlspace access door was observed. The door to the crawlspace access was not flush to the floor (Picture 23), which can allow materials/odors from the crawlspace to migrate into occupant areas. Measures should be taken to render the access door airtight to prevent penetration of odors into the AV storage room.

**Crawlspace access not flush**

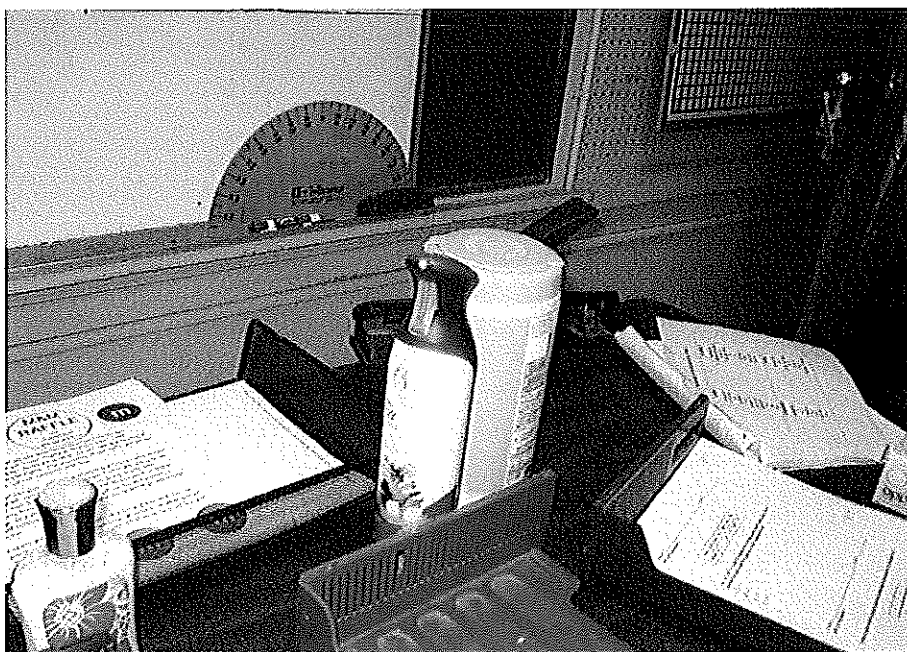
**Picture 24**

Household cleaning products, air fresheners and deodorizing materials were found in several areas (Picture 24, Table 1). Cleaning products and air deodorizers contain chemicals that can be irritating to the eyes, nose and throat of sensitive individuals. Many air fresheners contain 1,4-dichlorobenzene, a VOC which may cause reductions in lung function (NIH, 2006). Furthermore, deodorizing agents do not remove materials causing odors, but rather mask odors that may be present in the area. Additionally, a Material Safety Data Sheet (MSDS) should be available at a central location for all school chemicals in the event of an emergency such as an adverse chemical interaction between residues left from cleaners used by the facilities staff and those left by cleaners brought in by others.

**Cleaning products and air deodorizers**

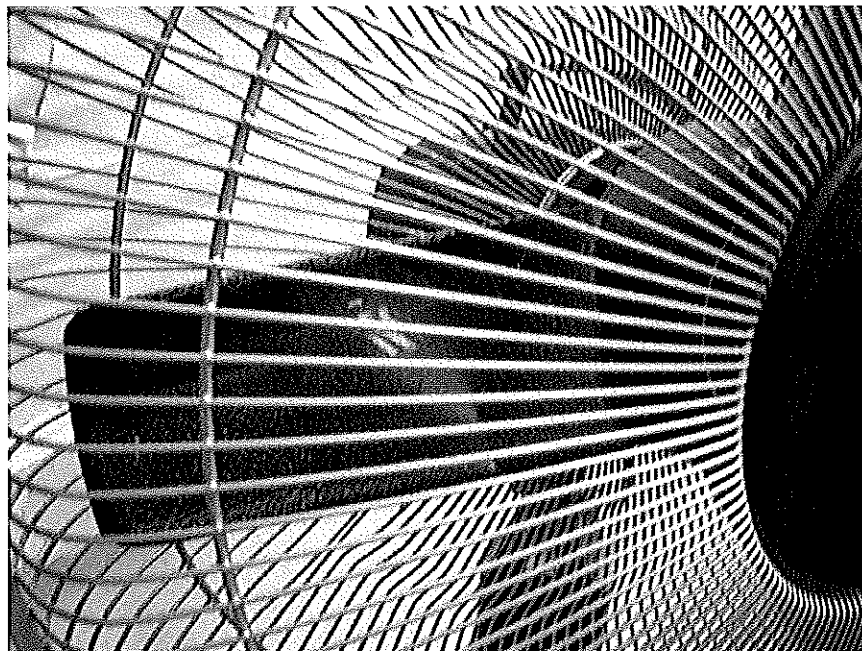
Picture 25

A number of fans/blades (Picture 25), exhaust vents (Picture 6) and air-conditioners (Picture 26) had accumulated dust/debris. Fans should be cleaned periodically in order to prevent them from serving as a source of aerosolized particulates. Exhaust vents should also be cleaned to prevent re-aerosolization of dust due to back drafting. Air-conditioners and their filters should be cleaned periodically to prevent distribution of materials.

Dust on fan blade

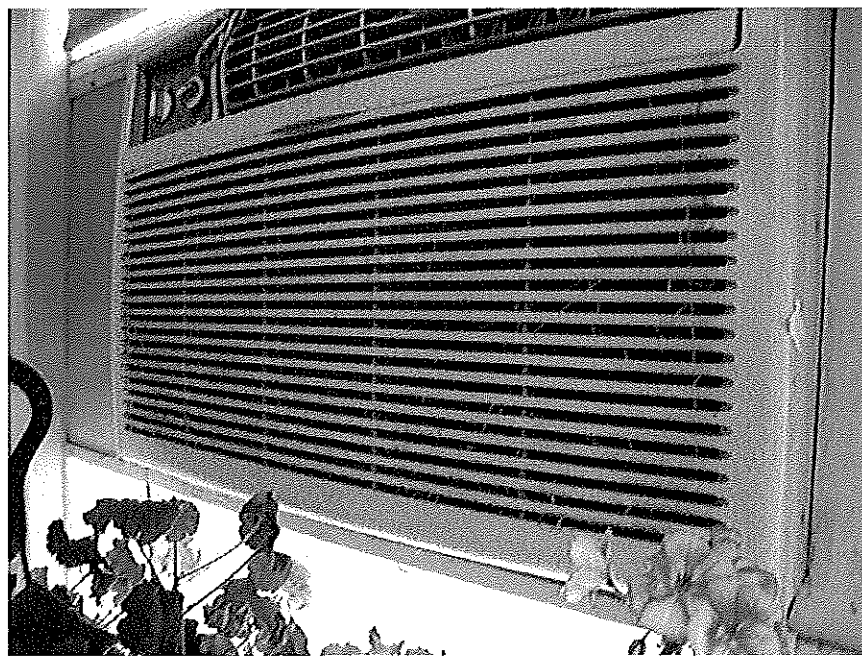
Picture 26

Air-conditioner occluded with dust

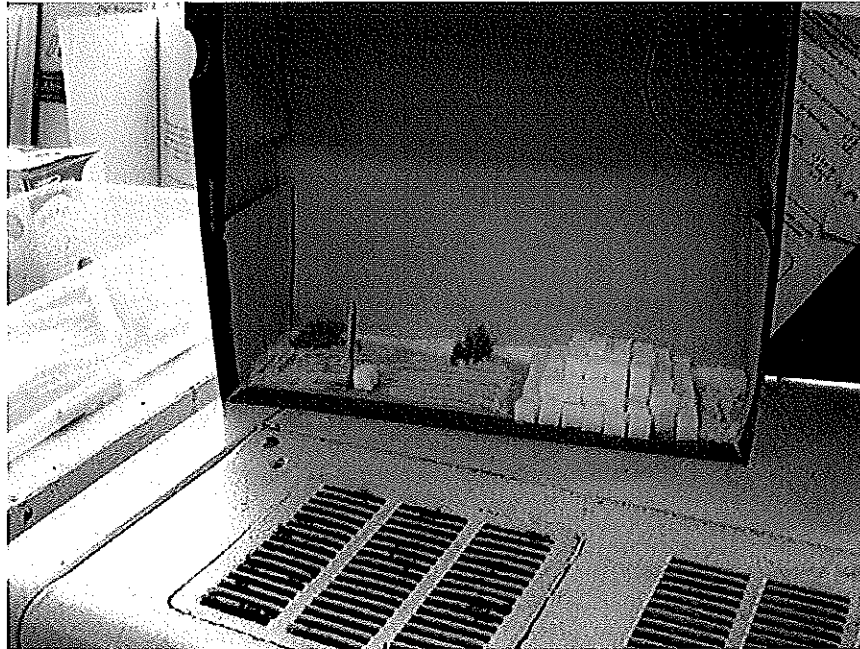
**Picture 27**

Open food items were seen in classrooms, including being used as art materials (Picture 27). Food is an attractant to pests and rodents. Proper food storage is an integral component in maintaining IAQ. Food should be properly stored and clearly labeled. Where food products are used in art, the artwork should be stored/displayed in a container or the food components should be treated in a manner that does not attract pests (i.e., non-toxic white glue sealant or other clear coat product). Reuse of food containers is not recommended, since food residue adhering to the surface may serve as an attractant to pests.

**Food as art; note placement on univent, which can distribute dried food particles throughout room**
