Re: School Building Needs Assessment  
Whittier Middle School  
Haverhill, Massachusetts  
RBA Project No. 2019023

HVAC and Structural Assessment Report  
Photo Sheets  
Whittier Middle School  
Haverhill, MA

## **HVAC & Plumbing Evaluation**

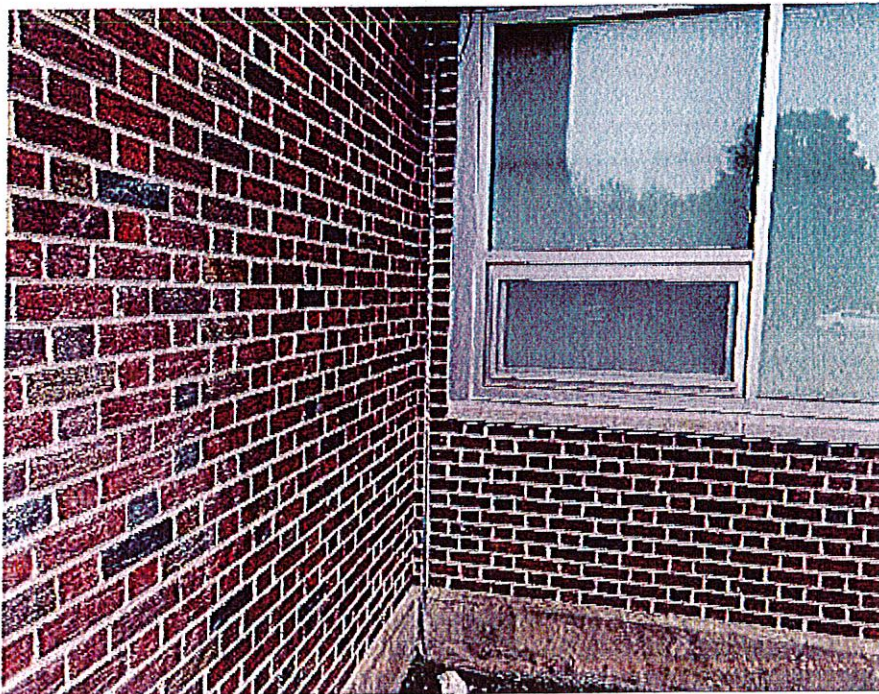
**Photo No. 06**

Masonry and expansion sealant joints are a concern. The sealant joints along the walls have dried and are cracking. The cracking has led to separation in the joint and is allowing water to enter. This should be treated before it leads to leaks and deterioration. In addition, brick veneer and CMU interior walls need repointing in various areas.

**Description:**  
Expansion/control  
joint in masonry  
wall is cracked and  
separating.

Minor repointing of brick and CMU are needed throughout the building, along with sealant replacement at the expansion joints on wall elevations. Missing connection bolts and damage at front entrance canopy roof should be repaired to prevent further damage.

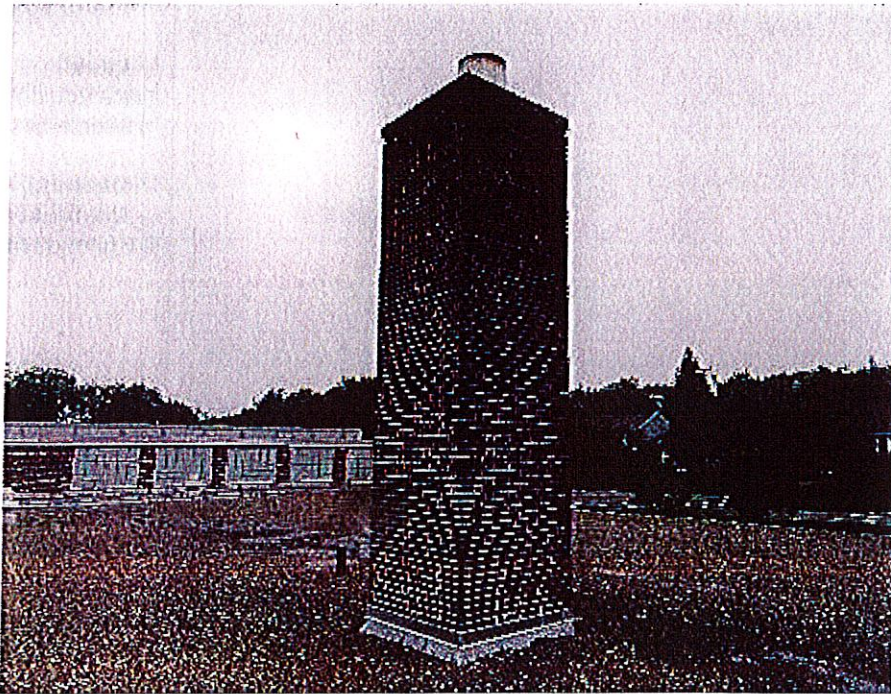
**Photo No. 08**

The chimney is the second concern, it has major cracks in the CMU at the base and major cracks in the brick veneer at the top. Further investigation would be required to determine if the cracking in the CMU has continued the up the chimney. Cracks in the CMU or back-up wall towards the top of the chimney would require the chimney to be removed and be rebuilt or repaired. The chimney is a tall, slender structure that will only get worse over time if not treated. The new flue may have slowed down deterioration, but major cracks will lead to failure.

**Description:**  
Photo of existing  
chimney that has  
major cracks in  
masonry.

Repair on the chimney will need to be investigated further to determine if the cracking in the CMU backup continues to the top where the brick facing is cracked. This will be investigated with test cuts in the brick. If there are significant cracks in the back-up, the chimney will need to be rebuilt from potentially the base in the boiler room to the top, above the roof. Otherwise partial repairs to the cracks, and repointing above the roof line may be warranted.

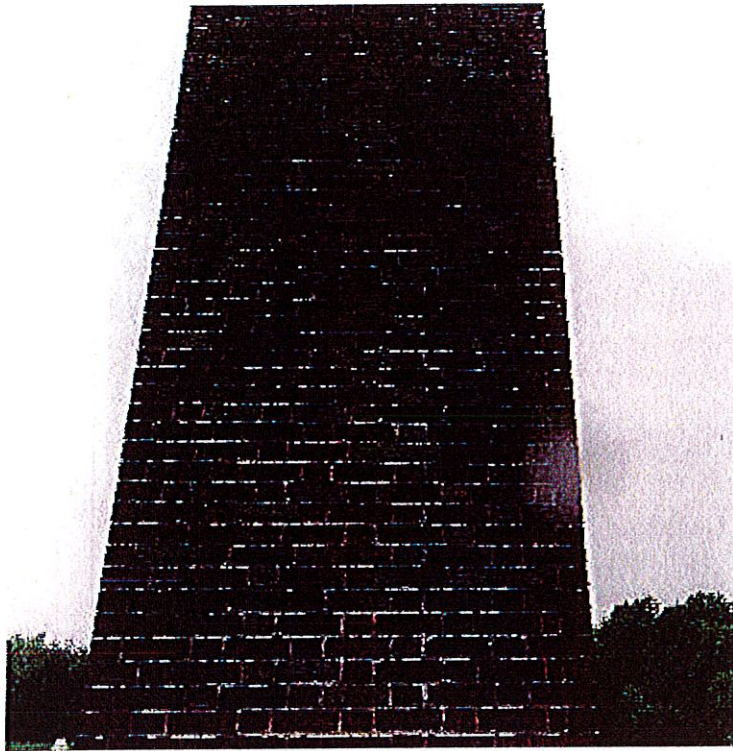
**Photo No. 09**

**Description:**  
Close up of cracks  
in masonry of  
chimney.

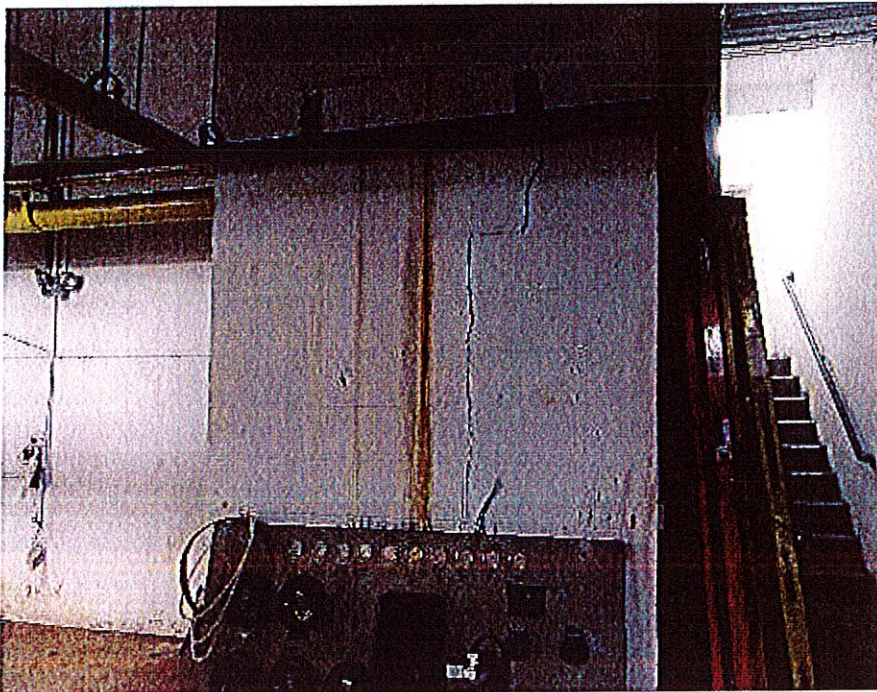
**Photo No. 10**

**Description:**  
Crack at base  
of chimney masonry.

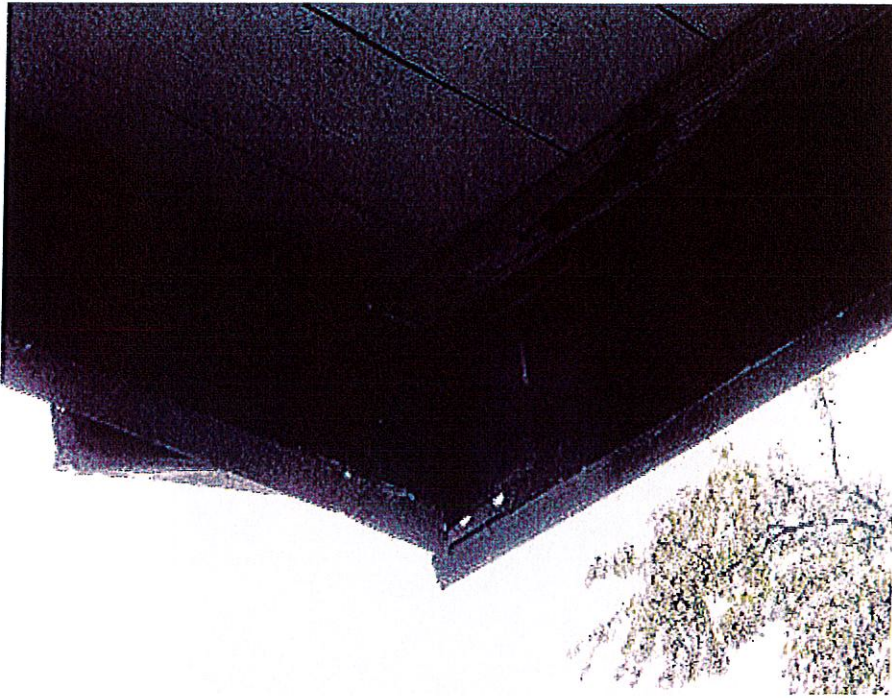
**Photo No. 11**

**Description:**  
Missing bolt in front  
canopy, can lead to  
further damage.

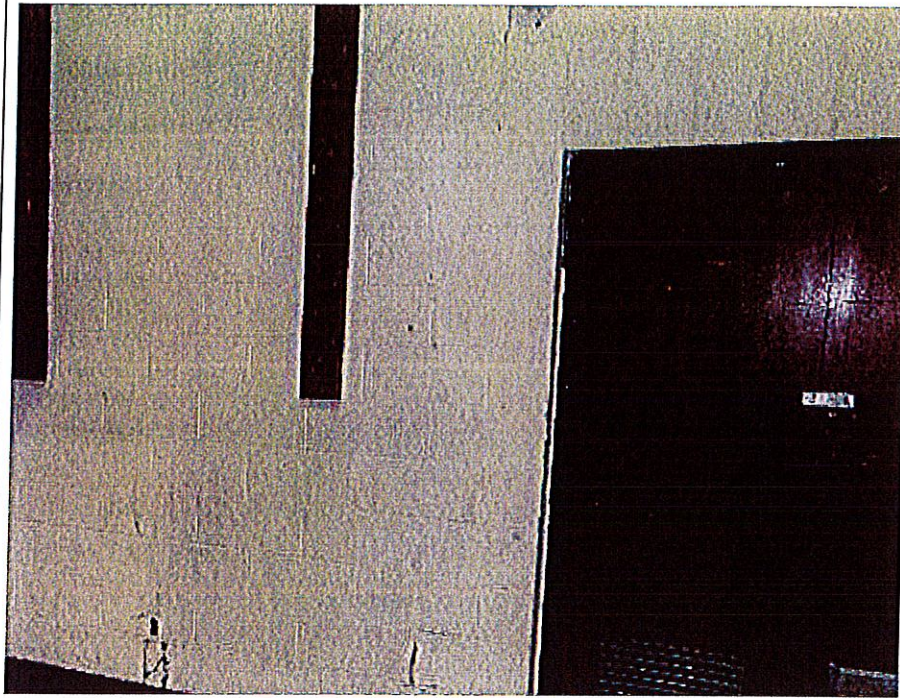
**Photo No. 15**

The CMU walls have not been a problem in the past and they appear to be in good condition with some cracks mostly on the high walls in the gymnasium and cafeteria and also at doorways. The doorways have lintels that are called out in the structural drawings as masonry lintels with rebar, it doesn't specify the size or number within the CMU block. No structural information has been called out associated with the CMU walls, and investigation of end connection will need to be conducted in order to run analysis of the component. Any significant renovation would possibly trigger the requirement for structural reinforcement of these walls, to meet current building code requirements.

**Description:**  
Typical step cracks  
in CMU walls.

Repair or reinforcing of the CMU walls, which are suspected to be deficient under wind loads, was not specifically investigated for this report. Such investigation should be considered, especially if further study confirms the deficiency of the walls, or significant alterations to the building trigger the required code updates. The repair could involve cutting into walls at all end connections to the steel columns and adding shear studs or similar to provide a connection for the wall to transfer loads to the structure.

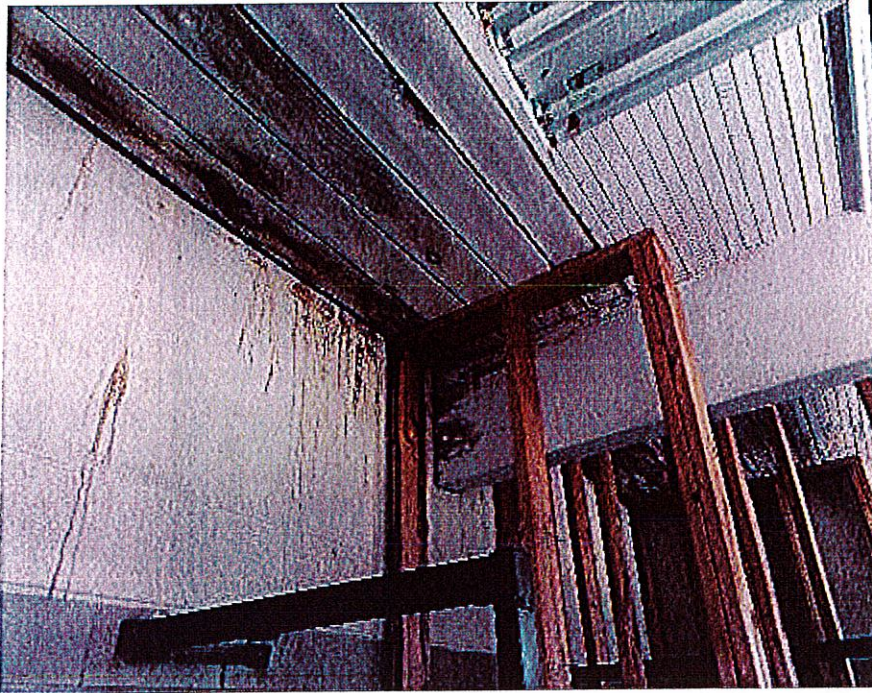
**Photo No. 17**

The main structural concern is the areas in which were damaged by failures within the steam heating system (Locker Rooms). The roof decking should be replaced, and damaged beams repaired or replaced, in the affected areas so the temporary shoring can be removed, and the locker rooms can be restored. To allow proper installation of new roof decking, the roofing above will need to be removed and replaced above. The laminated beams in the area that were affected should be investigated further to determine the extent of moisture related rot and deterioration, to determine if the beam(s) still have the required structural capacity. The beam(s) will need to be treated or replaced based on the findings and calculations.

**Description:**  
Girls locker room  
experienced steam  
leak causing  
deterioration and  
failure in roof  
decking. Temporary  
shoring has been  
installed.

The issues in the locker rooms, including replacement of the roof decking and repairs to the laminated beams in the affected areas, will need to be investigated further. In areas, it appears that the roof decking has been a problem in the past (possibly due to roof leaks) and has had replacement before. Future moisture in this locker room needs to be corrected and/or proper ventilation will need to be added if this is to be used as a locker room in the future, in order for this issue to stop occurring. Once the HVAC problem has been resolved (if it has not already been completed), we recommend replacement of the affected deteriorated roof decking by tearing off the roof above. The areas of roof will be replaced and new roof decking can be installed. The extent of rot on the laminated wood beams will be determined and treated with either repairs to the existing beams, or replacement, as required.

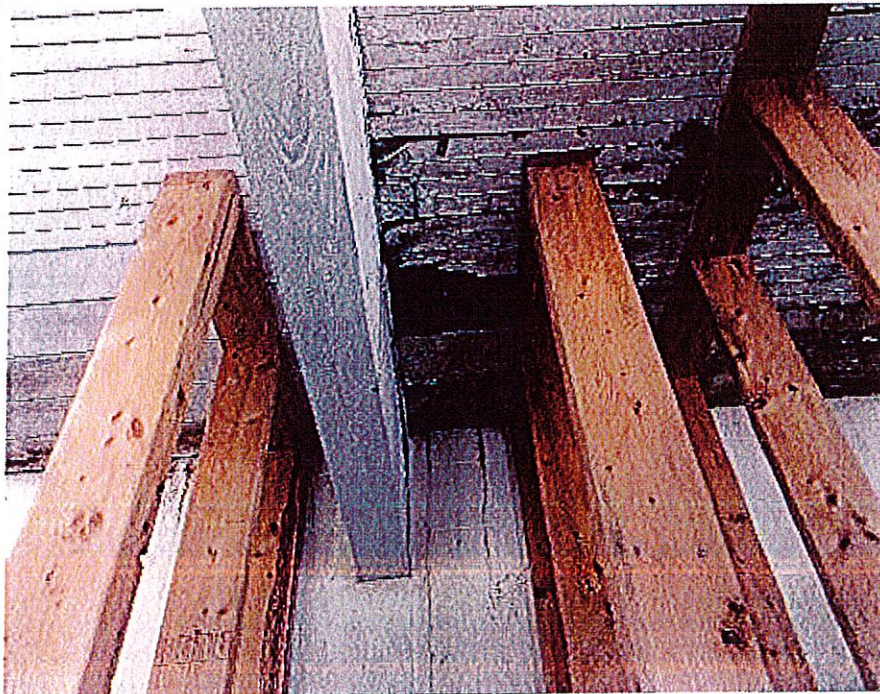
**Photo No. 18**

**Description:**  
Another photo  
showing extent of  
deterioration in roof  
decking due to  
steam leak.
