EVALUATION OF EXISTING CONDITIONS

SUMMARY OF EXISTING CONDITIONS

The Albert B. Consentino Middle School is located at 685 Washington St. in Haverhill, Massachusetts and is one of five middle schools in the district. The project site is situated in a residential neighborhood of single and multi-family homes. Access to the site is by Washington St., a winding thoroughfare that connects Lowell Ave. to River St. (Image 1) The site was developed over time through the taking and consolidation of individual residential properties.

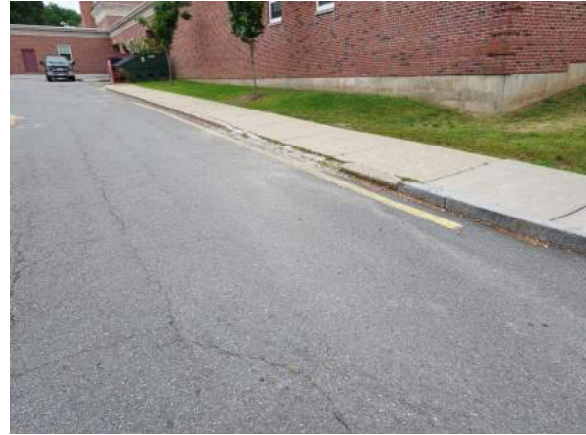
Image 5

Pedestrian walks are protected with a combination of concrete curbing and granite curbing. The original construction documents indicate granite curbing where site drives intersect Washington St. and along the street itself; these original curbs are still in place and are in fair condition with some sections significantly displaced and in poor condition (Image 4). The documents also indicate concrete curbing at the walks immediately adjacent to the school. Many of these curbs have crumbled and failed over time and in some sections been replaced with new granite curbing. The new granite curbing is in good condition while the original concrete curbing is in fair to poor condition. (Image 5)

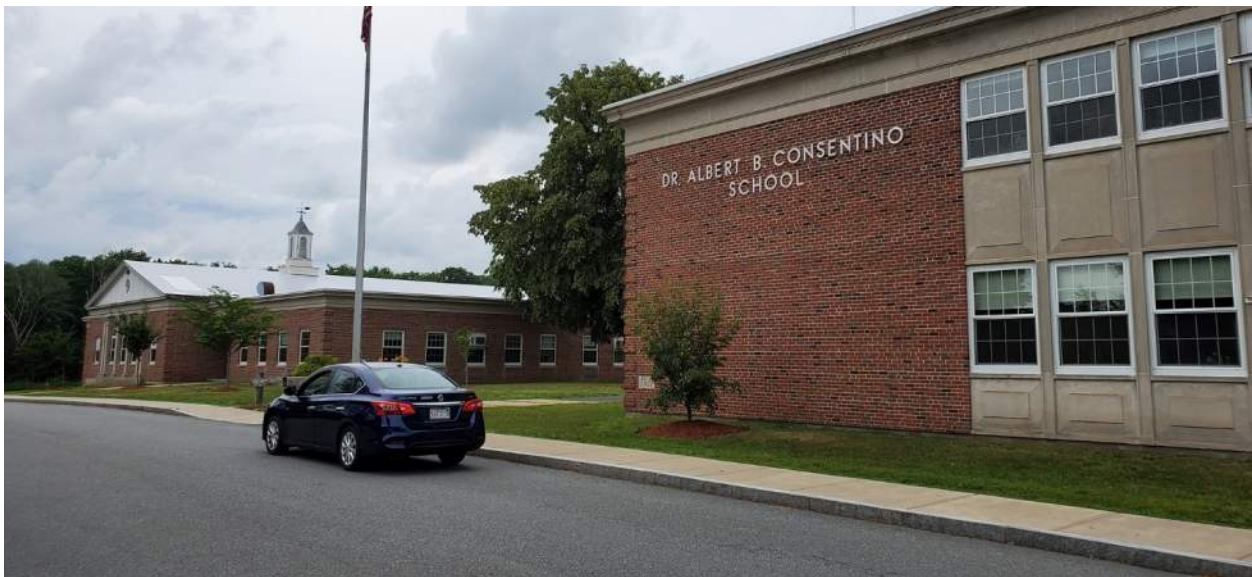
In front of the building, there exists a granite-curbed, cast-in-place concrete sidewalk that appears to have been recently installed. While the curb and sidewalk are in generally fine condition, the existing granite curb should be salvaged and reused to the greatest extent possible. The existing cast-in-place concrete sidewalk should be removed and replaced with a new cast-in-place concrete sidewalk due to the likelihood that the majority of the pedestrian sidewalks throughout the site will need to be replaced with new cast-in-place concrete (given their condition and the anticipated impact that construction will have on their existing condition). The main entrance walkway should match the color, material, and age of all new pedestrian sidewalks throughout the site.

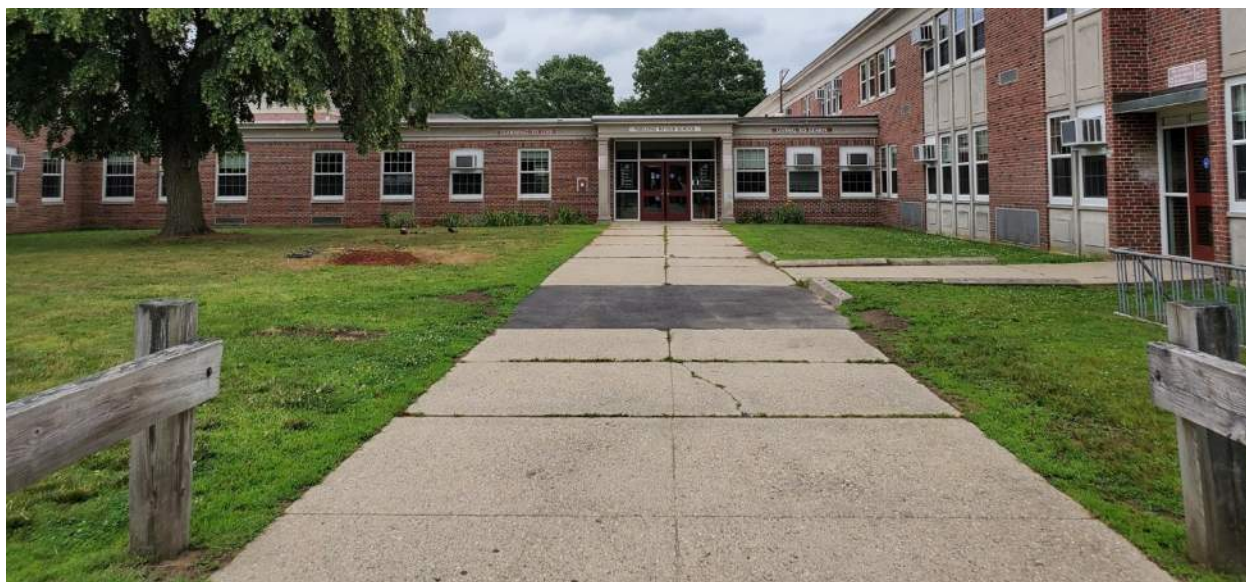
Within this west entrance courtyard, the wood rails need to be removed and discarded as they are weathered and splintering. The existing, surface-set curbs need to be removed and discarded. The galvanized pipe bicycle rack will need to be removed and replaced with bicycle racks that meet the Town's bicycle/alternate transportation code requirements. The topography is relatively flat; therefore, careful attention to maintaining positive drainage throughout this semi-enclosed courtyard will be critical. There does not appear to be any walkway lighting within this entrance zone; pedestrian walkway lighting should be considered. The existing flagpole and its associated plantings should be removed and relocated to accommodate the likely pedestrian circulation/gathering improvements. The existing mown lawn extends to the base of the building and has clover and crabgrass throughout, while the plantings at the main entrance are sparse, with the exception of a fantastic, mature *Tilia 'Linden'* tree to the left of the front doors that should be preserved to the greatest extent possible.

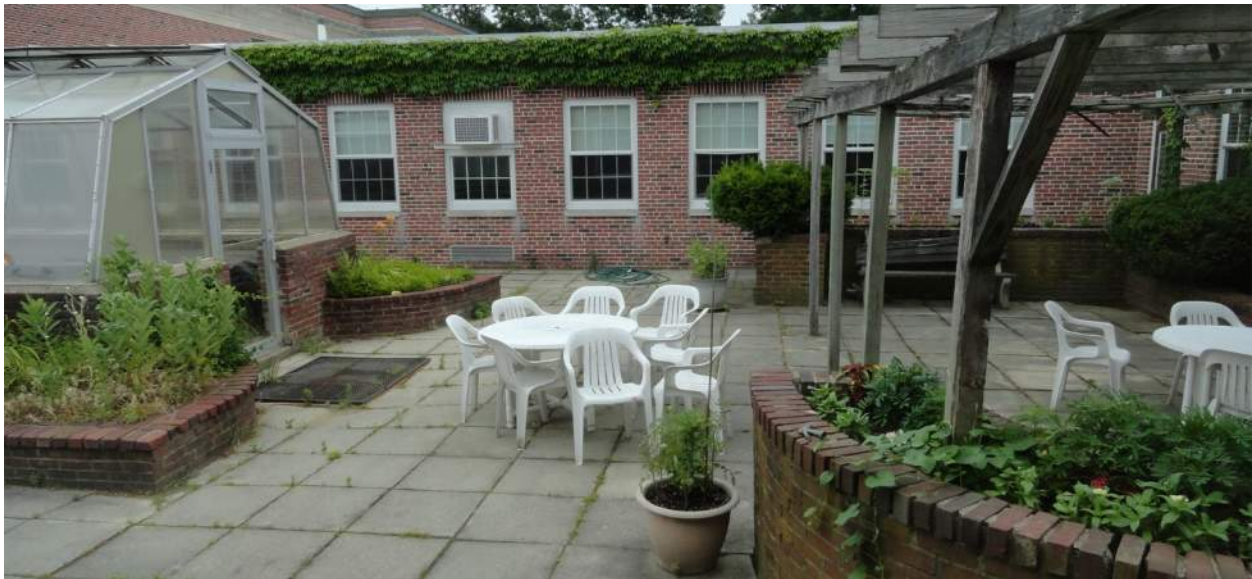
While this space appears to be successfully activated, the physical condition of the space is unsafe, aged, likely inaccessible (per ADA standards), and in need of update. The trellis has been weathered overtime and is rapidly deteriorating, creating an unsafe overhead condition. The greenhouse does not appear to be code compliant and contains uneven pavement, in addition to metal, desk-height edges that obtrude into the walkway. The raised brick planters are in disrepair as many of the bricks have shifted and the mortar is eroding, creating a potentially unsafe condition where users may try to sit, or stand, on a compromised condition. The concrete pavement contains evident weed growth and is beginning to shift and heave due to the natural freeze and thaw impact of an outdoor environment; thereby creating dangerous tripping hazards. Many of the plantings are invasive and overgrown, while the suckering vine is slowly overtaking the building façade, compromising the integrity of the brick. The site furnishings are worn, unsightly, and are not code compliant. Given these observations, the majority (if not all) of the elements throughout courtyard will need to be removed, and the courtyard redesigned, to create an ADA accessible and physically safe environment for all users.

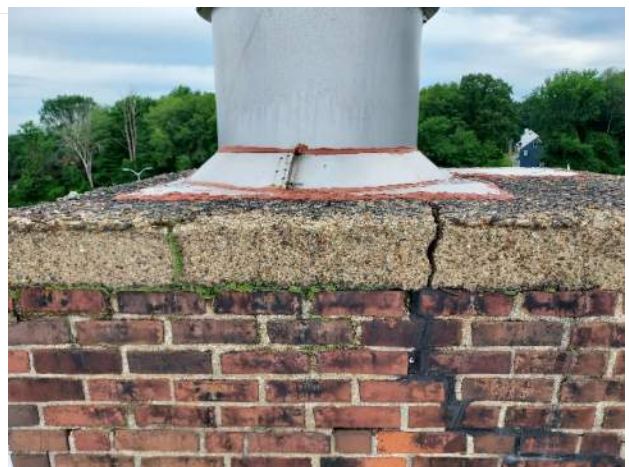
Image 6

For the most part, the brick veneer is in excellent condition with some areas in need of repointing. The concrete cap at the boiler breeching chimney is severely cracked (Image 6), leading to significant

Some areas of facing brick require repointing.	Repoint as needed (approximately 20% of brick area).
Boiler chimney cap is cracked, resulting in water infiltration and efflorescence.	Replace chimney cap. Clean brick at chimney. Repoint brick at chimney following replacement.

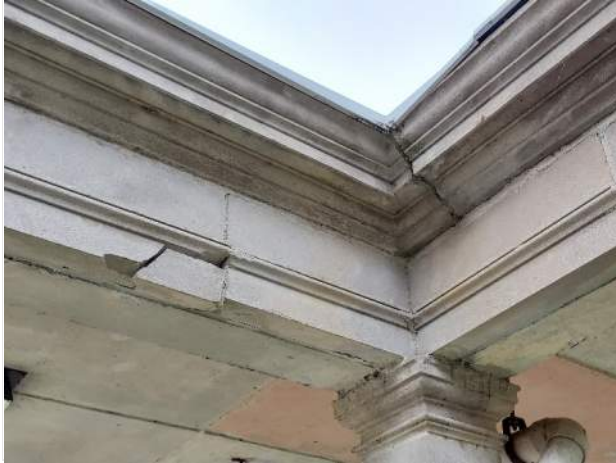
Image 13

Precast concrete colonnade is in poor condition; reinforcing steel is exposed on the underside; concrete columns are heavily eroded and/or cracked clear through; portions of the corning are crumbling and loose.	Demolish precast concrete colonnade and replace with a new entry canopy.
Skyward facing precast cornice pieces at the gymnasium with prior surface and/or membrane joint treatments are largely washed away or failed.	Provide prefinished metal flashing cap at all precast cornice locations to protect all skyward facing joints from water intrusion.
Wood pediment at cornice trim at the cafeteria (east and west elevations) has paint faded or missing; wood trim is rotted, particularly at the rake to eave transition.	Replace rotted wood trim elements. Repaint all wood trim, pediment at both elevations.
Exterior soffits in some locations are sagging, suggesting back-up framing may be failing. Some soffits have minor plaster cracks that could be repaired.	Replace sagging soffits (approximately 50% of soffits). Patch or repair balance of plaster soffits. Paint / repaint all soffits.

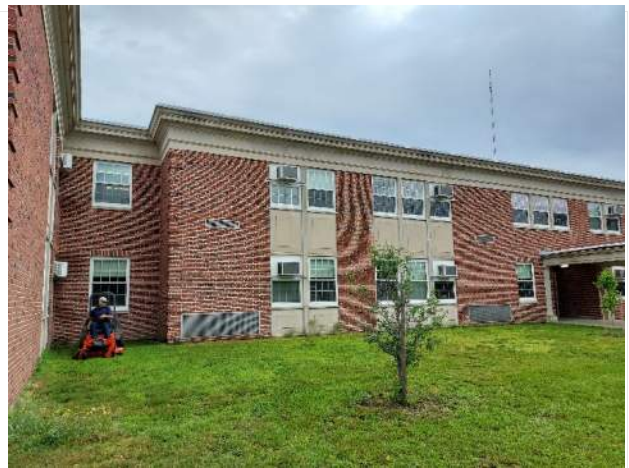
Image 24

Classrooms and most other spaces are provided with through-wall unit ventilators, resulting in numerous louvers on most elevations of the building (Image 24). Proper maintenance and sealing of louvers is critical for a facility of this age since there are so many locations where potential failure could result in water and air leakage and/or improper ventilator function. Most unit ventilator louvers are in fair to good shape, which is notable given their age. Still, some louvers were noted to have damaged protective grilles and/or louver blades and should be replaced (Image 25). In most locations, perimeter sealants had dried and hardened and pulled away from adjacent surfaces, leaving perimeter conditions vulnerable to water intrusion, particularly at near-grade locations. Louvers at the generator room are in poor condition and should be replaced (Image 26). A new louver at the boiler room was installed as part the 2012 boiler replacement project (Image 27); the louver is in good condition and the adjacent brick infill appears to be performing well.

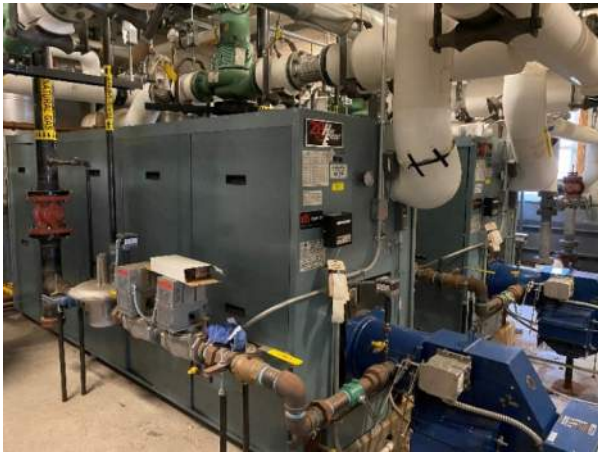
<p>Main heating hot water boilers are not high efficiency and provide a max of approximately 82% efficiency.</p>	<p>Replace entire heating system with a new high efficiency condensing boiler plant with electronically commutated motors (ECM) pump arrays for increased energy savings. Save existing high efficiency condensing boiler and reuse for renovation or at other Town location.</p>
<p>Signs of corrosion on pumps/piping and flanges. Pipe integrity unknown. Water damaged insulation.</p>	<p>Replace entire piping system with a combination of schedule 40 black steel and copper piping and utilize dielectric fitting for dissimilar materials. Replace insulation.</p>

Image 1: HB Smith Cast Iron Boilers, Model 28HE-17

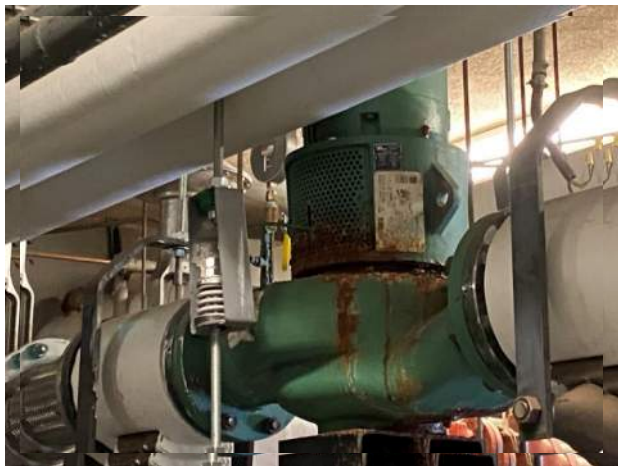
Image 3: Existing Boiler Pump With Signs of Leaking

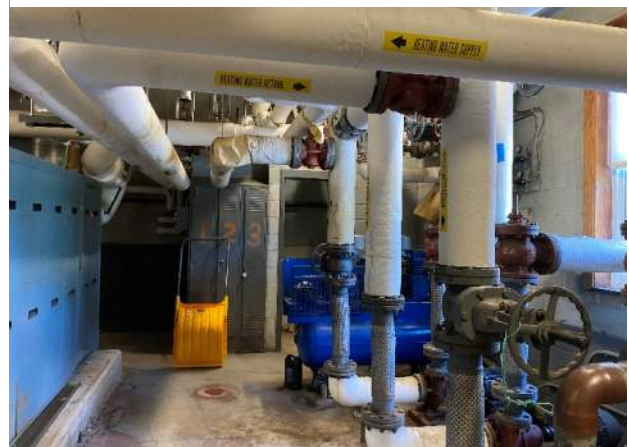
Image 4: Heating Hot Water Pipe Insulation with Water Damage

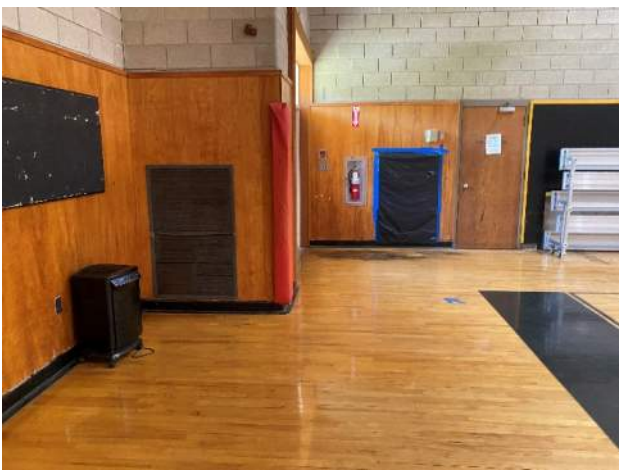
Image 10: Low Wall Exhaust/Relief Grilles (Note: Left Grille Damaged, Right Grille Covered/Blocked)
