# **INDOOR AIR QUALITY ASSESSMENT**

**C.D. Hunking Middle School  
98 Winchester Street  
Haverhill, MA**

Prepared by:  
Massachusetts Department of Public Health  
Bureau of Environmental Health  
Indoor Air Quality Program  
April 2012

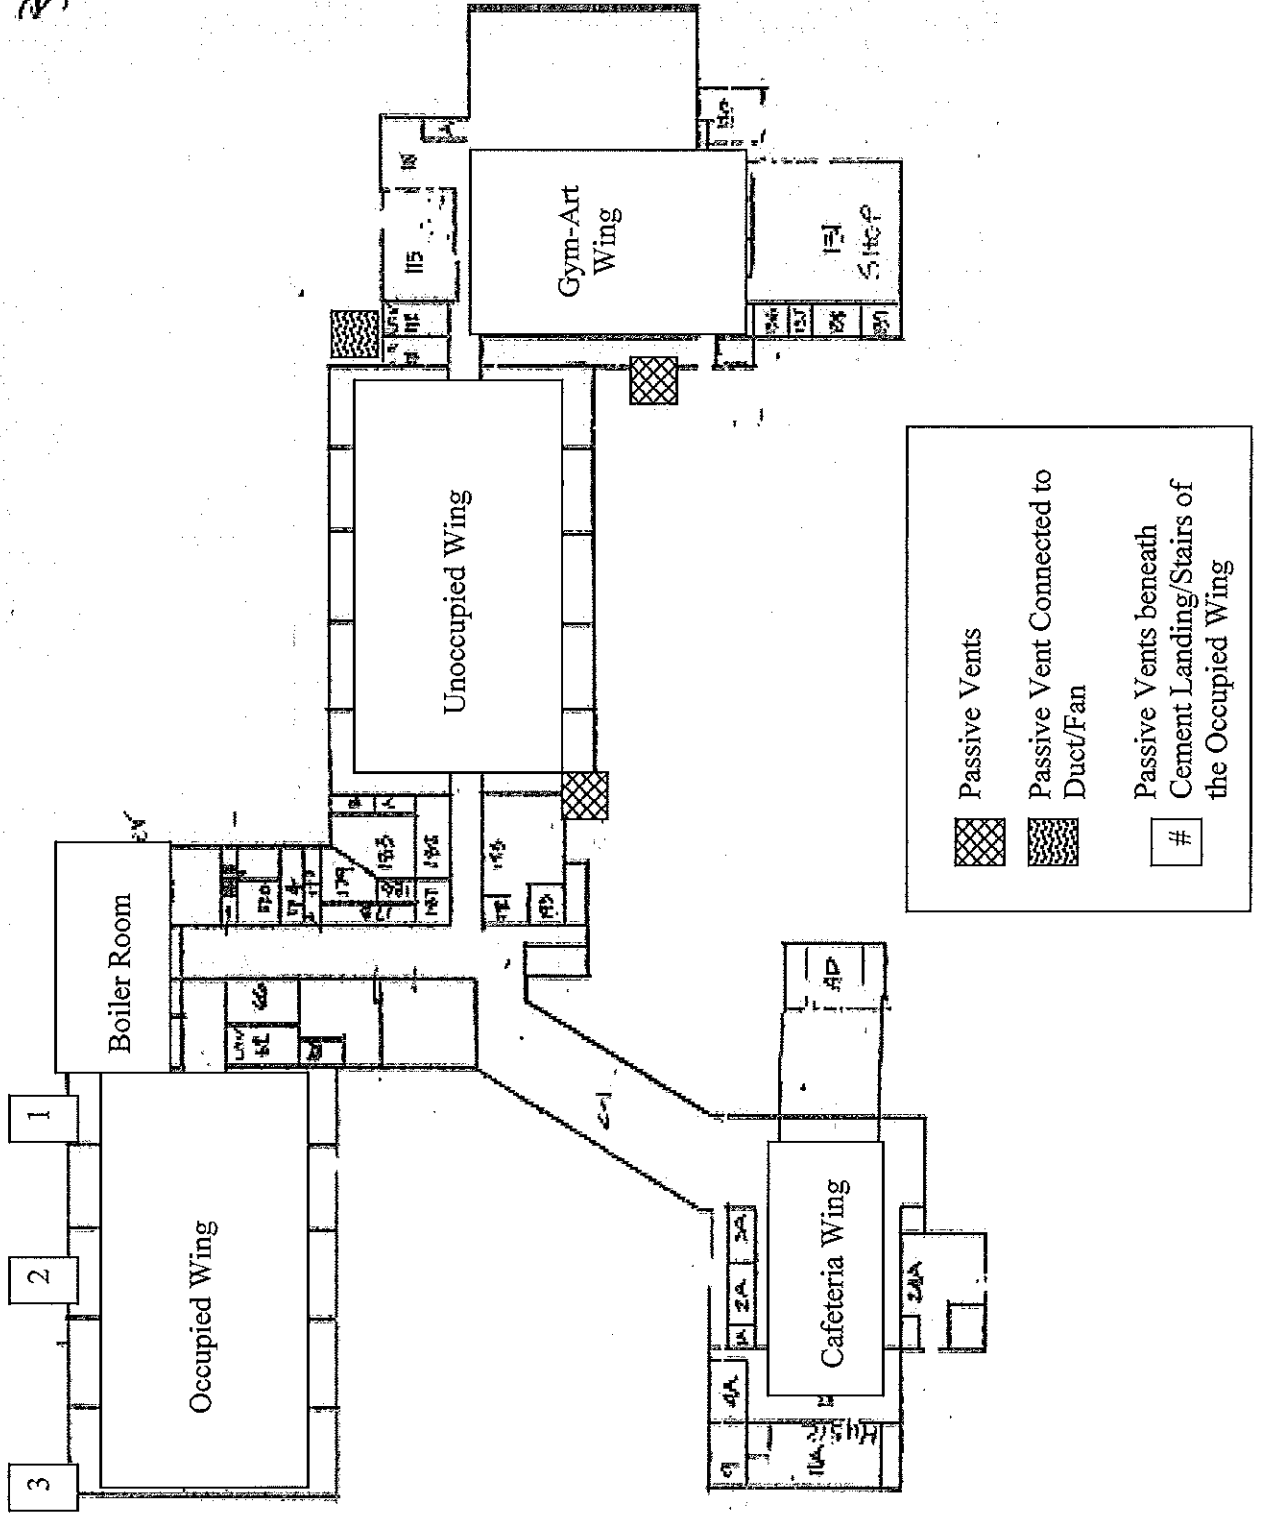
Figure 3: Location of Installed Crawlspace Passive Vents

Passive vents are typically installed to allow water vapor and other materials in a crawlspace to be removed or diluted. Such vents were observed beneath classroom exterior doors on the western side of the occupied wing (Picture 10). These vents were installed in a manner to create cross-ventilation in the crawlspace. Of note is the orientation of the exterior doors and their stairs/landings, which likely takes advantage of New England's prevailing westerly wind direction. The stairs at position 1 face northwest, while the stairs at positions 2 and 3 face southwest (Figure 3; Picture 11). Depending on the orientation of the wind, the cement stairs/landings either form an air scoop to direct air into the passive vents (windward side) or provide a sheltered location for air to escape from the crawlspace (leeward side). For example, a southwest wind can force air to enter the space formed by the stairs and landing in Positions 2 and 3, creating pressurization that forces air in the crawlspace to escape via the passive vent in Position 1. This airflow created through passive ventilation allows water vapor to escape the crawlspace.

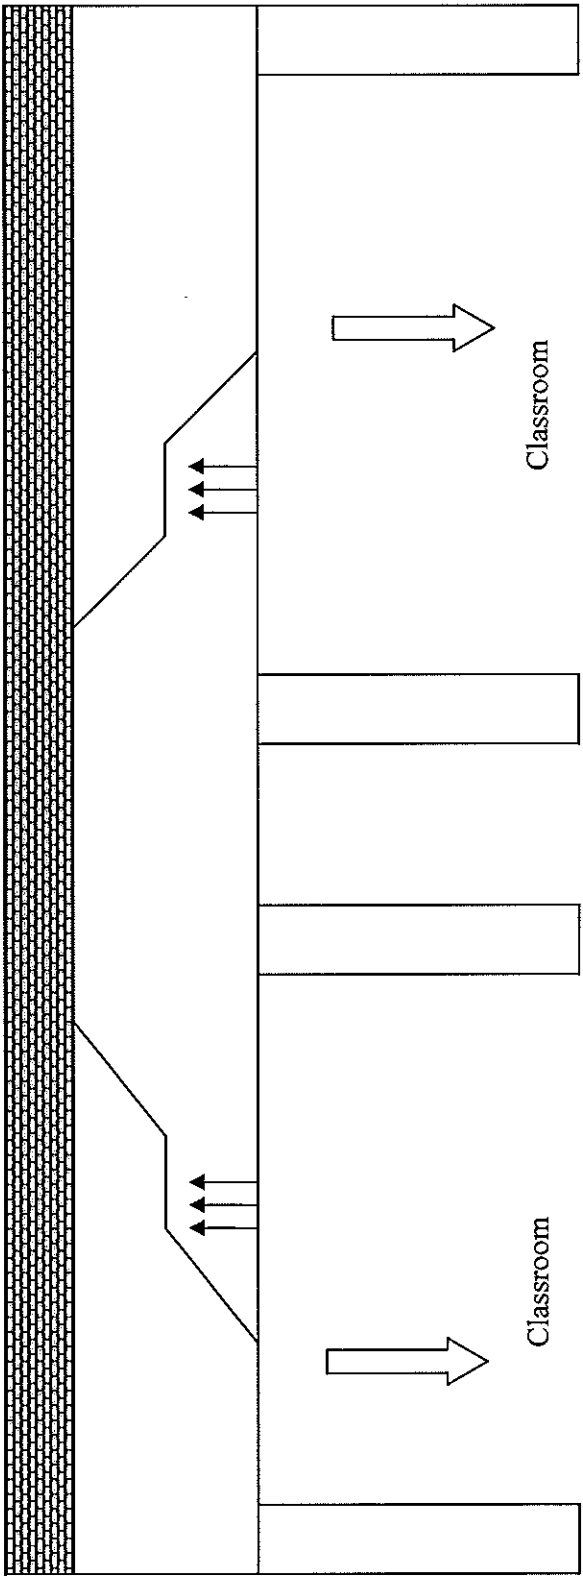
**Figure 4: Theoretical Orientation of How Roof Beams Should Have Been Installed to Provide Support for Entire Roof Deck**

According to the report by AECOM (2011) and observations made by BEH staff, the roof support system at the HMS consists of three components: two classroom beams and a hallway beam (Figure 4). Bolts join the beams to create a system consisting of classroom beam - hallway beam - classroom beam (Picture 17); this beam system traverses the building. Seams where beams were joined were observed to be roughly one-quarter the distance from the interior wall within the classroom. This configuration creates a discontinuous system from the exterior wall to the interior wall within the classroom.
