Re: School Building Needs Assessment  
Whittier Middle School  
Haverhill, Massachusetts  
RBA Project No. 2019023

HVAC and Structural Assessment Report  
Photo Sheets  
Whittier Middle School  
Haverhill, MA

## **HVAC & Plumbing Evaluation**

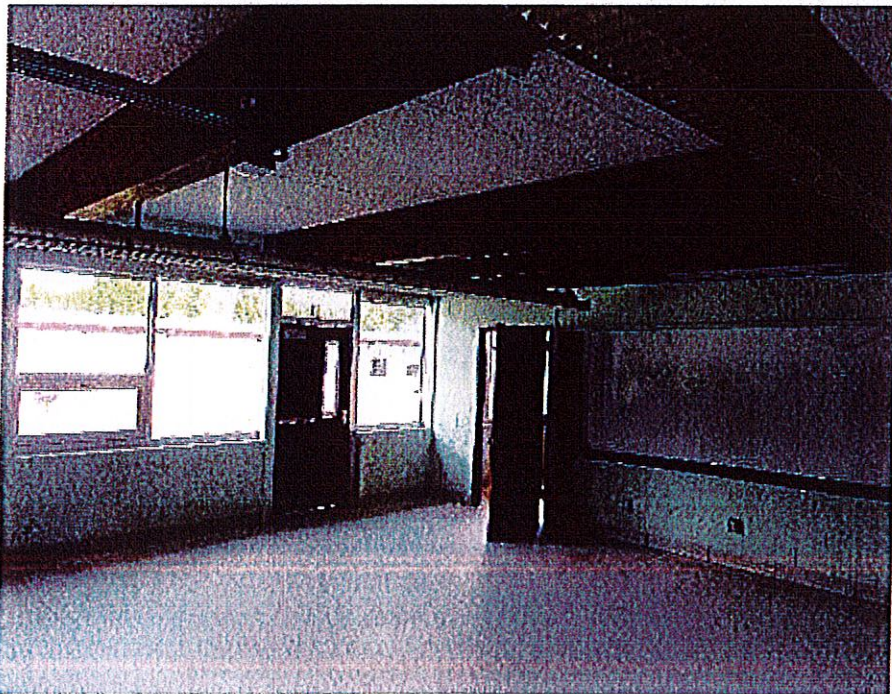
**Photo No. 12**

**Description:**  
Typical classroom  
which has exposed  
laminated wood  
beams and plank  
roof deck.

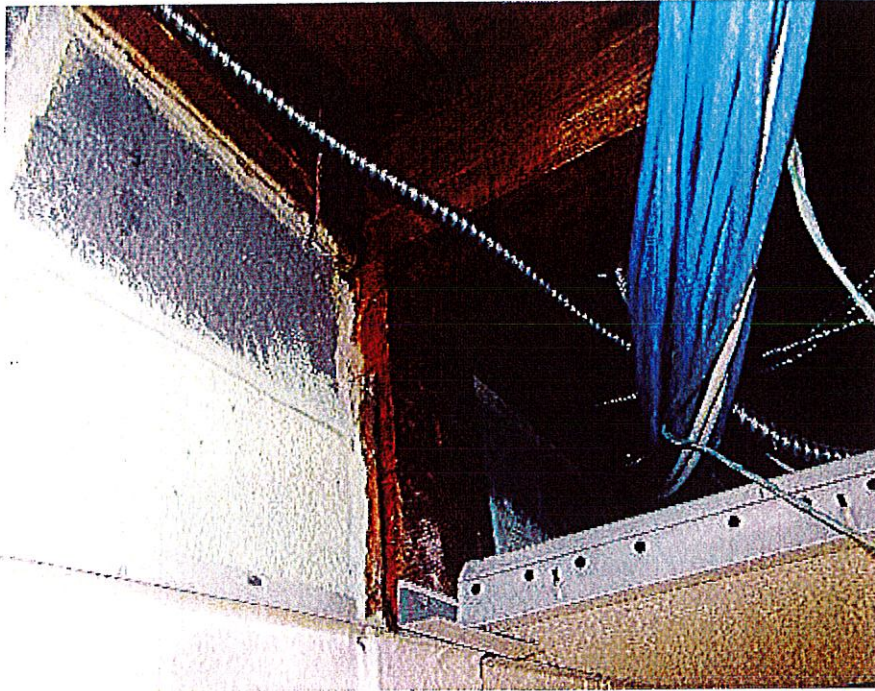
**Photo No. 13**

**Description:**  
Typical intersection  
of roof joists to  
column with seats  
in interior space.

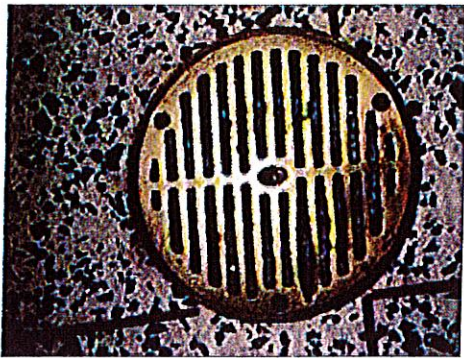
The building is currently provided with municipal domestic water and sanitary connections. The domestic water service is 4" in size with 4" compound water meter and 3" backflow preventer located at the basement level. Based on the existing drawings provided it appears that the building has multiple sanitary and storm drain connections to the street. There is a 5" sanitary connection located near the kitchen and dinig area where is also existing an 8" storm drain. There are also 8" sanitary and two 6" storm drain connections located at the opposite end of the building. The building has two gas service connections, one dedicated to the commercial kitchen and the other supplying the HVAC equipment as well as the domestic hot water equipment. All piping and the majority of the plumbing fixtures appeared original to the building construction. Currently an ongoing renovation has completed one of the bathrooms and all plumbing fixtures were updated. The bathrooms/showers next to the gymnasium are non functional and the plumaing fixtures are either removed or damaged. The domestic hot water system has been upgradet around 2003 and replaced the old heat exchanger and storage tank with 84% efficient gas fired boiler with small 60 gallon storage tank. The commercial kitchen appears to be partially functioning, and all equipment, fixtures and their connections require replacement and an upgrade. All roof drains appear obstructed and retainig water puddles around them. Some drains alaso show signs of corrosion and water damage of the rooms below.

*Floor Drain*

All sanitary, storm and domestic water piping shall be replaced. The current plumbing upgrade shall be postponed and complete bathroom renovation shall be considered in order to bring them up to code meeting the accessibility requirements as well as to repair the damaged bathrooms next to the gymnasium. The domestic hot water heating system is getting closer to the end of its life expectancy and shall be replaced with new, more efficient system. The water service accessories, such as meter and backflow preventer shall be replaced. The roof drains shall be replaced, during the roof replacement. All sanitary and storm drain connections shall be hydrojetted and video inspected for potential pipe damage. The commercial kitchen shall be provided with grease interceptor and all new sinks and floor drains, in compliance with Department of Health regulations. CO detection and notification shall be added to the area around the gas fired appliances.

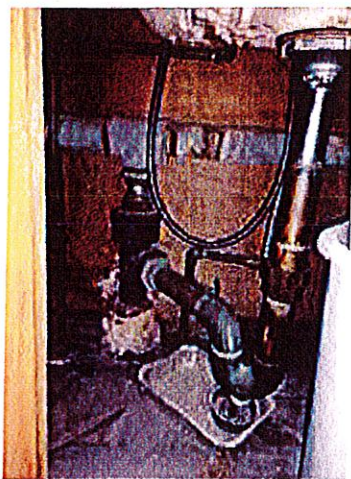
*Plumbing Piping*

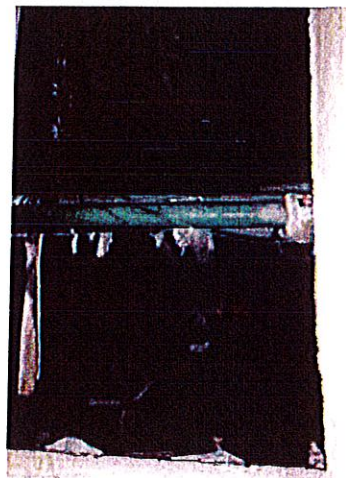
*Plumbing Piping*

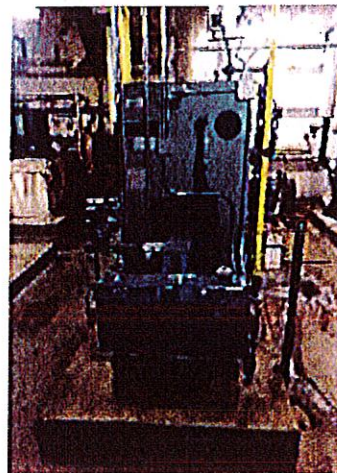
*Existing Steam Boiler*

1. The existing steam heating system has long exceeded its expected life and will require replacement in its entirety including piping systems; a new hot water heating system is recommended.

2. Replace existing steam heating system with new hot water systems including three (3) 2,000 MBH gas fired condensing boilers, two (2) hot water circulating pumps with variable speed controls, water specialties, new insulated hot water distribution piping system to new hot water terminal equipment throughout the building; and new automatic temperature controls.

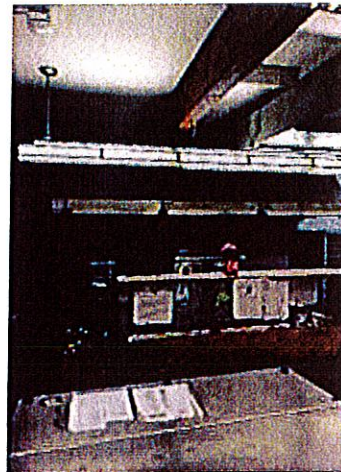
*Existing Kitchen Hood/Duct*

6. Provide new hot water heating ventilation units interconnected to the new hot water heating system and new DDC Controls for the locker rooms.
7. Provide new grease duct, roof upblast and hot water heating makeup air system for Kitchen.
8. Replace all existing terminal heating equipment (CUH/UH/FTR) with new hot water heating equipment and DDC controls.
9. Replace all existing roof fans with new roof fans with new DDC Controls.
10. Clean all existing ductwork to be reused.
11. Balance and Commission all new systems.

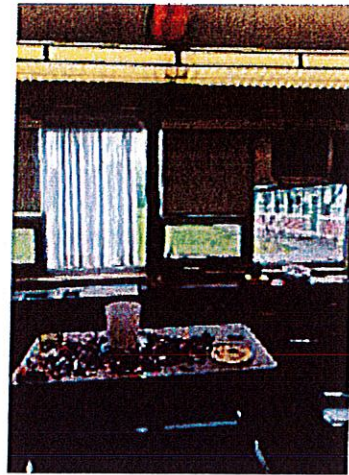
*Existing Classroom UV/AC*

3. Replace all existing unit ventilators with new hot water unit ventilators with
4. hot water coils interconnected to the new hot water distribution piping systems and DDC controls.
