EVALUATION OF EXISTING CONDITIONS

SUMMARY OF EXISTING CONDITIONS

The Albert B. Consentino Middle School is located at 685 Washington St. in Haverhill, Massachusetts and is one of five middle schools in the district. The project site is situated in a residential neighborhood of single and multi-family homes. Access to the site is by Washington St., a winding thoroughfare that connects Lowell Ave. to River St. (Image 1) The site was developed over time through the taking and consolidation of individual residential properties.

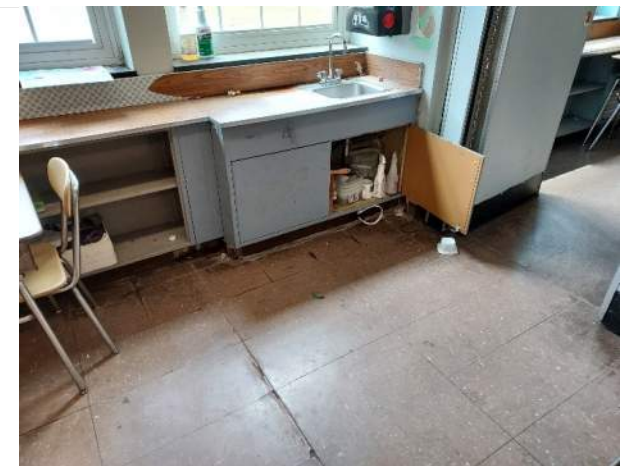
Image 12

- Accessible signage is not provided to any observed space. (One men's room included a sign with the symbol for accessibility. However, the sign was mounted on the door and the room did not contain any accessible fixtures or features.)
- Typical classroom (Image 12), specialty classroom (Images 13, 14, and 15), and staff workroom (Image 16) casework is generally inaccessible with counter heights that are non-compliant and sink bases that do not provide knees space.
- In many spaces, room controls and equipment such as thermostats or wall-mounted telephones were mounted outside the reach ranges.

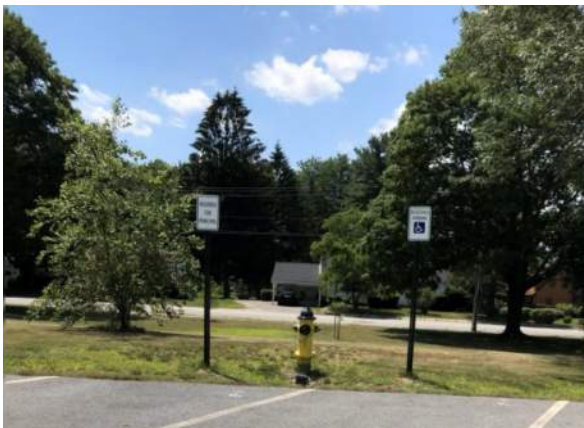
Fire Hydrant in Front of School

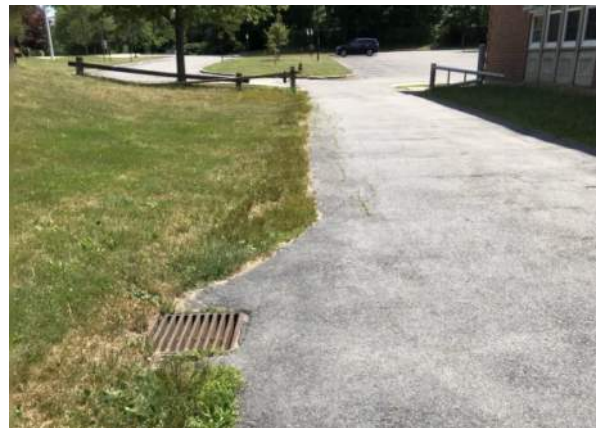
Catch Basin in Rear of School

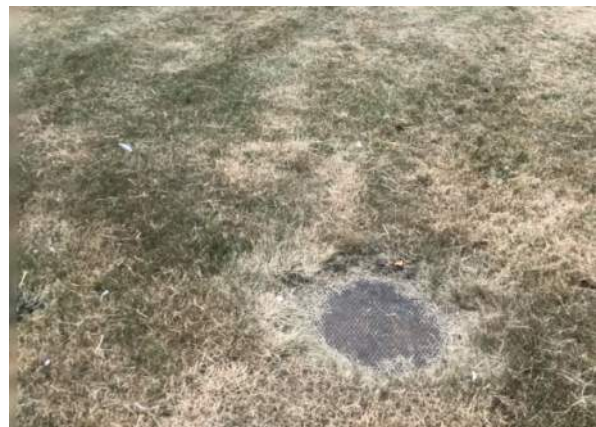
Possible Sewer Manhole in Front of School

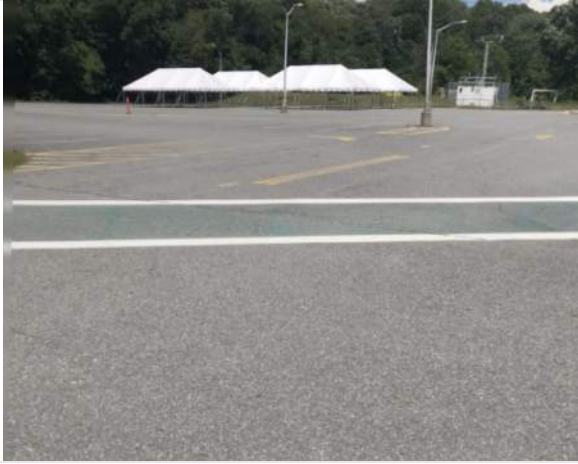
Northern Parking Lot (No catch basins observed)

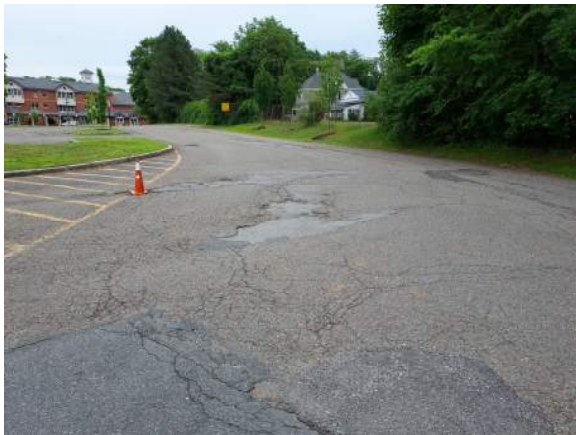
Image 3

Site vehicular drives and parking areas are paved with bituminous concrete. The paved surfaces are aged and cracked in several areas and re-paving of different areas at various times is evident with the visitor loop / parking area appearing to be the most recently paved portion. The western visitor parking & drive is the most recently paved area and is generally in good condition (Image 1); the northern parking & Consentino parent drop area is older and shows more signs of cracking and wear, but is still in good to fair condition (Image 2). The southern parking / bus / Silver Hill loop area is older and shows more significant wear with some severe cracking & delamination of paved areas and is in fair to poor condition. (Image 3).

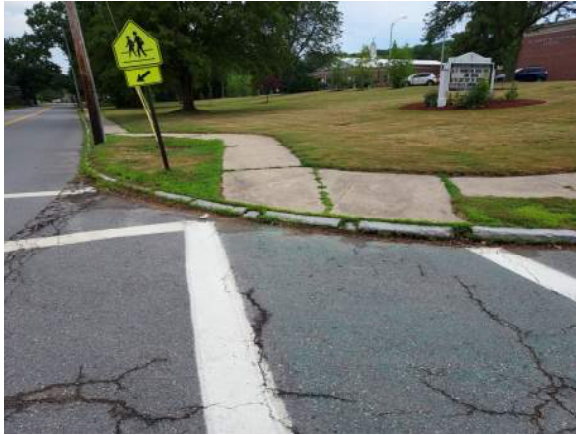
Image 4

Crosswalk locations where pedestrian walks intersect roadways, drives, or parking areas were in various conditions. Many did not include curb cuts and / or curb ramps (Image 4). The visitor entry route connecting the accessible parking spaces to the main building entry did include a curb cut with flared sides, but no detectable warning tiles (Image 6). Detectable warning tiles are not a specific requirement of accessibility regulations but are considered a best practice and generally included in all new curb ramp designs. Some locations associated with the Silver Hill school did include such detectable tiles (Image 7), but none of the six crosswalks associated with Consentino included them.

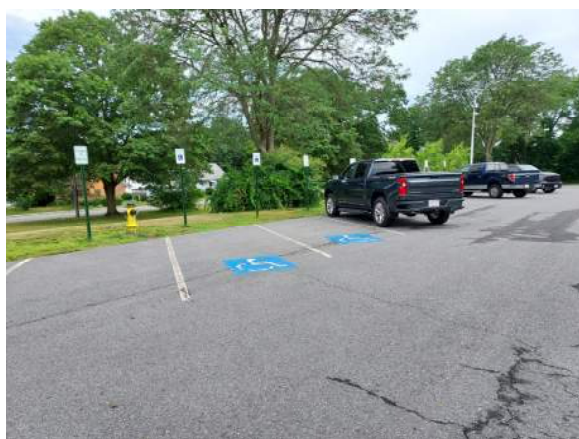
Image 8

than would be required under current zoning regulations (150 spaces). Additionally, current accessibility regulations (521 CMR) would require 4 accessible parking spaces, at least one of which would need to be a van accessible space. While two spaces are marked as “accessible” they do not include the required loading zones and therefore do not comply with the current code (Image 8). As such, the facility does not currently have any compliant accessible parking spaces.

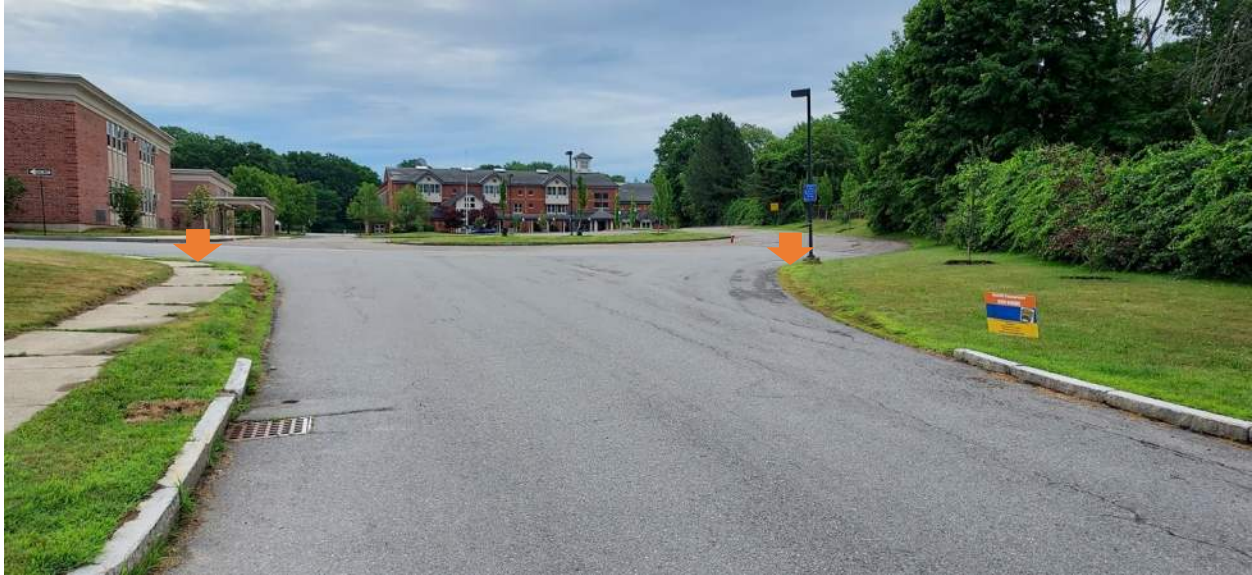
Further along the entrance drive, the visitor is met with a large, open, surface parking lot to the right and the two-story classroom wing of the Middle School building to the left. The vehicular entrance curbs and sidewalk are in disrepair with cracks and weed growth evident in several locations. The curbs terminate at the approximate midpoint of the first leg of the entrance drive, which has resulted in lawn damage, likely due to snow removal and/or vehicles. The sidewalk should be replaced with a new cast-in-place concrete sidewalk and the curbs should be replaced with new granite curbs that extend, at a minimum, to the end of this first leg of the entrance drive.

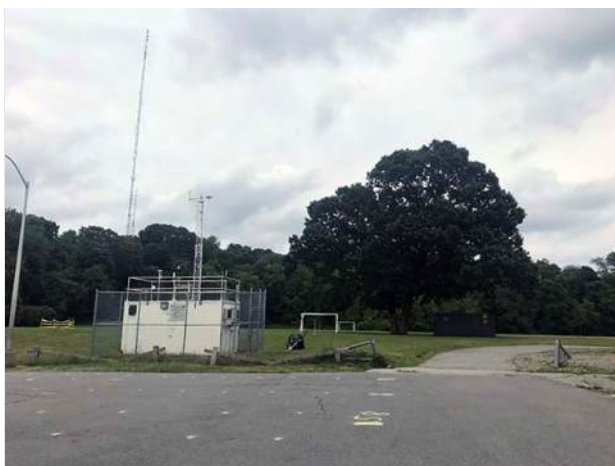
Image 5

Several areas throughout the property have damaged wooden vehicular guardrails and steel vehicular gates. PLEASE REFER TO IMAGES 5 AND 6 BELOW	Remove and replace the damaged rail and vehicular gate elements relative to the security and access requirements as directed by the Owner and/or the Facilities Department.
Site furnishings and amenities are outdated and potentially hazardous for use. PLEASE REFER TO IMAGES 7 – 12 BELOW	Remove and replace with new site features and amenities (outlined below are anticipated quantities that will be further refined upon design development): (40) Bicycle Racks (12 sets) Movable Table and Chairs (6) Wooden Courtyard Benches (1) Baseball Field Chain-Link Backstop (2) Metal Player's Benches (10) Metal Benches (with backs for field viewing) (6) Basketball Hoops (6) Vehicular Gates New Playground Equipment Site Lighting (Pedestrian and Vehicular) Irrigation System

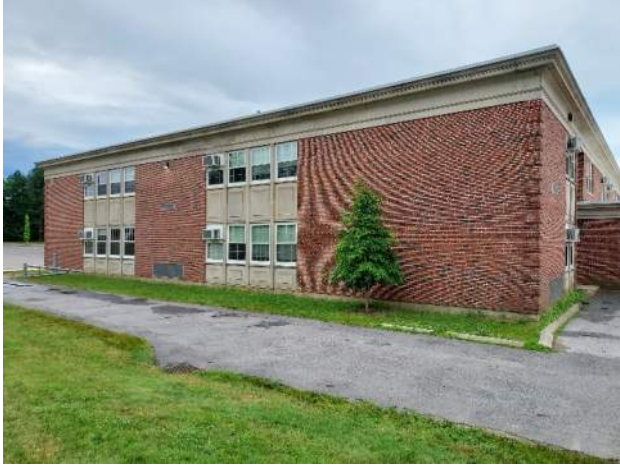
Image 1

almost all locations, the brick shelf transitions to grade are two courses below the Level 1 finish floor elevation (Image 1) with two exceptions where the brick shelf steps to accommodate grade around the northern portion of the building. There are a few locations where small cracks were noted, but these cracks appear to be shrinkage cracks and not an indication of settlement as they had not telegraphed into the brick veneer above (Image 2). At the northwest corner of the kitchen office, there is one crack that has telegraphed slightly into the quoin corbels of the brick veneer above; this was the only noted location of this condition (Image 3).

Precast concrete elements include window sills, pilasters (Image 4), spandrel panels at the two-story classroom wing (Image 1), and an entablature on nearly all portions of the building made up of separate frieze and cornice profiles (Image 9). All of the precast elements are dirty and/or stained and the condition of precast elements varies widely, ranging from good condition at window sills, spandrel panels, and frieze panels to fair condition at the pediment pilasters and cornice (Image 10), to poor at the south entry colonnade (Images 11-13) and numerous cornice elements. The cornice profiles were originally installed with skyward facing exposed surfaces and joints (Image 14), which would have accelerated their deterioration. Nearly all of these have been covered with metal flashing caps as part of reroofing projects except at the mid-height profiles at the gym which have not been covered. These joints appear to have been coated with a waterproofing membrane and/or had skyward facing joints covered with membrane flashing. However, nearly all of these treatments have failed.

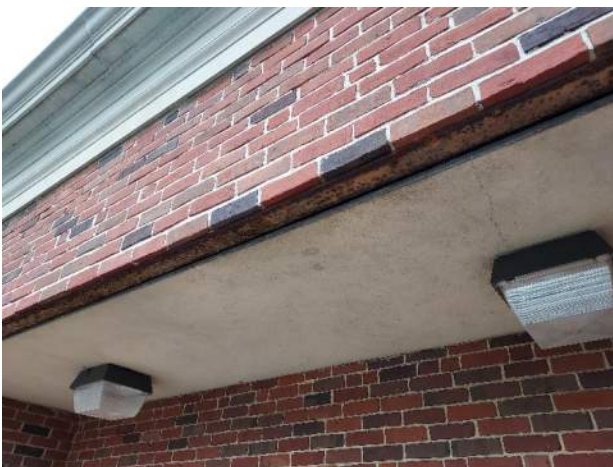
Image 5

water infiltration as shown by the efflorescence on the chimney. Steel lintels at openings show some signs of surface rust or scaling but are in sound condition and could be readily cleaned and re-painted (Image 5). At most window sills there are signs of a whiteish outwash, presumed to be from perimeter sealant used during the 2012 window replacement breaking down (Image 7). The existing drawings show no indication of an air or vapor barrier material and one portion of the wall that was observed to have some brick removed revealed that no such barrier is present (Image 8).

Soffits associated with exterior walls – such as at exterior doors and some recessed window conditions – are plaster over metal lath. Most appear to be in fair condition with some areas of cracking, but are generally intact with no large portions broken away from the lath. In some locations, the soffits are bowing, suggesting some of the tie wires supporting the framing may have rusted and broken (Image 5).

Brick corbelled quoin cracked at northwest corner of kitchen office	Replace brick or repair in situ.
Steel lintels are lightly rusted or scaling	Clean all lintels of rust and scaling. Prepare surface for paint and re-paint all lintels.
At windows with precast sills, signs of outwash from sealant is staining brick below sills.	Following replacement of perimeter sealant (see Exterior Windows portion of this assessment) clean brick below sills.
A portion of the north gymnasium wall facing brick has been removed and could result in bulk water intrusion into the wall cavity.	Infill wall opening.
Precast concrete elements are dirty and/or stained. Many pieces are cracked or crumbling. Surface joints require resealing or repointing.	Clean all precast concrete elements. Repoint all precast concrete joints. Replace precast concrete cornice elements that have broken or failed (Approximately 20% of cornice). Repair miscellaneous precast shapes as needed.

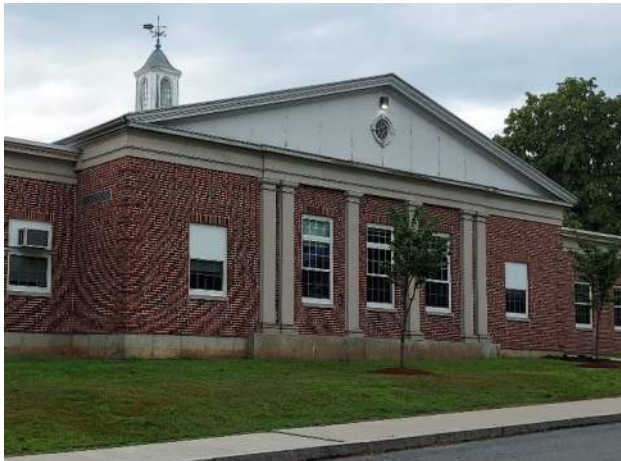
Image 15

The east and west gables at the cafeteria are clad with painted plywood at the pediment and wood trim at cornices (Image 15). The paint is in poor condition and in many areas the wood trim is rotting (Image 16).

The 2012 window project entailed the replacement of all the original single glazed metal exterior windows with dual glazed double-hung fiberglass windows (Image 17). The only windows that were observed to be original are the windows of the cupola and the round window in the pediment of the cafeteria (Image 15); these remaining windows are painted wood and are in poor condition. The project also included the addition of window air-conditioning units supported by aluminum angles anchored to the brick veneer. The windows appear to be functioning well for the most part; only one condition of a misaligned sash was noted. The window exterior perimeters are finished with metal panning and sealed to the jamb brick or precast concrete sills. In most locations, the sealant is dried, hardened, and no longer adhered to the panning (Image 18). The air conditioning units have the effect of blocking natural daylight and views while adding considerable background mechanical noise into the classrooms and offices. These air conditioners also drip condensate on adjacent wall surfaces (Image 19), keeping them constantly saturated during warmer months. This perpetual saturation can accelerate deterioration of wall materials – particularly mortar and precast concrete – contribute to moss or other growth, and even saturate back-up wall or interior finishes since the walls are monolithic construction.

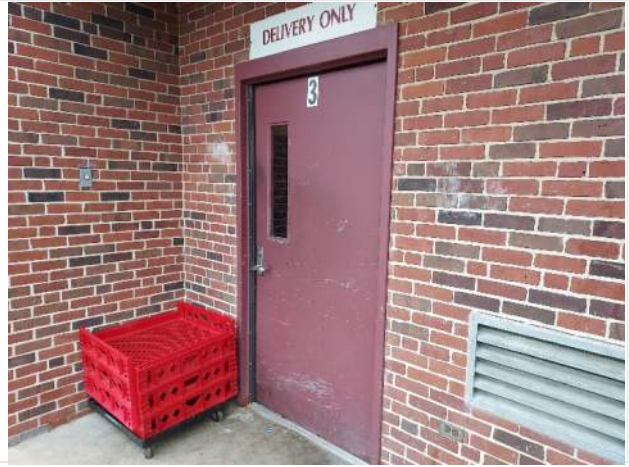
Image 20

The 2012 project also replaced nearly all the exterior doors on the project. The remaining original doors are the hollow metal doors at the loading dock (Image 20) and boiler room. While perimeter gasketing has been added, the frames are rusted at the bottom, the doors are dented and scratched, and the thresholds are damaged and/or not sealed. The paneled overhead door at the maintenance storage bay was also not addressed in 2012 (Image 21). This door frame is still in sound condition, but the door itself is not insulated or gasketed and in poor condition with the plywood panels – which appear to be replacements themselves – delaminating and paint flaking off.

Two hollow metal doors and associated frames remaining prior to 2012 window & door project are in poor condition.	Replace doors, frames, and associated perimeter gaskets and thresholds with new insulated and thermally broken assemblies.
Overhead door is not insulated or gasketed and plywood panels are in poor condition.	Replace overhead door with insulated and gasketed overhead door.
Perimeter sealants at many aluminum storefront systems have hardened and are at the end of their service life.	Remove and replace all perimeter sealant with new sealant.

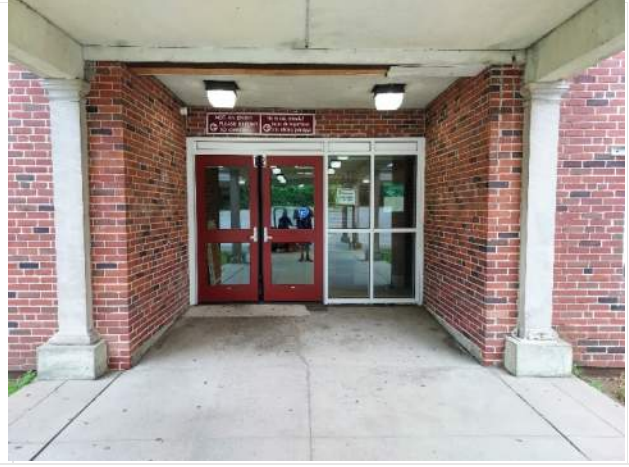
Image 22

incorporate insulated glass sidelights and transoms, aluminum door systems at more public entries (Image 22), and fiberglass reinforced plastic (FRP) doors at more utilitarian locations (such as the gymnasium egress doors) (Image 23). The new entry systems are all in good to very good condition. Perimeter sealants at jambs and soffits have hardened and, in some locations, pulled away from the framing system.

the door (Image 22). Most of these are in fair to good condition with little signs of cracking or settling. The concrete apron at the maintenance door is the one exception where the apron has broken away from the door opening. Frost pads that have a step down to the adjacent pathway do not meet accessibility code requirements. Refer to the Code & Accessibility portion of this report.

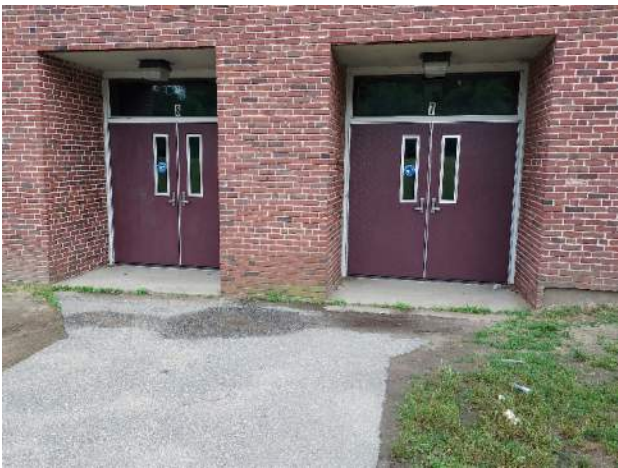
Image 23

Exterior doors are provided with either isolated frost pads (Image 23) or site paving that extends to

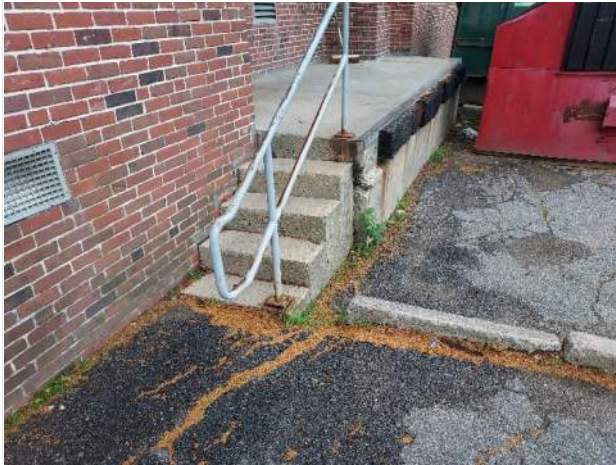
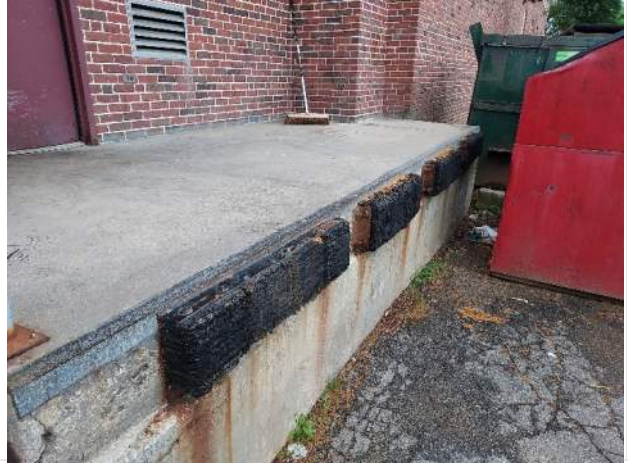
The loading area at the north end of the building, near the kitchen entry, incorporates a concrete loading dock, concrete stairs to grade, and rubber loading dock bumpers (Images 37 & 38). Like many things in the school, these features appear to have fared well over the years, but components are starting to show their age and are nearing the end of their useful life. The stair serves as a means of egress from the kitchen corridor and these stairs do not meet means of egress dimensional requirements. Refer to the Code & Accessibility portion of this report. Fasteners on the rail and dock bumpers are rusting and the bumpers themselves are worn.

Concrete apron at the maintenance overhead door is severely damaged.	Provide new apron at maintenance door.
Loading dock accessories such as railing, and dock bumpers have reached the end of their service life.	Replace loading dock stair rail and dock bumpers.
Cupola is in general disrepair.	Repair cupola: Remove existing roofing membrane and copper flashings. Investigate and replace rotted or damaged wood trim and framing members. Reconstruct portions of plinth and lantern base with pressure treated wood and prefinished metal flashings. Provide new custom window sashed. Repair damage wood trim at lantern. Repaint.

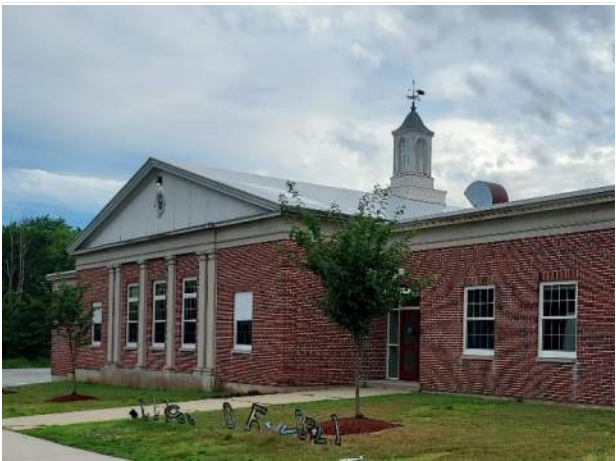
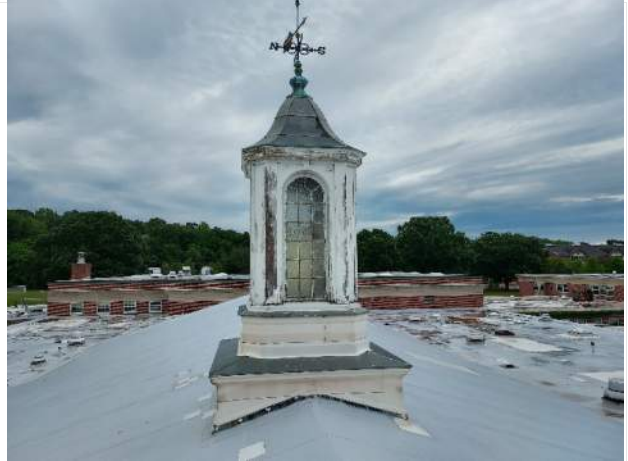
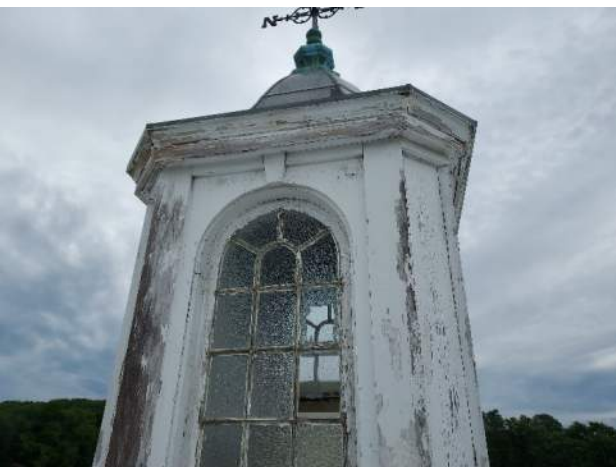
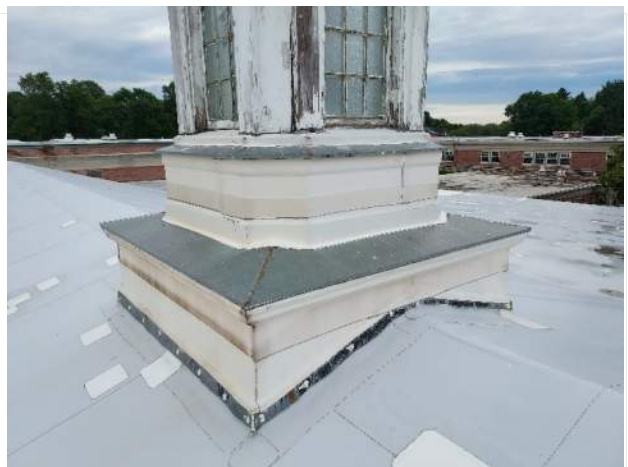
A cupola perched above the cafeteria is, along with the classical precast elements, one of the more notable ornamental features of the building (Images 39 - 42). The octagonal base of the lantern, the square plinth, and the sills of the windows have been wrapped with white roofing membrane (Image 42). The membrane itself appears to be in good condition and there were no obvious signs of water infiltration between the membrane portions and the copper flashing, which is also in good shape. The wood lantern framing and window sashes are in very poor condition (Images 40 & 41). Beyond peeling paint, there are signs of wood rot, missing or broken windowpanes, and all glazing compound has long since been replaced with sealant. Still, there appears to be enough integrity to the cupola framing that would allow for in-situ repairs rather than complete reconstruction.

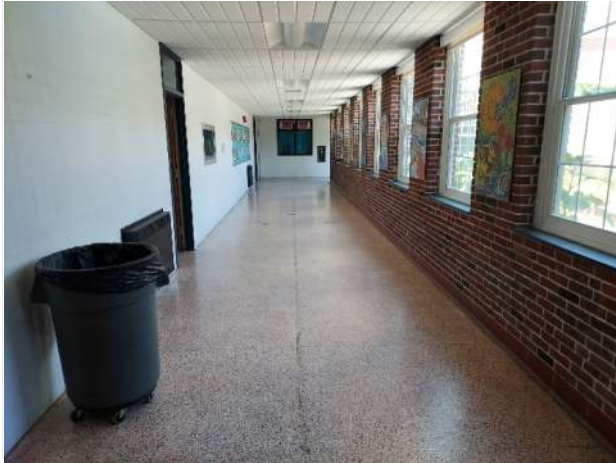
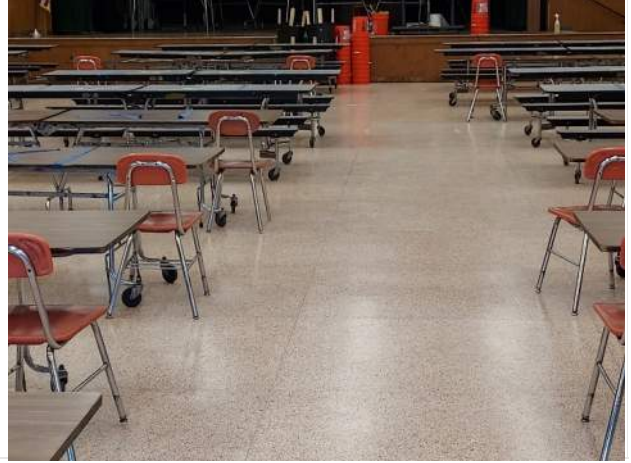
Original terrazzo floors feature prominently in vestibules, corridors spaces such as the cafetorium and the kitchen (Images 43 & 44). All of the terrazzo that was observed is in excellent condition, even in high traffic areas like the kitchen, and the only recommendation would be to continue to preserve and maintain them. Stair treads are also terrazzo with a slip-resistant strip. All of the observed treads appear to be in excellent condition except for a few locations where a resilient tread had been installed over the original terrazzo (Image 45).

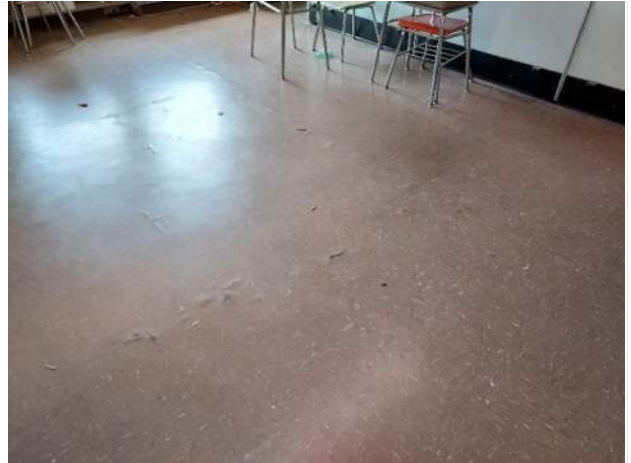
Image 46

Most educational spaces and offices areas still have the original vinyl tile floors. The majority of these floors are in good condition and appear to be well maintained with some localized areas in fair to poor condition (Image 46). The most consistent issue observed was shrinkage of the tile resulting in large gaps between tiles. There was also noticeable difference in wear between room perimeters and the center of the room, typical of older floors that have experienced decades of use and maintenance and the difficulty of cleaning near walls. In custodial closets, vinyl tile was in poor condition (Image 47), and in some locations the tile and resilient base were missing, and bare mastic was visible. In a few rooms, complete replacement of the floor tile was observed. In many areas wall base was worn or missing (Image 48). Although the floor tile has been well maintained, it has far exceeded its anticipated service life and the years of wear are starting to show in most places.

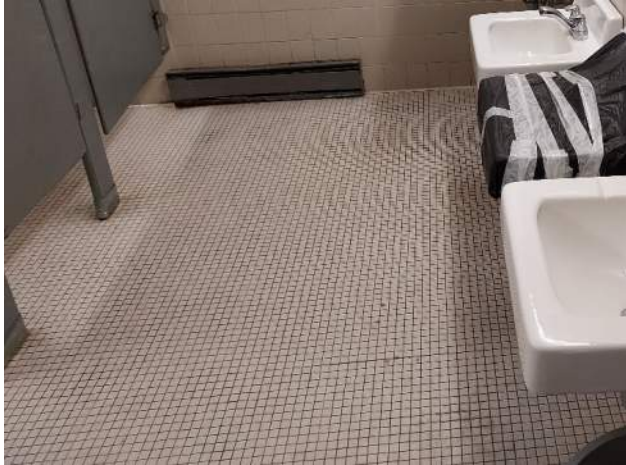
Image 49

Ceramic mosaic tile floors in toilet rooms, although dated, were generally in good condition (Image 49). The tile floors in the large shower rooms and staff toilet rooms were also observed to be in good condition (Image 50). In many locations, particularly the large shower rooms and some staff shower areas, the grout shows areas of staining; the tile could benefit from a thorough cleaning, but otherwise tile and grout are generally sound. There are also patches of mosaic tile in wet areas of the art classrooms, which are also in good condition.

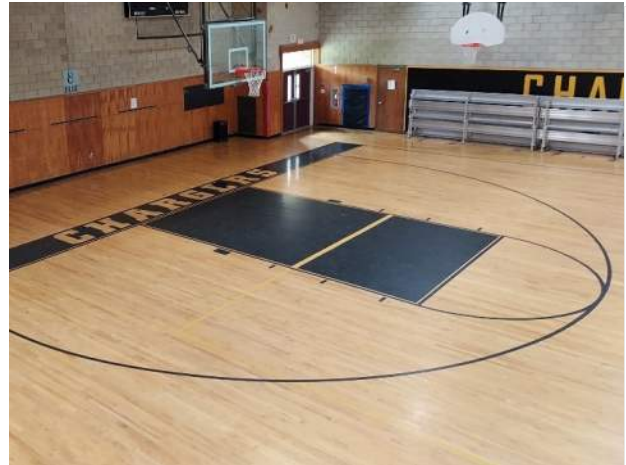
Image 51

original floor finish based on the degree of discoloration (Image 52) and are flaking off in some areas, but the main gym floor appears to have been re-finished more recently (Image 51). There were some areas of water staining observed, likely from the various roof leaks in the area and around drinking fountains (Image 53), and some perimeter wall base and flooring pieces were loose and in disrepair. The track location for the divider between the west aux. gym and the main gym was buckled, creating a potential tripping hazard. The other divider track location could not be observed due to storage of materials around the divider. The wood floor in the shop is also in fair condition. The majority of the finish in the space has been worn through and bare wood is exposed (Image 54), making it more susceptible to wear and staining. There were numerous floor patches and equipment mounting locations noted, but the floor was not buckled or loose and could be put into service with some patching and refinishing.

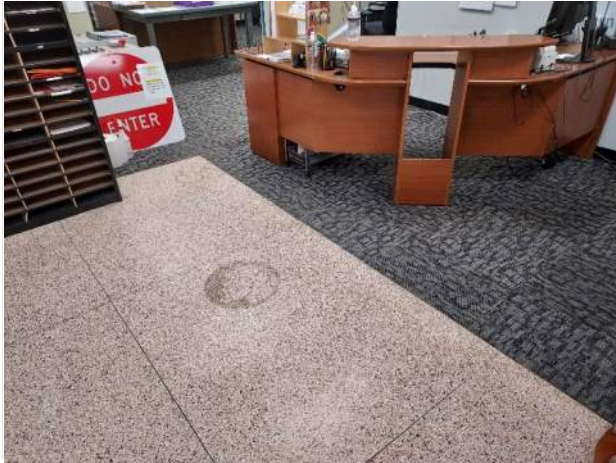
Image 55

There are relatively few areas that indicate carpet in the 1968 documents: the office area (Image 55) and the media center (Image 56). The carpets in these spaces have since been recently replaced with modular carpet tile and the carpet tile is in excellent condition.

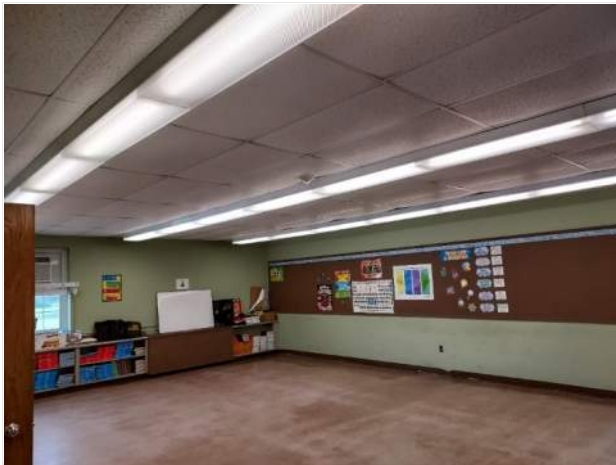
Image 57

Interior partitions are generally of two types: concrete block masonry and metal stud framed with plaster over lath board. Most walls and partitions are in good condition (Image 57) with only a few minor areas of cracked plaster finish observed. Janitor closets showed the worst wear of plaster finished due to the constant use of water. At one janitor closet (Image 47), water had infiltrated into one wall and plaster was failing in the adjacent room (Image 58); it is assumed that the studs are rusted in this location.

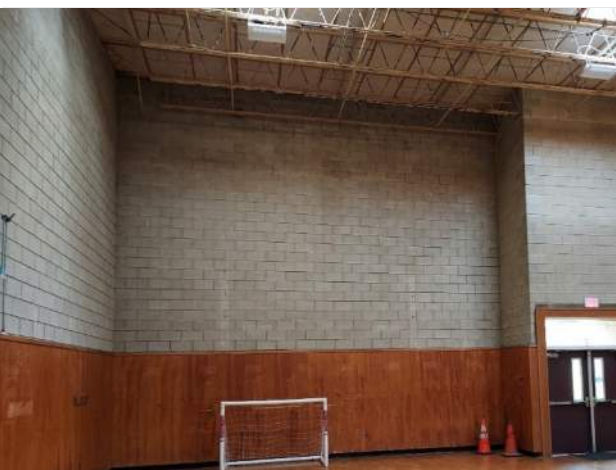
Image 59

Most of the exposed concrete block is painted except for the gymnasium, where bare pumice block was used (Image 59), presumably for superior acoustic properties. Similarly, most of the exposed plaster finishes are painted except for a teacher's work room where wall covering was installed over the plaster (Image 60). In that room, the wall covering has peeled away from the plaster. In locations with simple painted block or plaster, the finishes have held up quite well. Some areas, like janitor closets (Image 61), need cleaning/repainting of block walls or patching and repainting of plaster finishes.

In the main and auxiliary gymnasiums there is a wood wainscotting (Image 59) up to 7'-4" which is in fair to poor condition. It is heavily damaged and in some places the face veneer is delaminating.

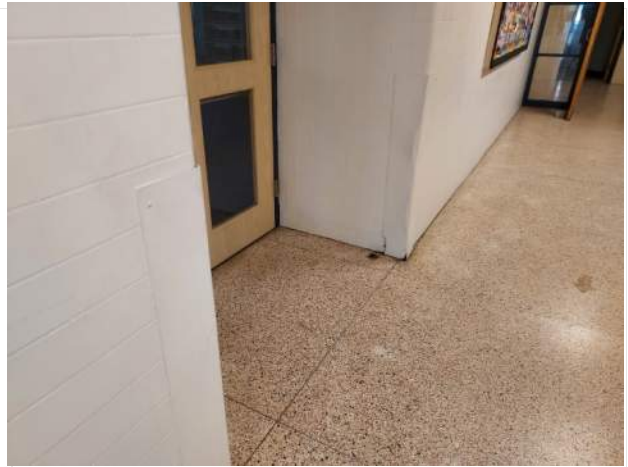
Image 64

Ceramic tile features prominently in many spaces such as toilet rooms, primary corridors, the cafetorium, entry vestibules, and various other high traffic, high visibility areas. Again, much of this tile is dated, but in good condition. There were some limited areas of observed tile damage, particularly in toilet rooms with some damaged areas observed in corridors and the locker rooms. Grout in many areas is stained, particularly in toilet rooms, shower rooms, and staff toilet rooms with showers (Image 63). Tile in some areas such as the main entry and corridors near the administrative offices have been recently treated with a spray applied elastomeric coating (which may simply be acrylic latex paint); these areas are in very good condition (Image 64).

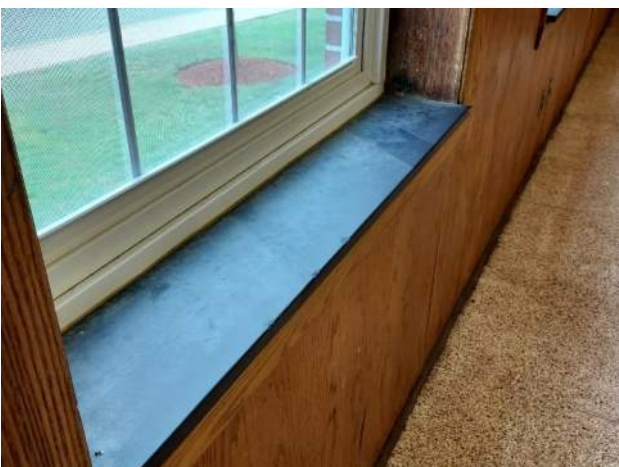
Image 65

The cafetorium also includes some molded solid redwood paneling and redwood veneer paneling. The solid wood molding is in good condition, and the veneer plywood paneling is in fair condition generally, but poor condition around windows where condensation appears to have stained the plywood (Image 65). This space also incorporates acoustic plaster at high soffits and walls (Image 66). Because the plaster is more porous and located near unit ventilators, it has accumulated more dirt than other plaster surfaces. Other than a dingy appearance, the acoustic plaster is in good condition.

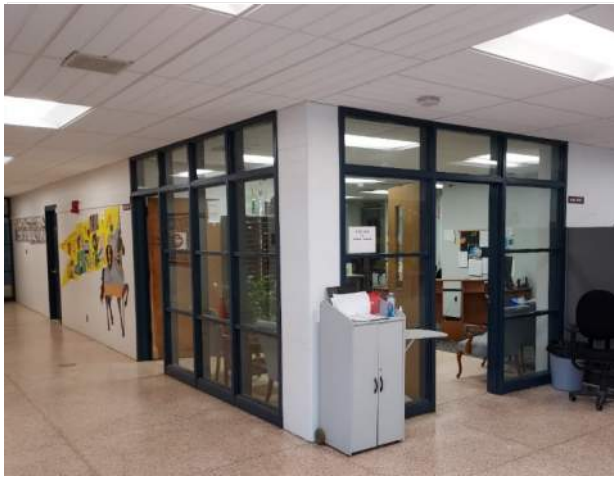
Image 67

There are very few interior windows in the building. Large hollow metal windows are featured in the library and main office (Images 67 and 68). Smaller hollow metal frames are located between offices areas and the spaces they serve such as at the art classroom office, girls shower room office, and kitchen office. All of the frames are in very good condition. All frames feature clear vision glass with the exception of the frames around the administration offices, which includes wired glass.

Interior windows at offices include wired glass, which is safety concern.	Replace wired glass with clear vision glass or tempered safety glass in areas required by the building code.
---	--

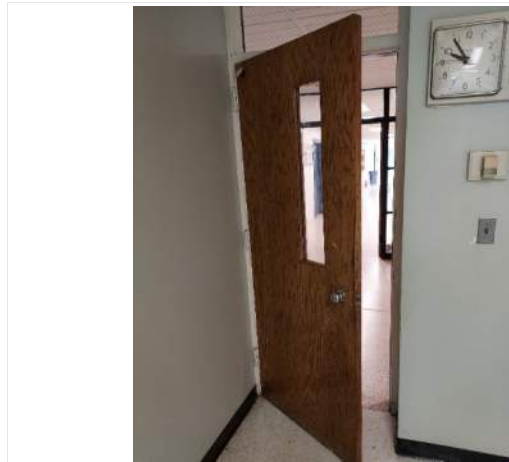
Image 69

Most interior doors to classrooms, offices, toilet rooms, storage rooms, and other occupied spaces are red oak wood doors in hollow metal frames (Images 69 and 70) with some hollow metal doors at back-of-house and custodial spaces. Exit doors at stairwells incorporate hollow metal doors with vision panels; these doors are provided in hollow metal frames with glazed sidelights and transoms (Images 71 and 72). All glazing in wood and hollow metal doors and transom or sidelight panels was observed to be wired glass.

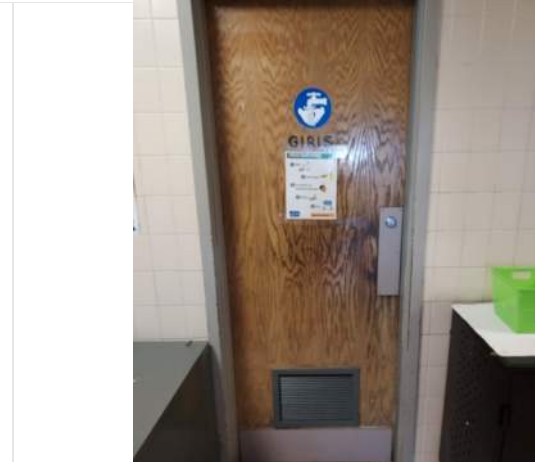
Image 70

Many of the wood doors are very dirty with staining and/or delaminated veneer observed around door hardware and near the floor, particularly at toilet rooms (Images 70 and 73). Typical doors do not feature modern classroom, storage, or office security function hardware, nor do they include hardware that is accessible. Some door leaves appear newer and are likely replacements, but many of the replacements still do not provide accessible hardware (Image 74). Egress hardware at stairs and in corridors varies in terms of function, but nearly all of it is non-compliant with some doors on manual hold-opens and several that do not latch (Image 72).

Wood door leaves are worn, dirty, delaminating, and do not incorporate door hardware that accommodates current security best practices.	Replace wood doors. (While some wood doors could be re-finished, the fact that many of them should be fitted with new hardware would add to the labor cost of simply refinishing.)
Hollow metal doors, including stair egress doors are antiquated, not rated where required (egress stairs), and do not incorporate door hardware required by current codes.	Replace hollow metal doors. (While some hollow metal doors could be modified and repainted, in many locations they are not part of fire rated assemblies as required by code.)

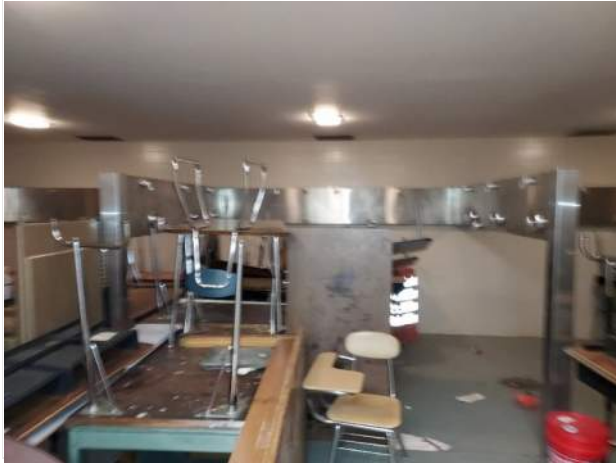
Image 79

In many wet service areas, such as the boy's and girl's lockers and many of the gang toilet rooms, the ceilings are plaster finish (Image 79). Locker areas and the kitchen include moisture resistant ceiling tiles (Image 80). Many of these are in good to fair condition with some minor areas of localized moisture damage. Evidence of repairs was seen in several toilet rooms (Image 81).

Plaster ceilings in some wet service areas have been damaged and/or paint is peeling.	Repair plaster ceilings. Repaint plaster ceilings with gloss paint to inhibit moisture damage.
Fiberglass roof form deck is stained from years of roof leaks. Paint on exposed roof joists is peeling and in many locations, bare steel joists are showing signs of surface rust.	Following replacement of the roof, prepare and repaint all exposed ceiling roof deck and exposed structure.

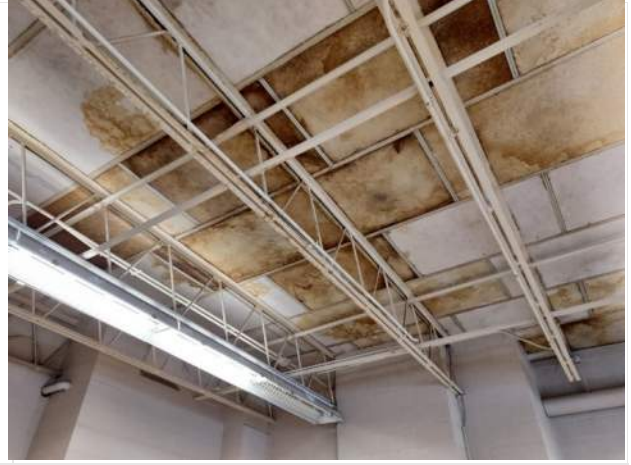
Image 82

Some high bay spaces such as the gymnasiums and the mezzanines above the locker rooms have exposed structure and roof form boards. In all spaces, the underside of roof is stained from years of water leakage and paint on exposed joists is flaking off (Image 82). These exposed ceiling spaces are showing signs of wear in all spaces and in need of refurbishment.

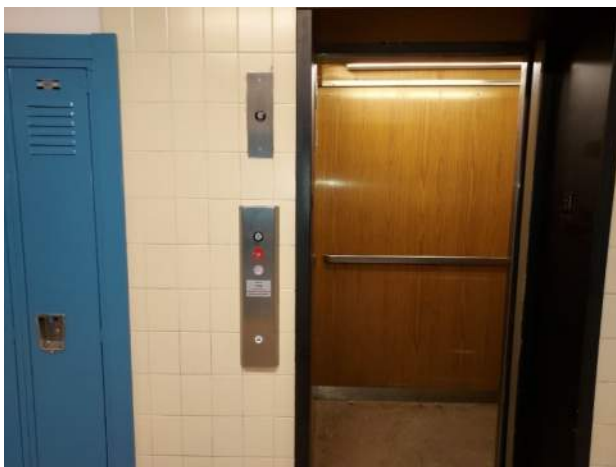
Image 83

The elevator is original to the building and still functions adequately. It has been updated with modern controls, including fire department controls (Image 84). The elevator cab finishes and lighting are dated (image 83), but otherwise in good condition. The elevator does not meet elevator and accessibility code dimensional criteria in terms of cab size or door opening.

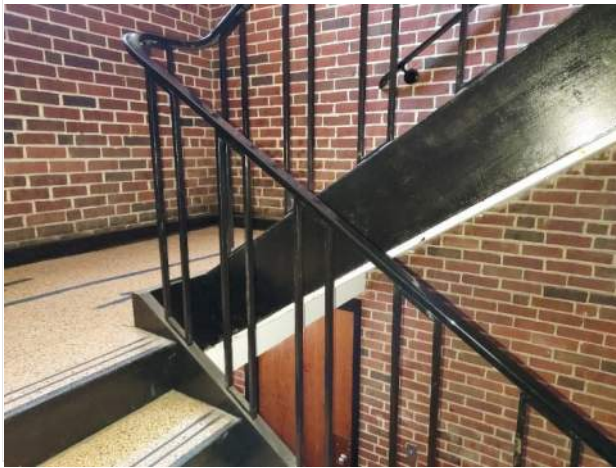
Image 85

Stair handrails/guardrails are also original to the building, and all appear to be in good condition (Image 85). However, none of the observed guardrail assemblies met the dimensional criteria in the building or accessibility codes.

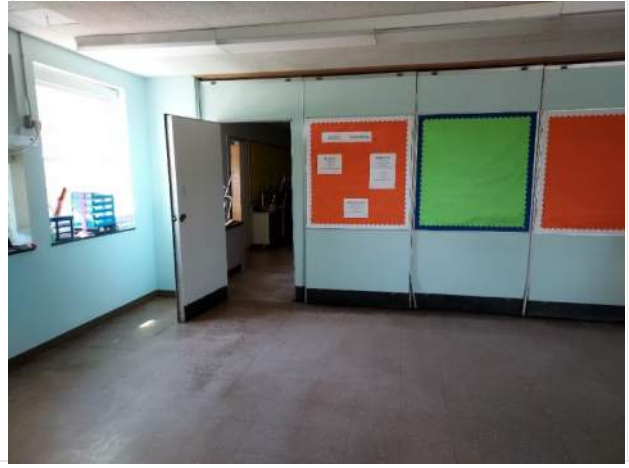
Image 86

Four types of operable partitions were observed. Manual folding partitions are used to subdivide classroom blocks in the two-story portion of the building, allowing groups of three classrooms to be opened to each other (Image 86). All these classroom partitions were closed during the visit. The finishes and tracks appear to be in fair condition, but it is unknown if the partitions still function. Based on the construction type and condition of ceiling tracks, floor seals, and passage doors, it is assumed that the partitions create poor acoustic separation between classrooms. An accordion style room divider remains in what was once teacher breakroom and workspace. The divider and track appear to be in good condition but use of the divider was not observed. Motor operated paneled dividers in the cafetorium can sub-divide the space into three smaller instruction spaces (Image 87). The condition of the tracks and panels appear to be good, and the panels may even be replacements given the relatively new look of the hardware. Operation of the partitions was not observed during the visit. Finally, large coiling wood slat dividers can subdivide the auxiliary gyms from the main gym and also subdivide the main gym in half (Image 88). One divider was observed to be in the closed position and the others were in the open position. Operation of the partitions was not observed during the visit. The condition of the wood slats was good with some observed damage on the lower portion of the closed partition. Operable passage leaf doors within the coiling dividers appeared to be in fair to poor condition.

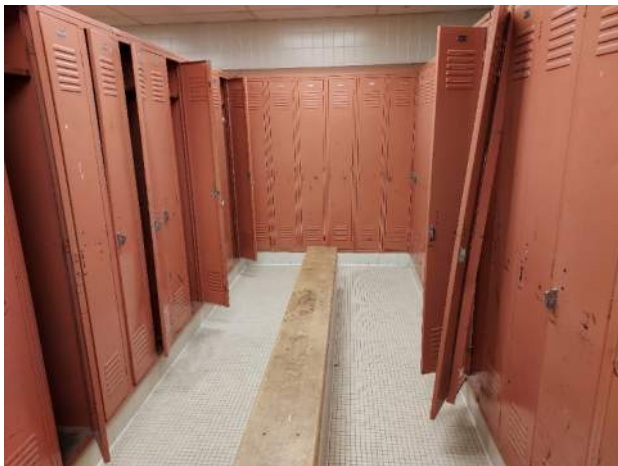
Image 89

Lockers in corridors appeared to be recently replaced and were in excellent condition. Lockers in other portions of the building, including boy's and girl's locker rooms and staff lockers appear to be original to the school and are in poor condition (Image 89).

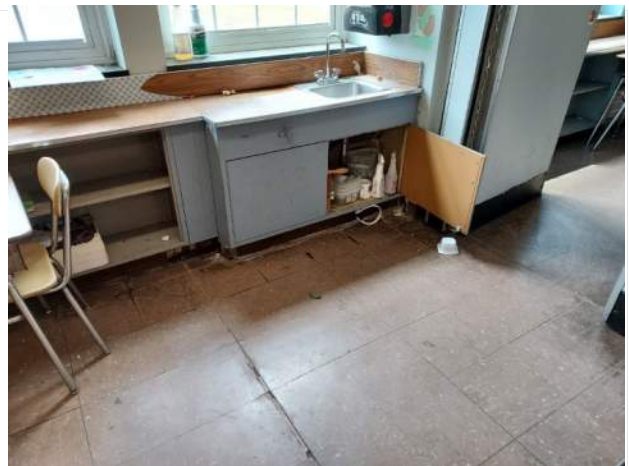
Image 90

There are various types and configurations of casework depending on the room type. Typical classrooms include bookshelves with laminate tops flanking unit ventilators along exterior walls and a corner sink base cabinet (Image 90) as well as a metal storage cabinet in the corner of each classroom (Image 92). Typical classroom casework ranges from fair to poor condition with mild to extensive wear and delaminating countertops observed in many spaces. Science classrooms contain perimeter base cabinets with solid resin countertops and a teaching station with a casework display island and tall storage cabinets (Image 91). The teachers station includes a sink and gas turrets and two of the three science teacher stations are provided on a low platform. Science casework is generally in good to fair condition with some casework in poor condition. Several cabinets were observed with delaminating veneers. Science countertops are generally in good condition. The food classroom incorporates various configurations of wood casework with laminate countertops; this casework is in poor condition with numerous missing or broken components, delaminating veneers and countertops, and outdated cooking appliances (Image 93). Art classrooms include wood veneer work tables with resin countertops and stainless steel sinks and the Clothes casework includes a series of tall wood storage cabinets. The casework in these spaces is in fair to poor condition, again with missing or broken components and delaminating veneer being typical. Teacher work spaces incorporated banks of casework with laminate tops, generally in fair to poor condition. No accessible classroom sinks were observed.

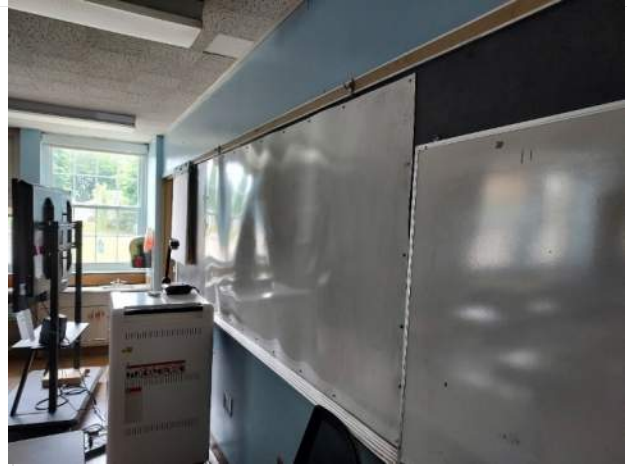
Image 94

rooms was observed to be buckled and wavy (Image 94). Electronic instructional devices vary widely from room to room; refer to the Technology Assessment portion of this report for additional detail.

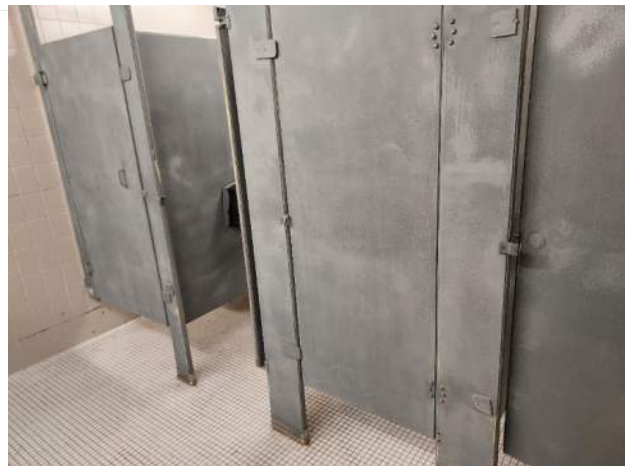
Image 96

Toilet partitions in most gang toilet rooms and boy's and girl's shower rooms are original to the building (Image 96); most are in poor condition with many damaged partitions noted. In some locations they are still in fair condition. In one gang toilet room, the partitions have been replaced and the replacement partitions are in fair condition. Toilet room mirrors are missing or the silvering has failed (Image 99). Toilet room accessories are of various types and few are original to the building. On the whole, their condition can be summarized as fair, but in nearly every space observed, accessories were not mounted in accessible locations. Similarly, plumbing fixture conditions vary widely: some are antiquated, in poor condition, and in many toilet rooms, plumbing fixtures have been removed (Image 97). Urinals are not screened from each other as required. Refer to the Plumbing Assessment portion of this report for additional detail.

Chalkboards are largely out of use or have been damaged by the installation of flexible marker surface.	Replace all chalkboards with markerboards.
Toilet room partitions and accessories have outlived their service life and are in various states of repair.	Replace all toilet room accessories, including toilet paper dispensers, soap dispensers, mirrors, sanitary napkin disposal units, and toilet partitions. Provide urinal screening.

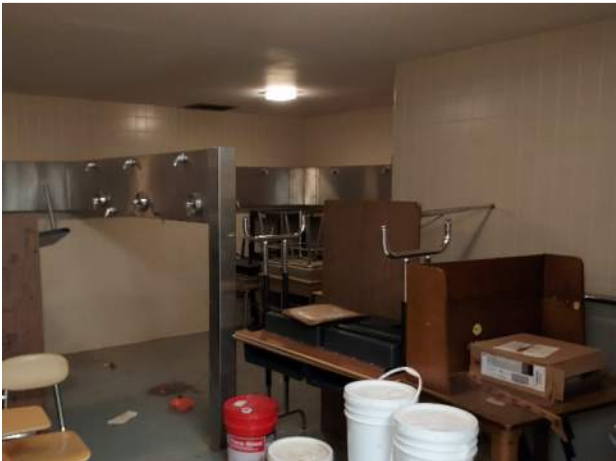
Image 99

Showers in the boy's and girl's locker rooms differ in layout; the boy's showers gang style with stainless steel enclosure (Image 99). The fixtures appear to be in good condition, but function was not observed. The girl's showers include private locker and changing areas on each side of a single shower stall (Image 100). These changing & shower areas are in fair condition with most finishes rusted or stained and many lockers not functioning. In various staff toilet rooms, stand-alone shower enclosures are provided. Nearly all of these are in poor condition with some showing many years of failed attempts at repair (Image 101).

Toilet room layouts are not accessible, and fixtures are in disrepair.	As part of a major alteration, provide all new plumbing fixtures incorporating accessible fixture layouts.
Shower room configurations are outdated and do not meet modern functional requirements. Locker room equipment and fixtures are antiquated, in poor condition, and do not meet accessibility requirements.	As part of a major alteration, provide all new locker and shower room layouts, including slab demolition and new shower room, locker room, and toilet room configurations and equipment complying with current accessibility codes.

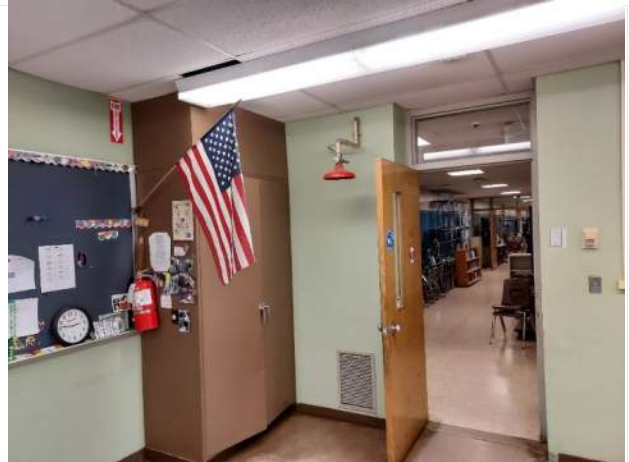
Image 102

Science classrooms include emergency showers which appear to have been added as supply piping is exposed in the corridors (Image 102). Function of the showers was not observed.
