EVALUATION OF EXISTING CONDITIONS

SUMMARY OF EXISTING CONDITIONS

The Albert B. Consentino Middle School is located at 685 Washington St. in Haverhill, Massachusetts and is one of five middle schools in the district. The project site is situated in a residential neighborhood of single and multi-family homes. Access to the site is by Washington St., a winding thoroughfare that connects Lowell Ave. to River St. (Image 1) The site was developed over time through the taking and consolidation of individual residential properties.

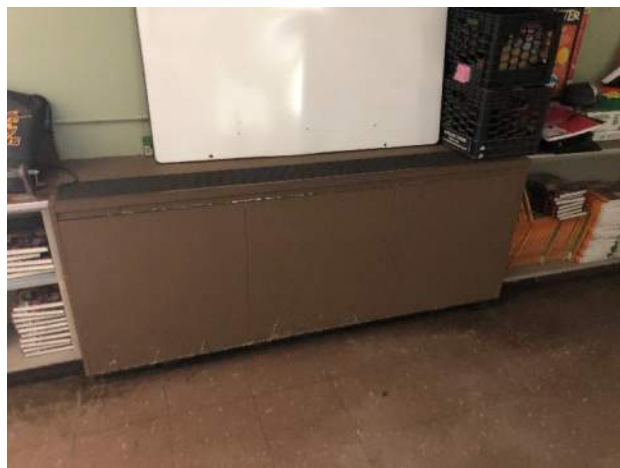
Image 1: Typical Classroom Unit Ventilator

Currently, installed Unit Ventilators have far-exceeded their expected service lives and are therefore noisy & approaching failure.	Provide new HVAC equipment & associated control systems to provide the classroom spaces with greater indoor environmental conditions.
---	---

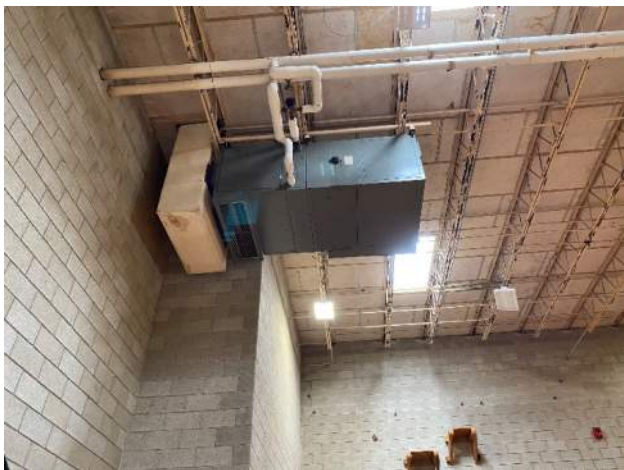
The large and small gymnasiums are heated and ventilated by several pneumatically controlled H&V units suspended from the ceiling. There are four units in the gym proper, and an additional unit in each small gym extension, for a total of 6 units. All units supply directly to the space. Return air is also brought directly back to the H&V through a unit mounted return air damper. Relief air is through several low wall mounted relief grilles. The H&V units are provided with a hot water heating coil, supply fan, filters and a mixing box. The outside air intakes are routed from the ceiling suspended unit, directly up through the roof. The exhaust/relief grilles are in generally poor condition and in some cases are blocked entirely. Likely indicating operational issues with dampers and/or exhaust fans. (Image 9, 10).

Image 9: Ceiling Suspended Heating and Ventilation Unit

Specific Issues	Recommendations
Currently, installed heating & ventilating unit has exceeded its expected service life and is in poor condition.	Provide new HVAC equipment & associated control systems to provide the gym with acceptable indoor air quality.

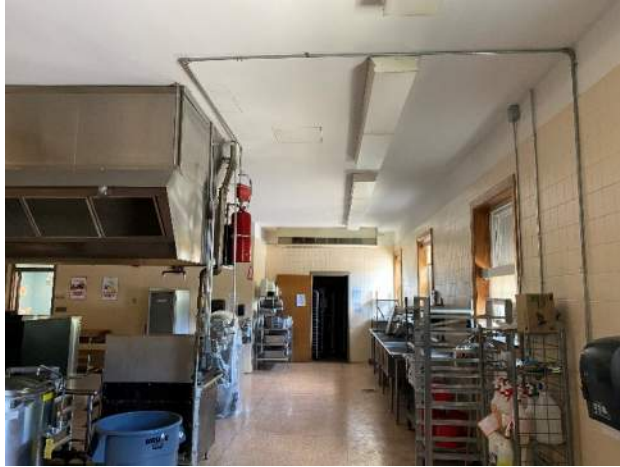
Image 11: Kitchen Unit Ventilator and Hood

Currently, installed unit ventilator units have exceeded their expected service life and is in poor condition.	Provide new HVAC equipment & associated control systems to provide the kitchen with acceptable indoor air quality.
--	--

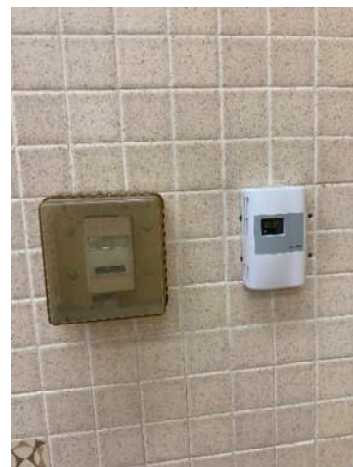
The cafeteria/stage area is served by six soffit mounted unit ventilators (Image 13). It is assumed outside air is provided from roof mounted intake hoods while exhaust/relief air is provided from low wall grilles (Image 14) connected to duct and fans that terminate at the roof level, similar to the classrooms and gymnasium. There is also a low wall transfer grille (Image 12, 15) between the cafeteria and kitchen which is utilized to maintain proper pressurization during hood operations. Unit ventilators appear to be controlled with upgraded direct digital controls, with older, pneumatic controls (Image16) being abandoned in place.

Image 16: Old Pneumatic, and New DDC Thermostats

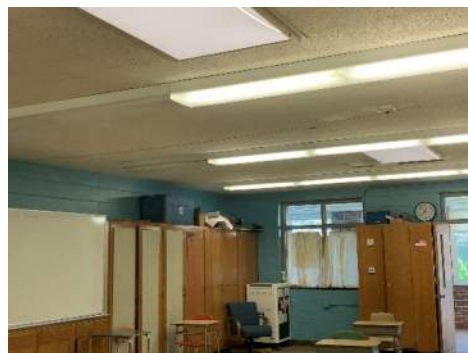
Image 8

Corridor lighting consists of a combination of 2X2 recessed lens fixtures with (2) T8 lamps (Image 14), some are breaker controlled, which is not energy code compliant. There are some newer 2x4 LED fixtures in the renovated area of the building (Image 10). Classrooms lights consist of 1x4 surface wraparound fixtures with T8 lamps switched by one switch (Image 8). No occupancy sensors exist in the classrooms.

No occupancy sensors exist in the classrooms.	Add occupancy sensors in classrooms to conserve energy.
No daylight harvesting.	Add daylight harvesting in all areas with outside exposure to conserve energy.
Lighting is not efficient.	Upgrade to LED type light fixtures with automated lighting control.

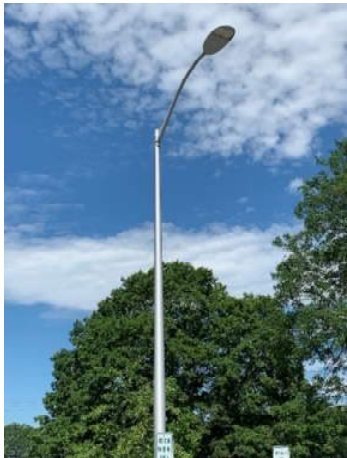
Image 15

There is newer pole lighting in parking lot areas (Image 15). Wall packs and flood light with some ceiling mounted exist at entrances (Image 16 & 17). Most fixtures are LED type but some are still fluorescent or incandescent. Time clocks were observed in the building that provide control to the existing site lighting. All exterior lighting should be LED type.

Specific Issues	Recommendations
Some lighting is fluorescent and incandescent type.	Replace fluorescent type lighting with LED.

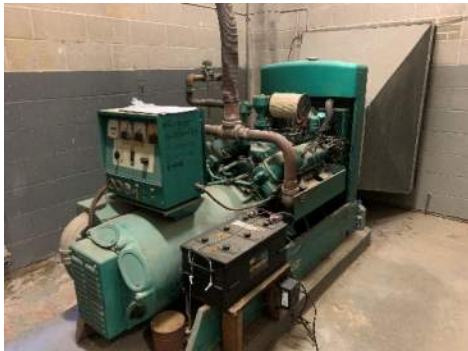
Image 18

The building has a 65KW Onan generator (Image 18 & 19). It has an Automatic Transfer Switch (ATS) to transfer power from the utility company source to the generator during an outage (Image 20). There is a distribution panel that serves remote panels throughout the building to provide emergency power (Image 21). The generator is sized for the current building load and will not handle added load.

Exterior doors have no exterior emergency lighting in the form of remote heads.	Add remote heads at exterior doors.
Emergency generator does not have the capacity for any new required loads.	Increase emergency generator to a larger size to accommodate life safety and optional standby electrical loads.
No separate life safety equipment (ATS) needed for code complaint.	Add required automatic transfer switches for life safety and provide rollup generator docking station with manual transfer switch to meet code.

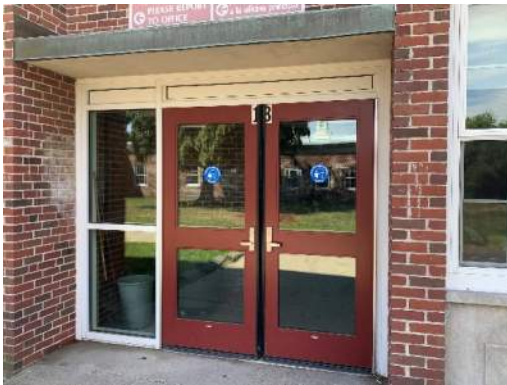
Image 22

The exterior doors have no exterior emergency lighting in the form of remote heads (Image 22).

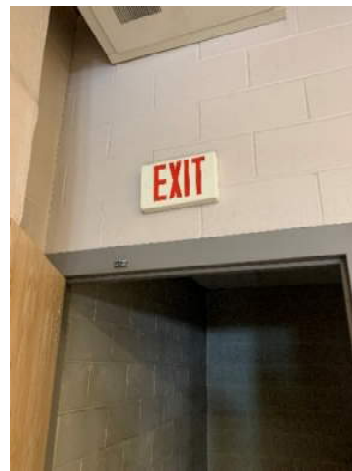
Image 23

Most exit signs have battery back-up (Image 23). Exit sign coverage appears adequate. Exit signs seem to be in proper operating condition.

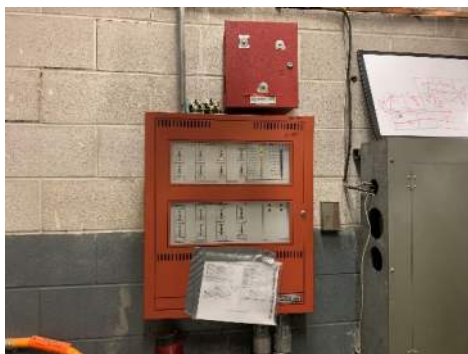
Image 24

The fire alarm system consists of a non-addressable Fire-Lite Sensiscan 1000 control panel located in the Main Electric Room (Image 24). The graphic annunciator is located in the Vestibule. The horn/strobes are not ADA compliant (Image 29 & Item 30). Pull stations are located at the exit doors (Image 28 & 31). Smoke and heat detectors exist in corridors and classrooms (Image 26 & 27).

The fire alarm system is antiquated and does not meet the current code and does not provide adequate detection and notification to occupants.

Replace fire alarm system with new code compliant system including notification.

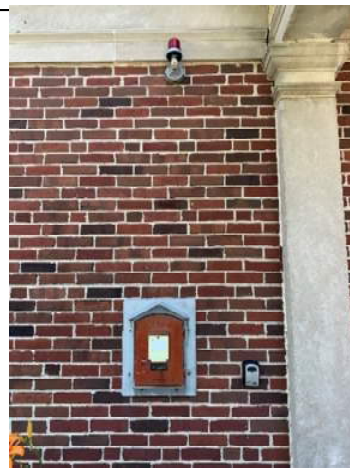
Image 25

A existing master Box is installed at the front entrance of the building (Image 25).

No duct smoke detectors were observed at the time of visit. Duct smoke detectors will need to be added as required for all mechanical equipment over 2000 CFM. Exterior beacons and knox box are provided at the main entrance (Image 25).

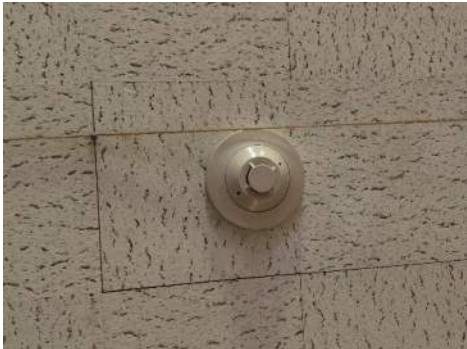
Image 27

The toilet rooms do not have strobes and smoke detectors. There are smoke alarms in classrooms (Image 27), corridors, stairways and offices.

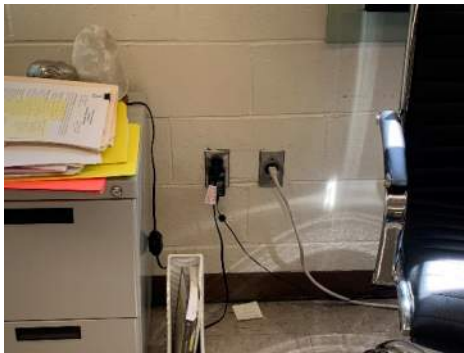
Image 32

The facility does not have lightning protection system. The receptacle coverage is inadequate in most spaces (Image 32 & 33). Typical classrooms have as few as two duplex receptacles per room. Some rooms have had surface mounted raceways with receptacles added (Image 34).

The facility does not have lightning protection system.	Add lightning protection system.
The receptacle coverage is inadequate in most spaces. Typical classrooms have as few as two duplex receptacles per room. Some rooms have had surface mounted raceways with receptacles added.	Add appropriate quantity of receptacles for space use.

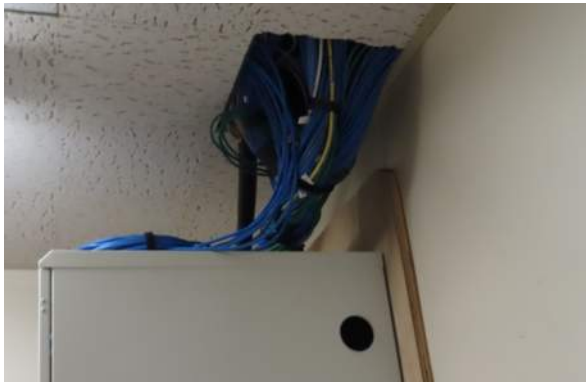
Image 3

The Haverhill Consentino Middle School appears to have newer network cabling installed throughout the school that is run from wall mount enclosures (Image 5) that are located in 4 or 5 shared spaces. These shared spaces include classrooms, storage closets, and offices. The new cabling is in very good condition. Older preexisting network cabling is exposed in many locations (Image 1 and 2) and in some areas abandon wire mold has been left in place. Some newer cabling has also been left exposed (Image 3 and 4).

Newer network cabling exists. However, cabling has been run to wall mount protective enclosures in shared spaces, which is common when implementing new cabling work in the context of an older existing facilities.	Dedicated network closets should be established as part of any building renovation project, with new Cat 6A cabling installed from outlets to closets. The wall mount enclosures will not support any new cabling.
Exposed older surface mount raceways and cabling exists throughout.	Remove older existing surface mount raceways and cabling as part of any renovation project.

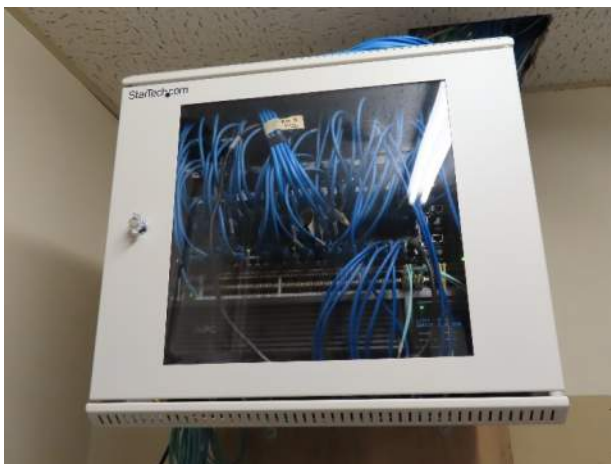
Image 5

Brocade Network switches are installed in wall mount enclosures along with patch panels, patch cords and UPS equipment (Image 5 and 6). In some situations, it was noted that the UPS equipment did not fit in the enclosure, and it was resting unsecured on the top of the enclosure instead.

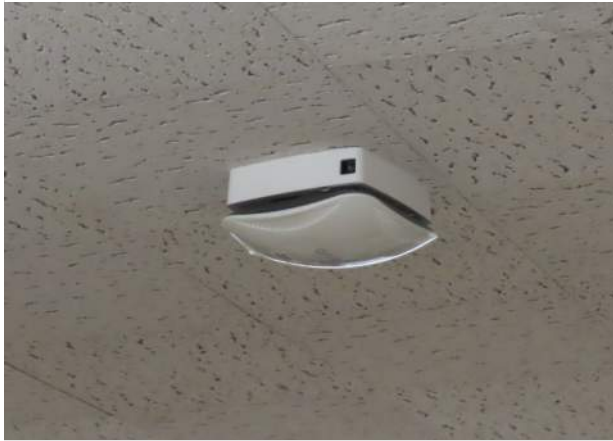
Image 7

Wireless Access points were observed throughout the facility and located in all classroom spaces (Image 7), in large assemble areas like the cafetorium (Image 8) and in other general spaces.

Specific Issues	Recommendations
The school is relying on newer wireless network equipment for achieving network connectivity. This is the best strategy in older buildings. However, there are applications, especially streaming applications where hardwired connections are preferable.	New hard-wired data outlets in addition to cabling for wireless should be installed in all educational spaces as part of any building renovation project so that teachers and staff can make a hardwired connection to the Network when required.

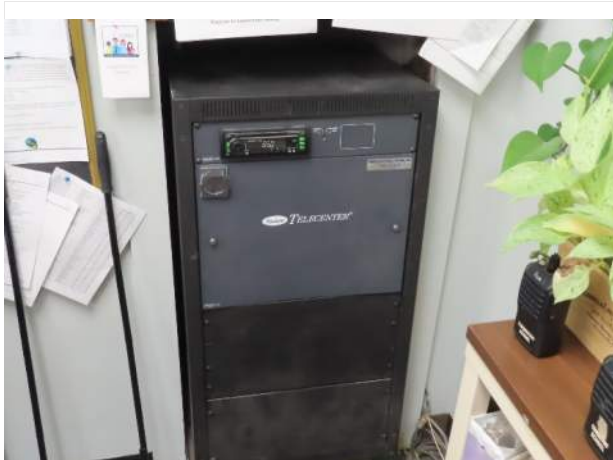
Image 9

The main public address system cabinet is located in the main office (Image 9), which is an antiquated Rauland Borg Telecenter System. Most classrooms have an intercom handset installed below the clock/speaker assembly (Image 10). A public address system console was observed in the main office (Image 11). Older Speaker-Clock assemblies original to the 1968 construction were in all classrooms but were observed to be in varying degrees of disrepair. Battery clocks of various types and sizes were observed throughout (Image 12).

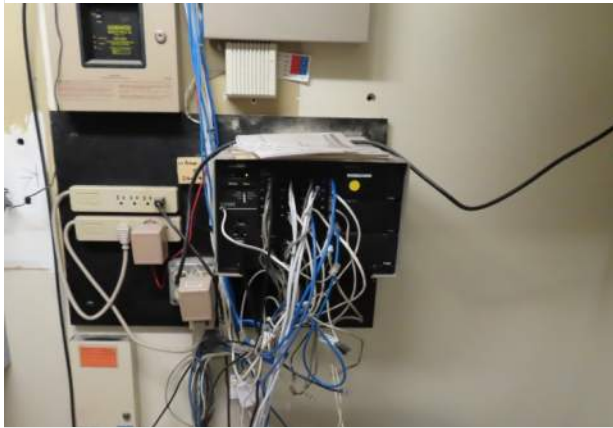
Image 13

The Telephone System serves primarily the main office administration area and is an antiquated AT&T Merlin System (Image 13 and 14). The handsets in the classrooms are strictly tied to the public address system for making calls between classrooms and between classrooms and the main office. There may be a connection between the public address system and telephone system at the main system side to allow for outside calls from the classroom handsets, but, it was not verifiable from the site visit.

Specific Issues	Recommendations
Telephone system is antiquated making it more difficult to service and maintain equipment in the future.	Install new Telephone System as part of any facility renovation and upgrade.
Telephone system capability may not currently extend to all classrooms and other spaces other than the main office.	Install a new Telephone system capable of incorporating telephone handsets in all classrooms and spaces.

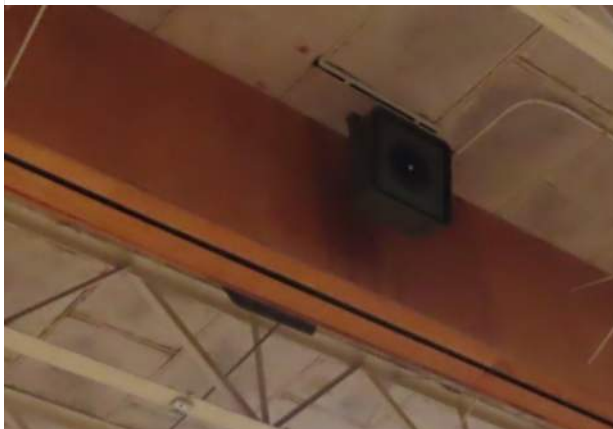
Image 15

The large assembly spaces include the Cafetorium and Gymnasium, which can each be further subdivided into smaller areas. Both spaces are equipped with older audio visual technology. The speakers in the Gymnasium appear to be the original speakers from when the school was constructed (Image 15). A podium with built-in hard-wired microphone was located on the stage of the Cafetorium. (Image 16). A relatively new large mobile flat panel display was located on the stage of the Cafetorium (Image 17). Appropriate levels of large assembly audio-video equipment were not observed.

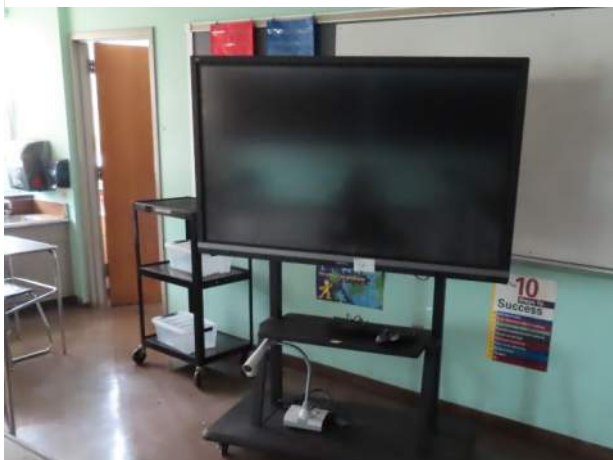
Image 18

Classroom instructional technology includes a variety of systems and devices. Most classrooms are equipped with newer mobile flat panel technology with Elmo style TT12 document cameras (Image 18). However, older CRT TV's mounted from the ceiling was also observed in many locations (Image 19). Pull down projection screens (Image 21), along with older wall mount and ceiling mount projectors (Image 20) were also observed in various rooms. Some rooms may lack the functionality and educational opportunities that more current audio-visual display technology provides. Modern voice reinforcement equipment was not observed.

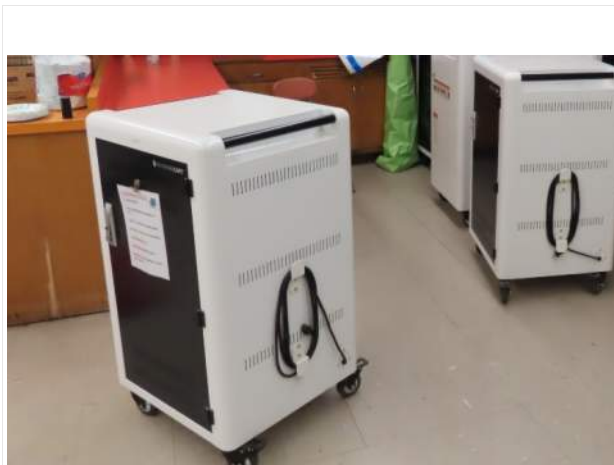
Image 22

Mobile student technology carts for Chromebook or iPad were observed through the school (Image 22). It was assumed without confirmation that the school is either 1-to-1 or close to being 1-to-1 by the number of carts that were observed. The carts appeared to be empty, and it was assumed that either the devices were with students for the summer or being centrally managed and updated at another location. Dell micro desktop computers were observed in some teacher locations and in offices (Image 23).

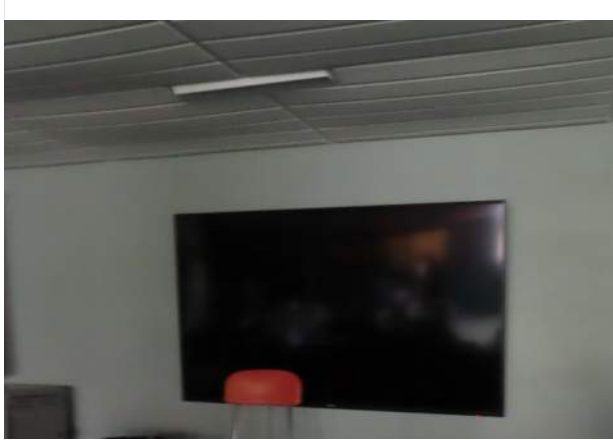
Image 24

One flat panel display was observed that may be associated with digital signage (Image 24)

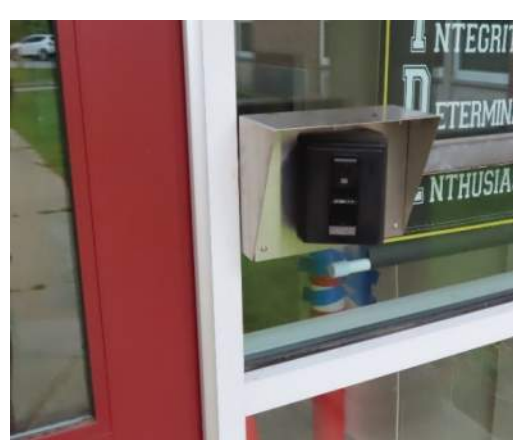
Image 25

Video surveillance and intrusion detection systems were observed with limited cameras and motion sensors respectively. A video intercom device was located at the main visitor entrance (Image 25), which had a corresponding monitor device located on the wall in the main office. It is assumed that this device also provides remote control of the main entrance door. An intrusion alarm panel was observed at the main entrance (Image 26). A surveillance camera was observed at the exterior to the main entrance (image 27). Surveillance cameras were also observed throughout the interior of the school (Image 28), and at the exterior to a secondary entrance. Generally, cameras were not observed at all entrances or on the perimeter of the building. The one exception was what appeared to be a multi-sensor camera installed on one of the light poles at the front of the school (Image 29). Access control was not observed.

Limited exterior video surveillance and relatively few interior cameras compared to modern schools were observed.	Add additional surveillance cameras and necessary Network Video Recorder storage as part of any facilities upgrade project.
Limited intrusion system motion sensors were observed.	Add infrared motions sensors to all windowed spaces on the first floor. Ensure all exterior doors have contacts to sense a forced entry.
There is no Access Control System.	Add an Access Control system to provide greater management and control of personnel to the facility as part of any facilities upgrade project.

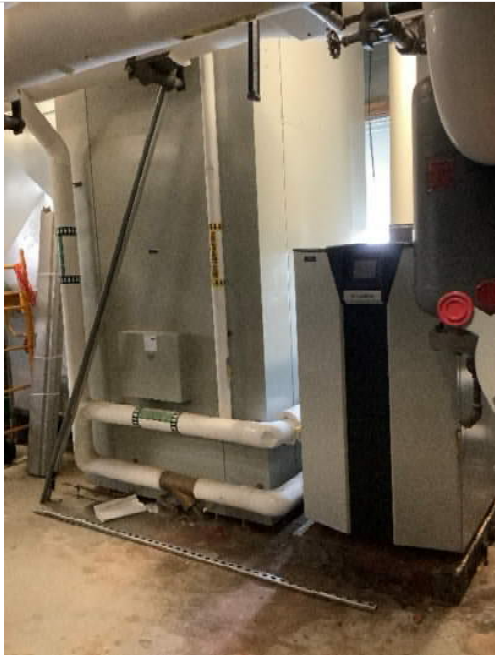
Image 11

The domestic hot water needs of the building are primarily supported by gas fired water heater and direct storage tank (image 11) to generate domestic hot water. The storage tank is Lochinvar Model TVC1250 with storage capacity is 1,250 gallons and water heater is Lochinvar Model AWN1500 with 1,745 GPH of recovery rate. The current configuration requires that the large water heater to remain active in summer whenever the building is occupied to generate hot water for the building fixtures is low. There is a mixing valve located on the discharge of the water storage tank which tempers the water for general building use (image 6). A separate tempering valve is provided at the locker rooms to support code required shower discharge temperatures. The science room has emergency shower (image 14) and lack mixing valve to supply tepid water. Kitchen has its own supply 140F of water to the dishwasher and pre rinse sink.

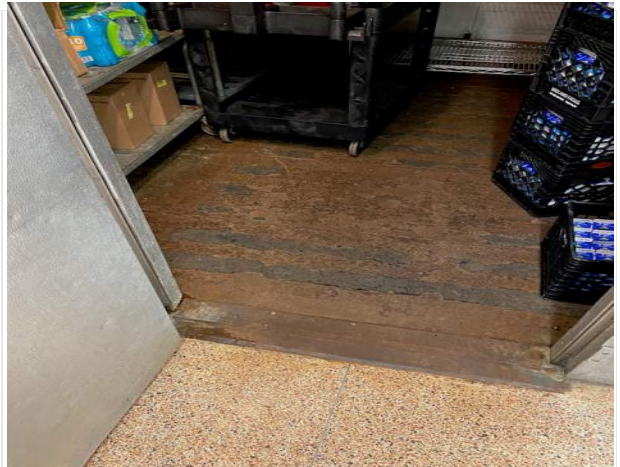
Image 6

Corrosion has set-in at the cooler floor and lighting level are poor and don't meet modern standards for lighting levels. Replace the walk-in cooler. (Image 6).	Replacement of the walk-in cooler and freezer is recommended.
The storage shelves within the walk-in cooler and freezer are original to 1968. The protective zinc coating on the shelving has begun to rub off and the shelves have failed. Additionally, zinc is no longer approved as a food contact surface due to zinc leach into food. (Image 7).	Replacement of the walk-in shelving is recommended. Replace with a non-corrosive shelving system.
Food Preparation Sink Piping The health code requires that the drain piping at food preparation sinks be air gapped to protect the food contact surface, in this case the sink bowl, from cross contamination in the event of a plumbing backup into the sink basin. (Image 8).	Modernizing the plumbing system is required in order to be complaint with modern health code standards.

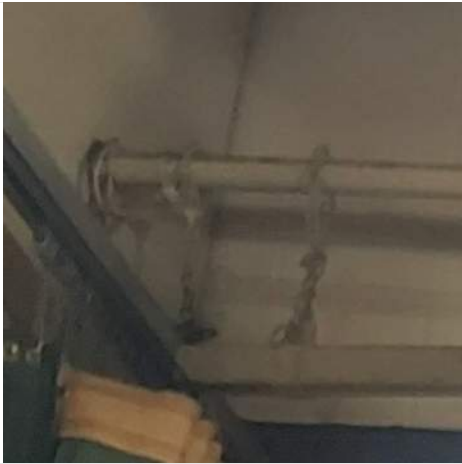
Image 11

<p>Rigging: The existing suspension hardware utilizes undersized (non-rated) chain and passing loop (Dog) chain, with unrated through bolts and "S" hooks to secure the ends. (Image 11, 12) The Valance "pipe" is currently made up of three (3) sections of galvanized electrical conduit held together with silver duct tape. (Image 9) The 20' side tracks are suspended only on the ends while the center points are not supported. (Image 5) There is an approximately 10' section of 2x4 tied to the building steel with knotted brown natural rope. (Image 10)</p>	<p>The existing rigging should be replaced / upgraded to meet current ANSI Standards. (See ANSI Standards on first page)</p> <p>Replace all suspension hardware, pipes and tracks, as well as supplemental support steel.</p> <p>Add new pipes for Valance, Borders, upstage scenic, and Lighting (x3). Replace all tracks.</p>
--	---
