AHERA Three-Year Re-inspection

**Walnut Square Elementary School**  
645 Main Street  
Haverhill, MA 01830

PROJECT: AHERA 3-Year Re-Inspection

SUBJECT: Walnut Square Elementary School  
645 Main Street  
Haverhill, MA 01830

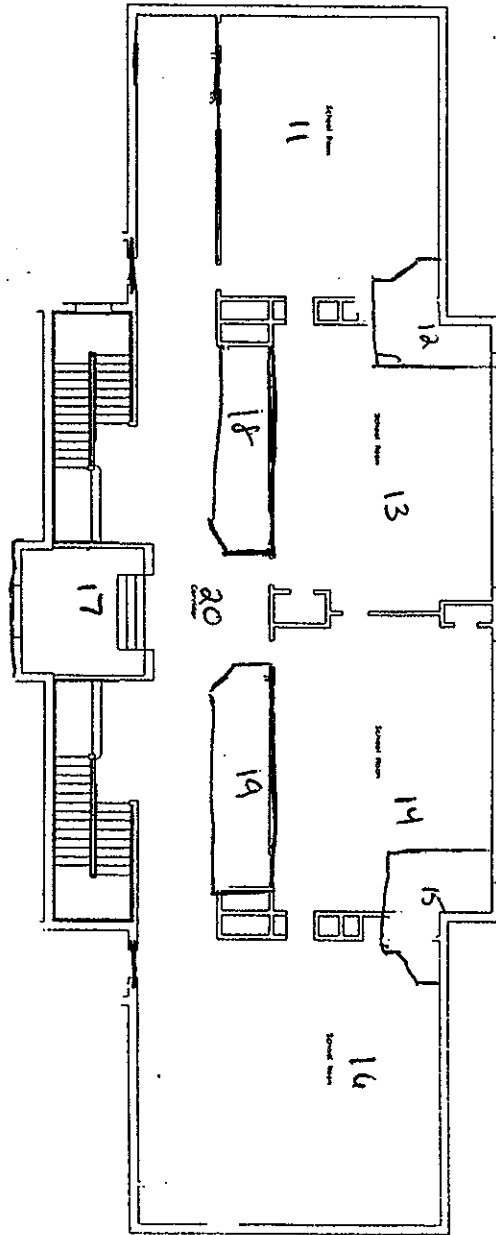
WALNUT SQUARE ELEMENTARY SCHOOL - BASEMENT PLAN

**02**  
 EXISTING  
 BASEMENT PLAN  
 DATE: 11/11/09  
 DRAWN BY: [illegible]  
 CHECKED BY: [illegible]  
 DATE: 11/11/09

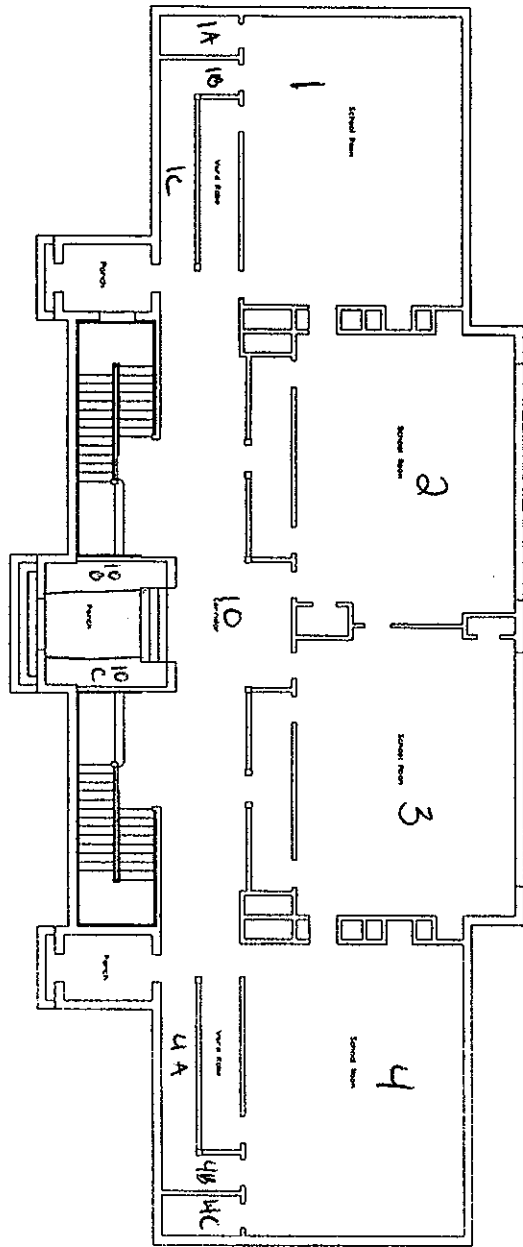
WALNUT SQUARE ELEMENTARY SCHOOL - BASEMENT PLAN  
1st

A102  
 EXISTING  
 BASEMENT PLAN  
 1st

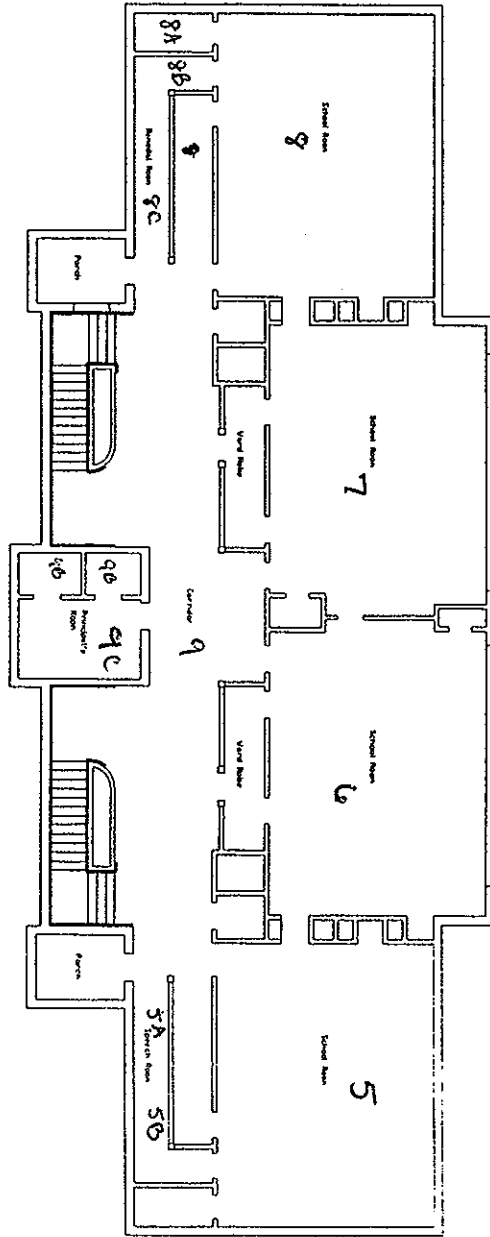
WALNUT SQUARE ELEMENTARY SCHOOL - THREE-FOOTER PLAN  
2nd

A103  
 DRAWN BY: J. M. B. 2.04.07  
 CHECKED BY: J. M. B. 2.04.07  
 DATE: 02/04/07

EXISTING FIRST FLOOR PLAN  
 SCALE: 1/8" = 1'-0"  
 DATE: 02/04/07
